# Whale Tail Mine - Landfarm

Agnico Eagle Mines Limited

## Construction Summary Report

6129-696-132-REP-001

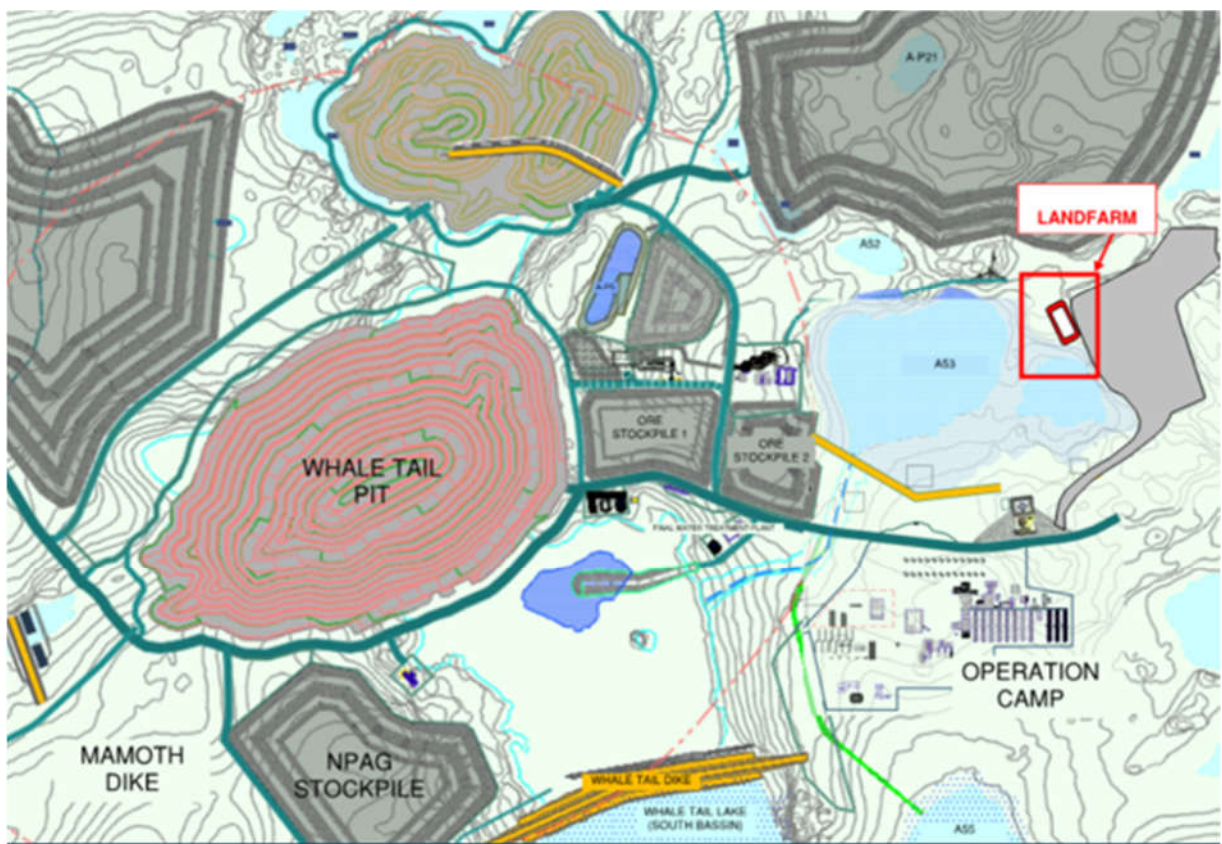
Figure 1 Landfarm Location

Agnico Eagle Mine Limited (AEM) Meadowbank Complex is developing the Whale Tail Mine in the Kivalliq Region of Nunavut (65°24'25" N, 96°41'50" W). The 99,878-hectare Amaruq property is located on Inuit-owned and federal crown land, approximately 55 km north of the Meadowbank Mine. The Meadowbank Mine is accessible from Baker Lake, located 70 kilometres to the south. The Whale Tail Mine, a Meadowbank satellite deposit located on the Amaruq property, is an expansion to the Approved Project (Nunavut Impact Review Board (NIRB) Project Certificate No. 008 and Nunavut Water Board (NWB) Type A Water License 2AM-WTP1830). The location of the landfarm at the mine site is shown on Figure 1.

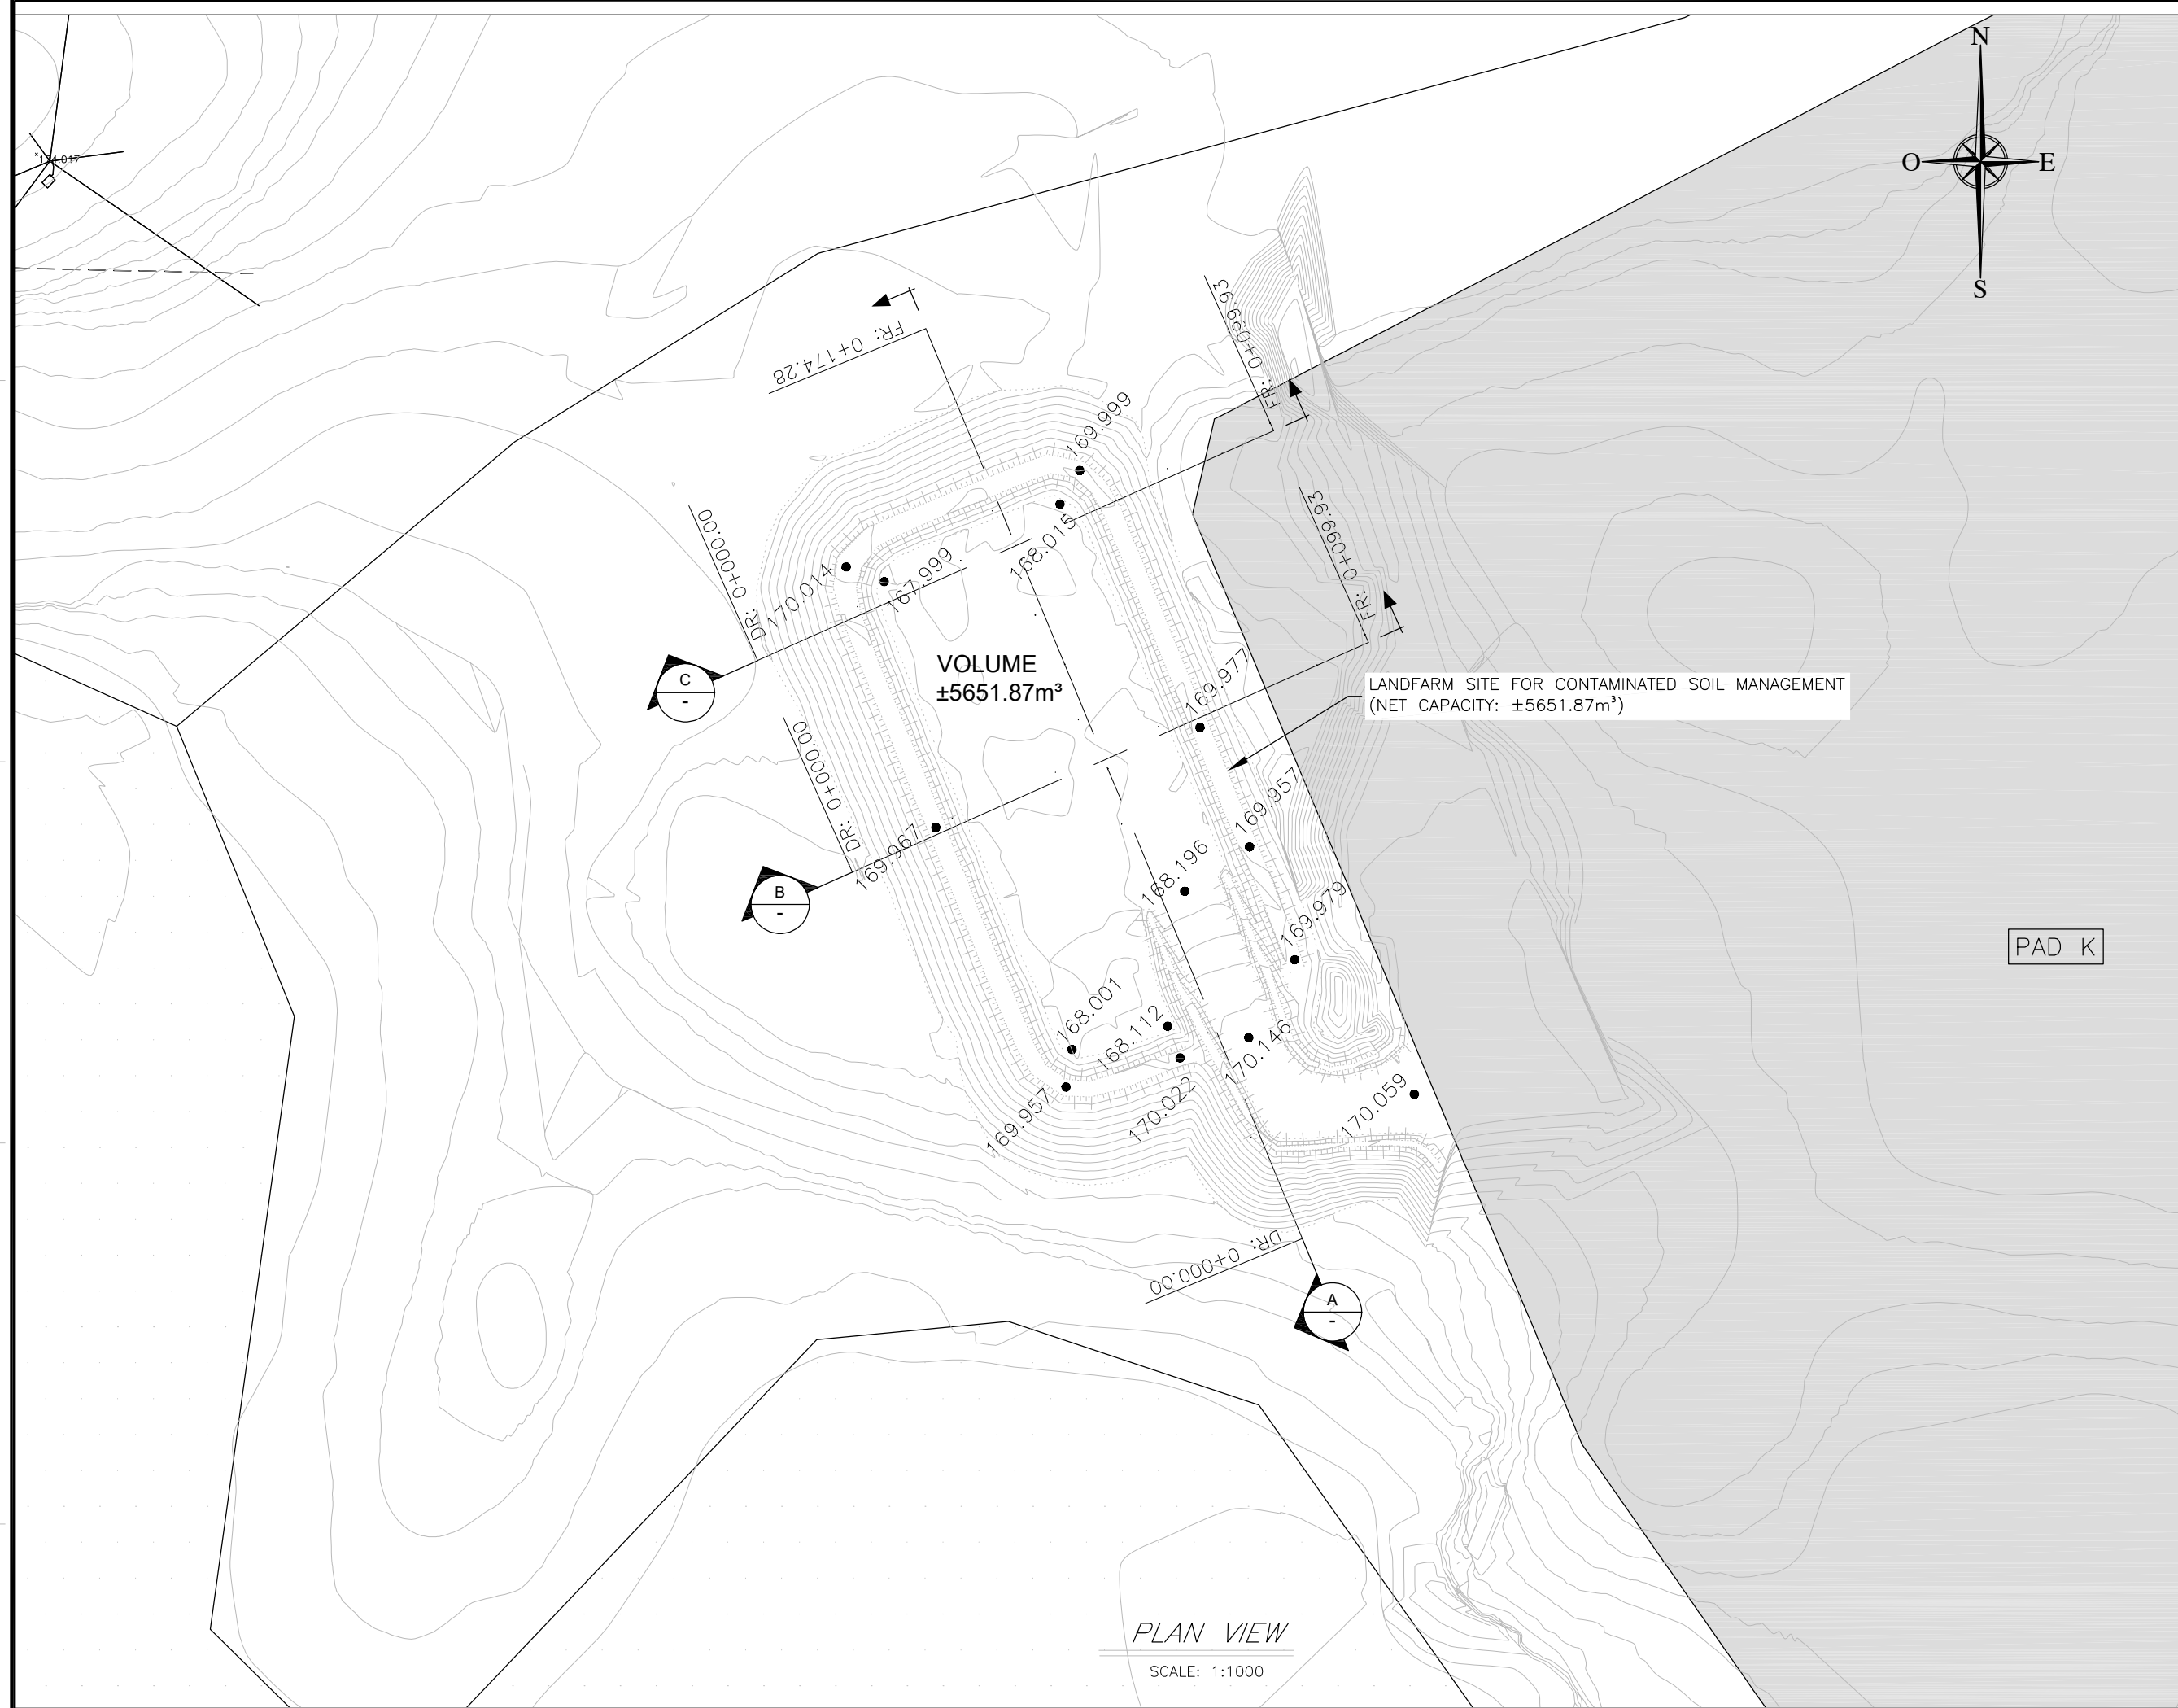
| # | THICKNESS | DESCRIPTION | UTILITY |
| 1 | 1500mm | MAXIMUM THICKNESS DESIGN HEIGHT FOR ACCUMULATION OF CONTAMINATED SOIL | USEFUL HEIGHT OF CONTAMINATED SOIL STORAGE FOR THE LANDFARM |
| 2 | 300mm | Ø0-20mm COMPACTED | SURFACE LAYER FOUNDATION |
| 3 | 550mm MIN. | Ø0-200mm BACKFILL MATERIALS COMPACTED | PROTECTION LAYER AGAINST PERFORATION OF THE GEOMEMBRANE BY HEAVY MACHINERY |
| 6 | 350mm | Ø0-20 mm COMPACTED | BEDDING OF THE GEOMEMBRANE |
| 7 | VARIABLE | 0-1000mm SUBGRADE BACKFILL MATERIALS | BASIN PERIPHERAL DIKE |

AS FINAL SURVEY VOLUMES :  
FOR CONTAINMENT BASIN AND ACCESS RAMP :  
- CRUSHED STONE Ø0-20mm = ±5 653.34m³  
- BACKFILL MATERIAL Ø0-200mm = ±2 530.26m³  
- BACKFILL MATERIAL Ø0-1000mm = ±16 804.5m³

**Table 4** compares the value of design parameters with the actual parameter value after construction. The after-construction values were calculated based on as-built drawing 6129-696-142 (Appendix B). Values listed as “By AEM” will be supplied by AEM.

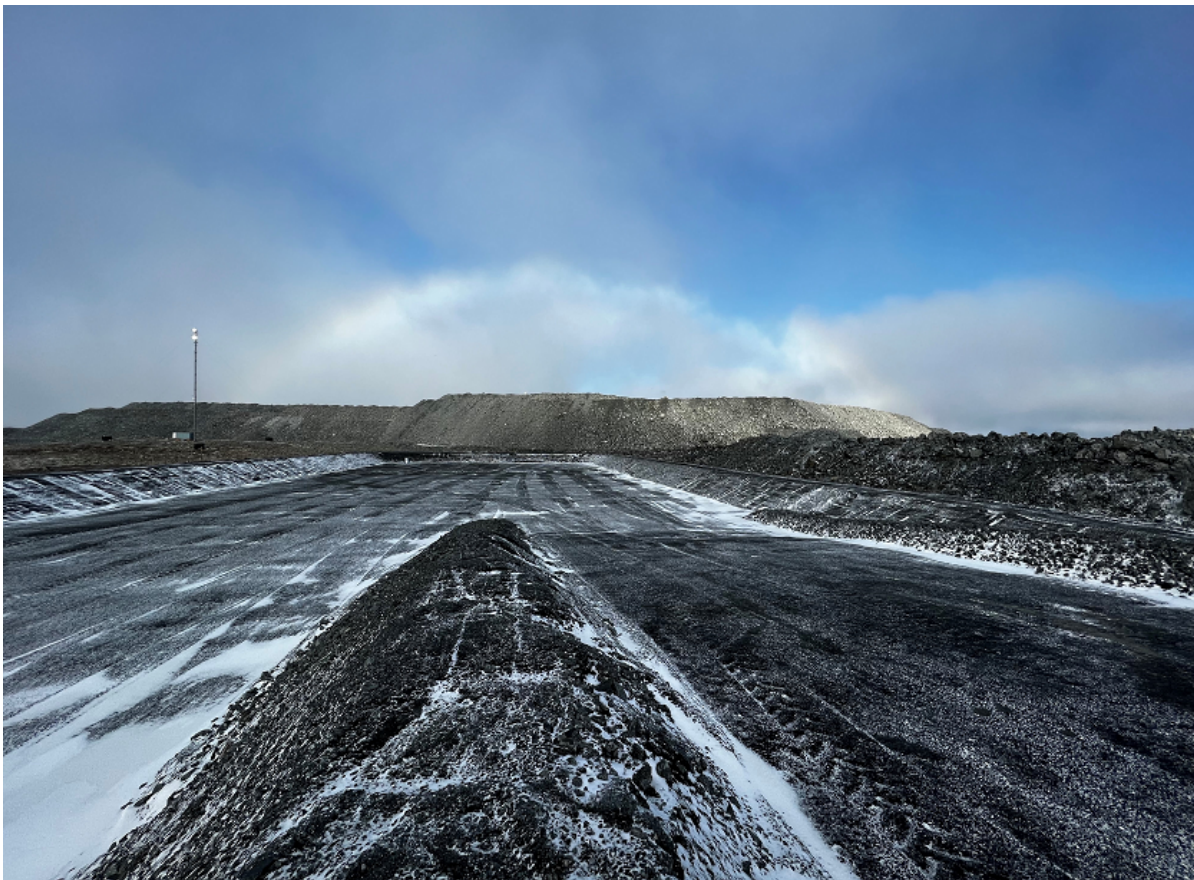
Landfarm Vehicle Ramp

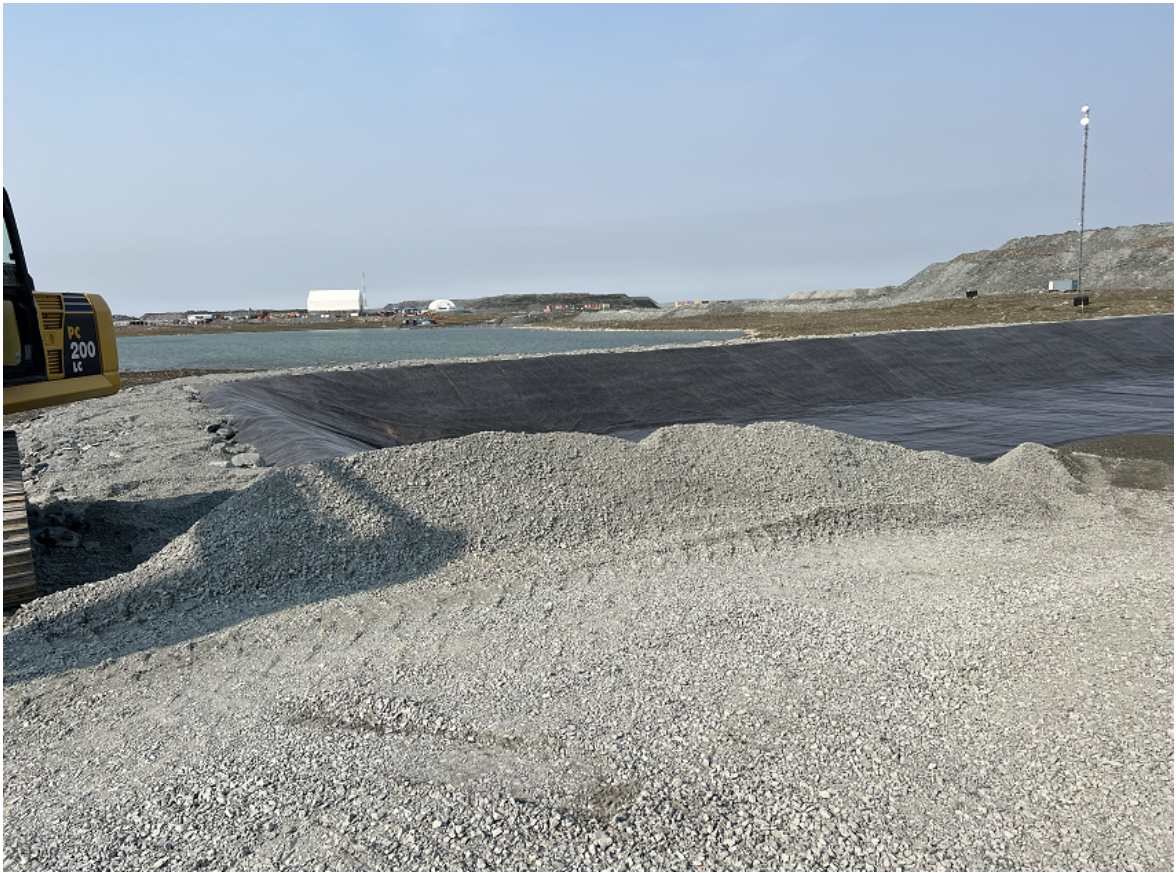
Geomembrane Installation

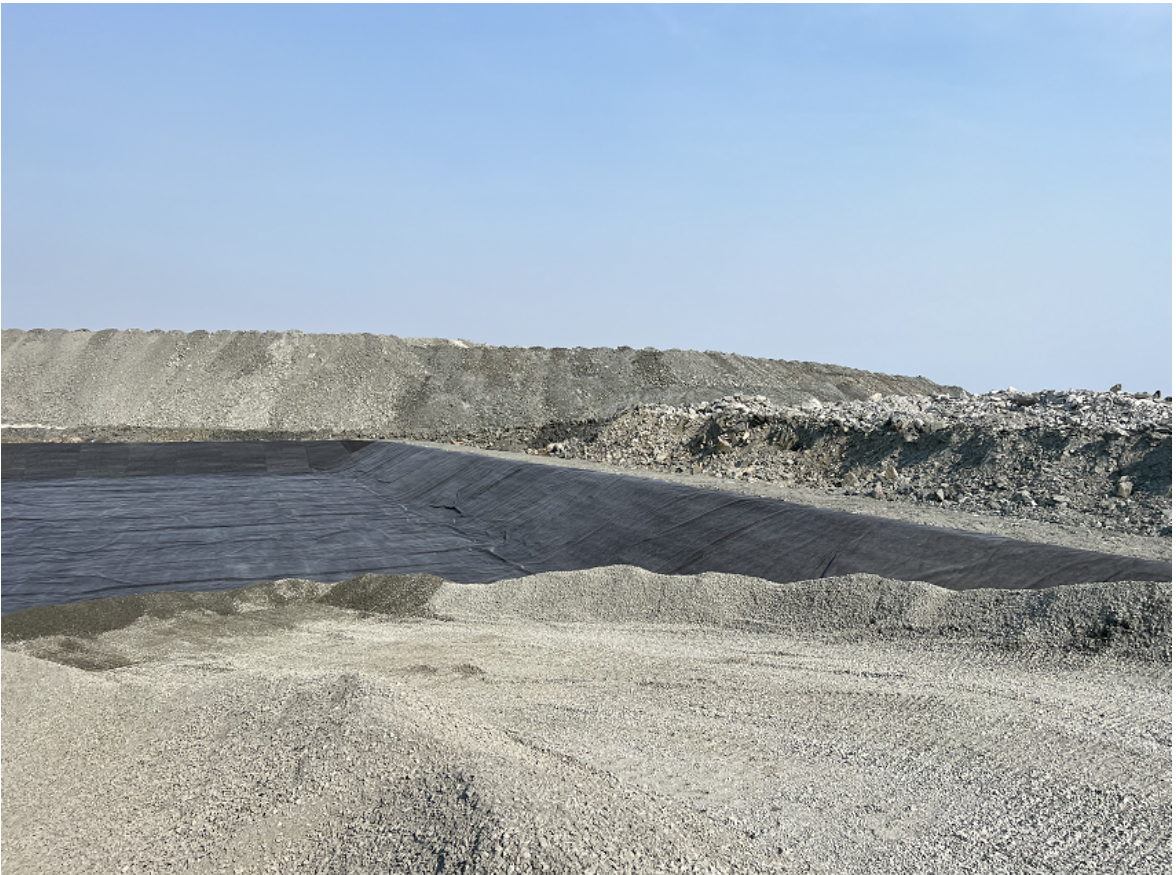
Geomembrane Installation
