# Assistance during construction of the water management and geotechnical infrastructures at the Amaruq project

As-Built Report of Whale Tail Dike – Report Only

Agnico Eagle Mines Limited

Report > Original > Rev. 00  
Internal ref. 658309-0000-56ER-0001

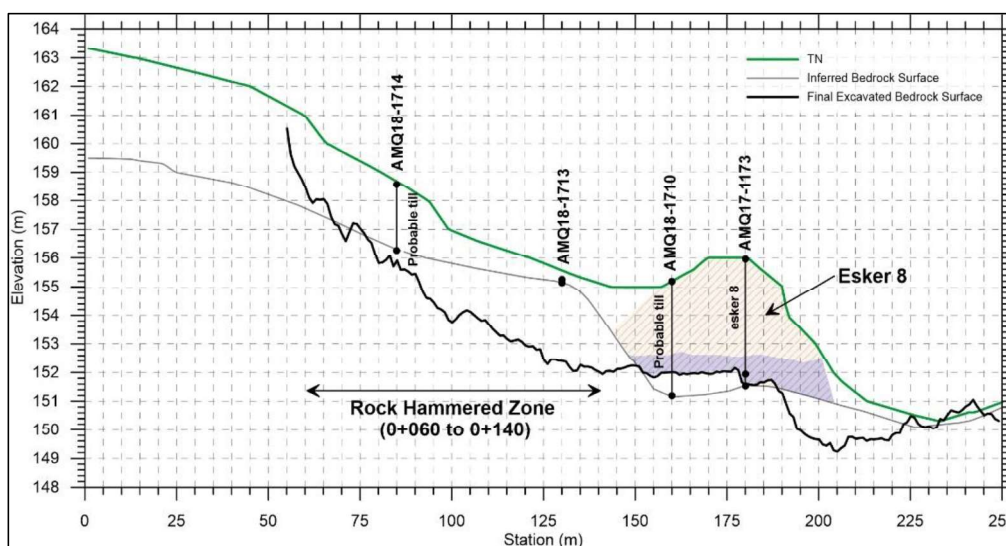
Following the excavation of the abutment, it was assessed that the slurry trench would be built between Stations 0+069 and 0+092 and the first secant pile from station 0+089 going eastward, based on actual bedrock profile and the minimal 1.5 m depth operational requirement for secant pile drilling.

**Figure 3-1: Excavation of the West abutment**

No ice lenses were observed during the excavation of the esker material at the west abutment (up to station 0+130), or into the bedrock. From Station 0+155 to 0+180, bedrock surface was significantly above inferred bedrock surface. Excavation activities were performed with caution in this zone to make sure that it was indeed the bedrock surface and not remaining frozen esker material. The excavation from Station 0+060 to Station 0+140 ended in bedrock. Bedrock in this area was found to be highly fractured and irregular with outcrops that required additional excavation of the foundation with a hydraulic rock hammer mounted on an excavator to obtain a reasonably even surface. The smooth surface was required to ease a good compaction of fine filter and to reduce risks of problems during the installation of the piles.
