2019-09-27 WTP FUEL TRUCK 3500 LITERS DIESEL

GN reference # : 2019-403

Please find the following information as a follow up to the Spill report submitted September 28, 2019 by Agnico Eagle Meadowbank division. This detailed report is submitted to the Inspector in compliance with the conditions under the Nunavut Water Board License 2AM-WTP1826, Part H, Item 8c.

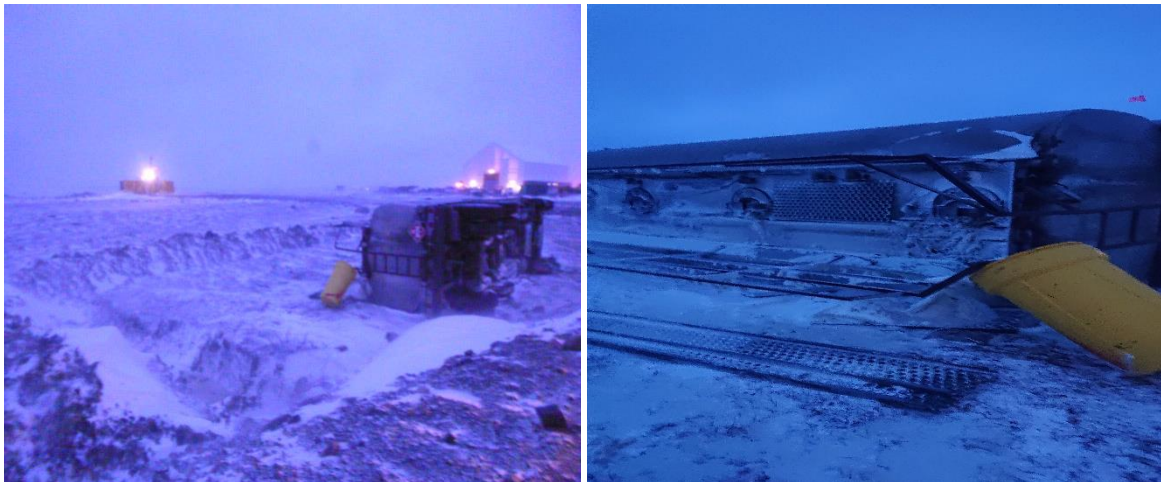
Fuel truck operator was returning from his fuel run at Whale Tail pit when he lost sight of the road due to poor visibility (blowing snow) and went off the road, tipping on its side. The fuel tank did not rupture but fuel was leaking out of the breather vents.

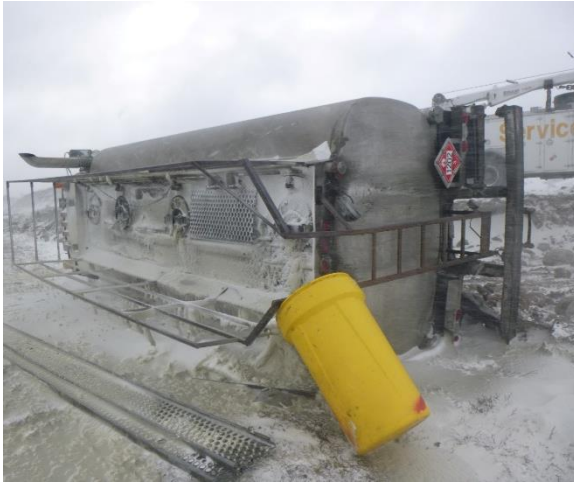
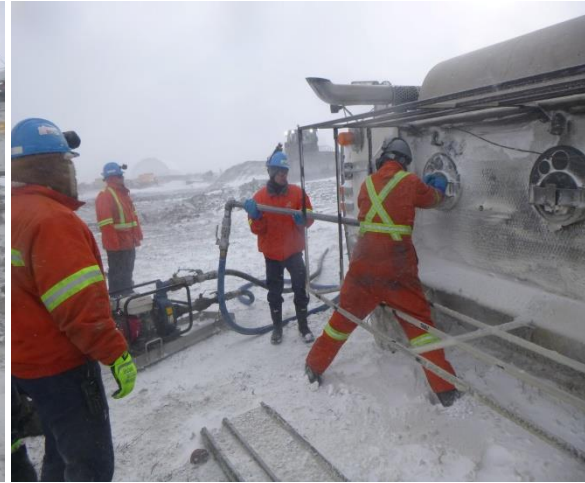
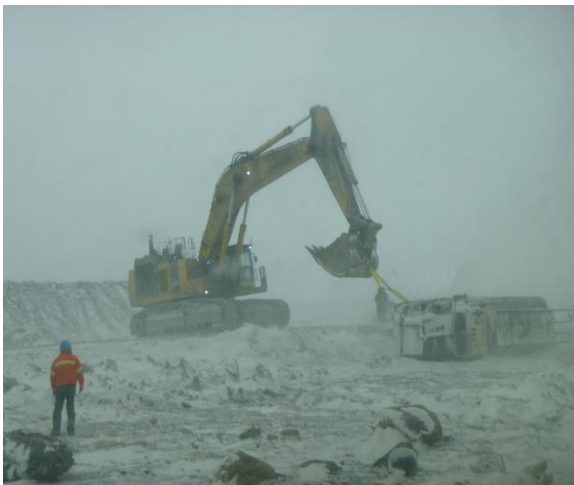
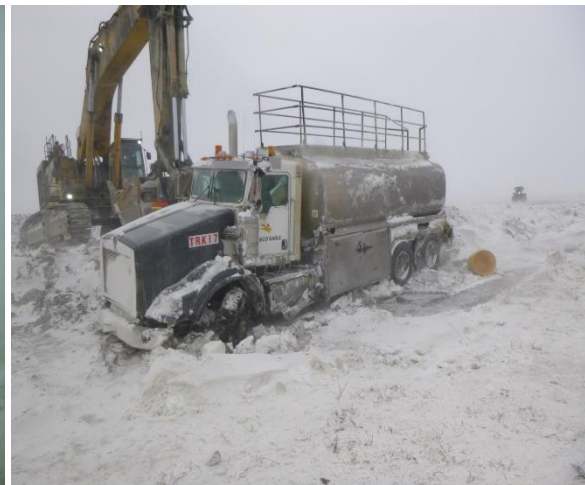
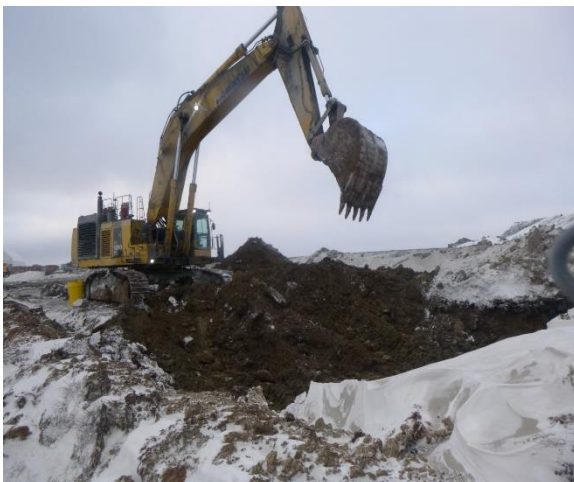
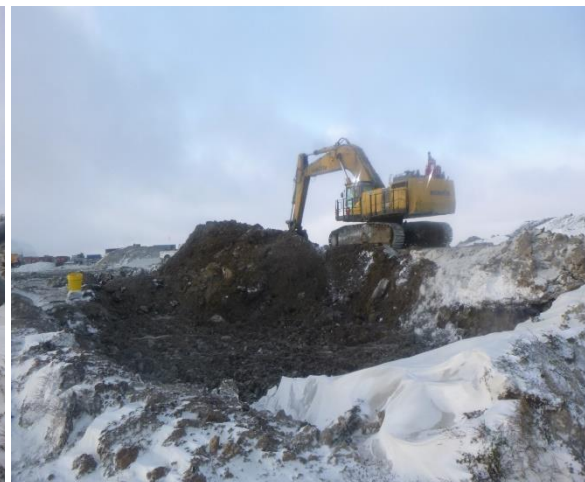
Spill pads and booms were placed on the ground, a small sump and perimeter trench was dug to collect any further fuel from going into the tundra. The fuel in the truck was pumped into another fuel truck and tipped upright. The fuel in the sump was pumped into totes and sent to the HazMat area with the spill pads and booms. Once the truck was removed from the scene, the contaminated material was scraped, collected and brought to the Meadowbank landfarm. Approximately 120m³ of contaminated material was collected.

During low visibility conditions when a fuel run is required to maintain operating equipment, a truck escort will be provided. High vis flags have also been installed on road where the spill occurred.
