2021-03-01 Whale Tail - Tote 150L Waste Oil

GN reference #: 2021-050

Spill Description

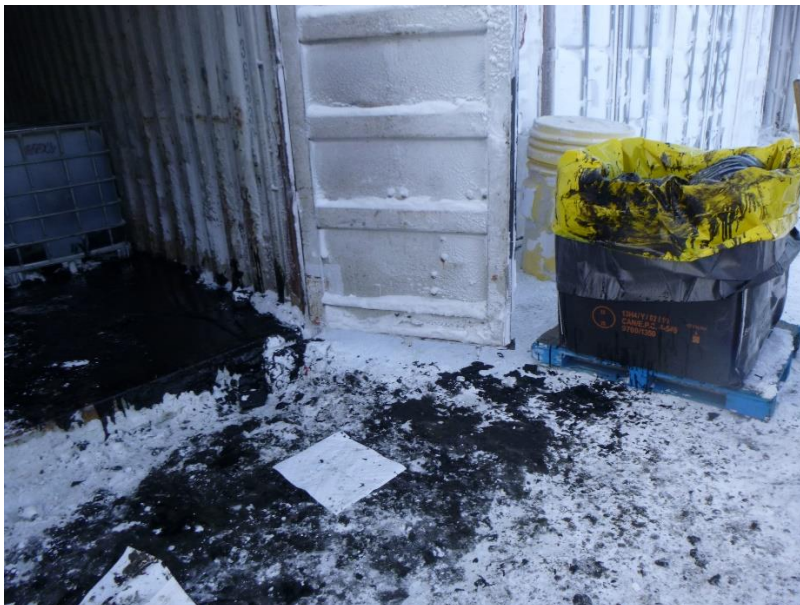
During operations at Whale Tail Pit Project, a waste oil tote containing 1000L of oil was punctured by a telehandler at the Hazmat area. The operator of the equipment quickly flipped the tote and placed it to drain in secondary containment. Approximately 8m² of the ground surface was contaminated. Contaminated soil was collected and transported to the Meadowbank land farm.

Use of improper tools resulted in the punctured tote. Forks of the telehandler were too long.

A discussion with Hazmat crew regarding the use of the proper tools for the job. Ensure that the equipment has the correct sized forks for the activity.
