## 2023-06-06 WTM 500L Waste Oil

GN reference #: 2023-244

Please find the following information as a follow up to the Spill report submitted June 7<sup>th</sup>, 2023, by Agnico Eagle Meadowbank division. This detailed report is submitted to the Inspector in compliance with the conditions under the Nunavut Water Board License 2AM-WTP1830, Part H, Item 8c.

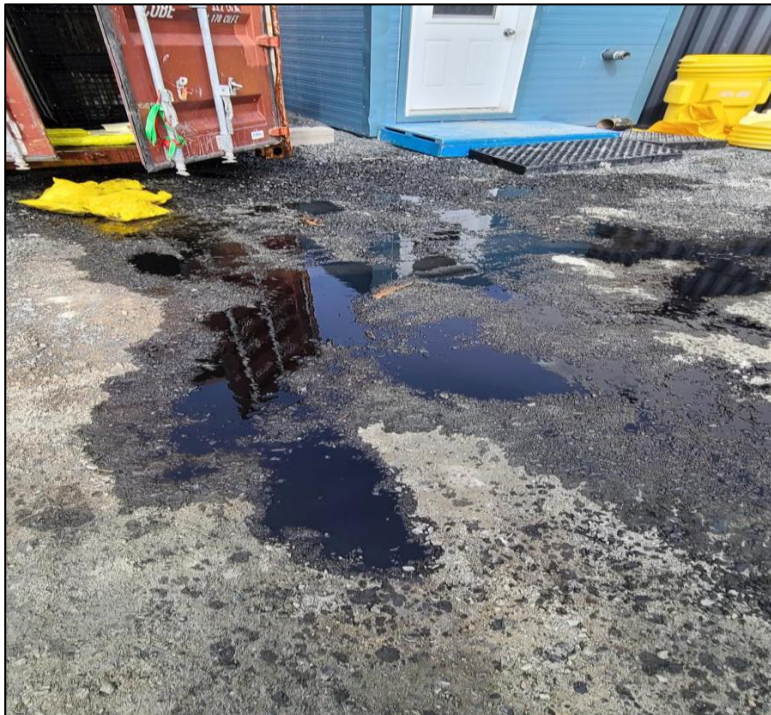
During operations at the Whale Tail Mine, an operator was placing a waste oil tote into the seacan with a forklift. While trying to adjust the tote, the forks on the forklift punctured 2 totes of waste oil, causing to spill onto the ground and floor of the seacan.

Spill Location: N65' 24'23 W96'40'47.2" on IOL

Punctured tote caused by misalignment of the equipment forks.

The totes were flipped over to prevent additional oil from leaking out of the sea-can and absorbent pads were placed on the floor of the sea-can. The oil in the punctured totes was transferred to a new tote. The area was immediately scraped clean and approximately 7m3 of contaminated material was collected and disposed of at the Whale Tail Mine Landfarm.

The incident was reviewed with all operators within the department. A site wide initiative requiring a spotter when manipulating totes and any other hazardous product with forked equipment has been implemented until the formal procedure has been created. A handling procedure is being created for site-wide training of all forked equipment.
