2023-06-25-WTM 200L Diesel Fuel

GN reference #: 2023-281

Spill Description

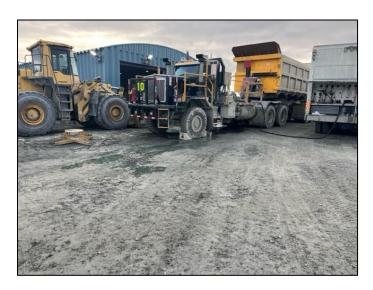
While replacing a tire on long haul truck 10 at the Whale Tail Mine, a loader made contact with the refueling adapter. The damage from the contact resulted in the release of approximately 200L of diesel fuel on the ground.

Spill Location: N 65'24'10.00" W 96'40'49.00"on IOL

There were no off-site impacts or discharges. Distance to the closest water body is 560 m to Whale Tail South

Loader tire manipulator contacted wiggins quick fueling system.

After conducting a thorough review of the incident, the crew was briefed on the situation. Subsequently, the operating procedure detailing the necessary precautions and safe distances to be maintained during the operation of the loader tire manipulator and the fueling system was reviewed to ensure that all personnel involved are familiar with these procedures and adhere to them strictly.

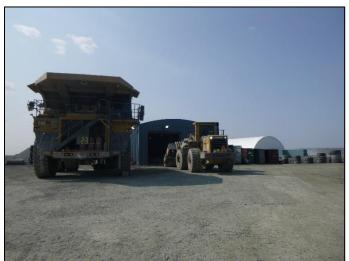
The loader operator immediately contacted the maintenance team and began containing the spill with absorbent material. Approximately 8m³ of contaminated material was collected and brought to the Whale Tail landfarm. All contaminated absorbent material was collected and disposed of as per the waste management plan.
