2024-05-03 WTM 25m3 Sewage

GN reference #: 2024-132

Please find the following information as a follow up to the Spill report submitted May 4<sup>th</sup>, 2024, by Agnico Eagle Meadowbank division. This detailed report is submitted to the Inspector in compliance with the conditions under the Nunavut Water Board License 2AM-WTP1830, Part H, Item 8c.

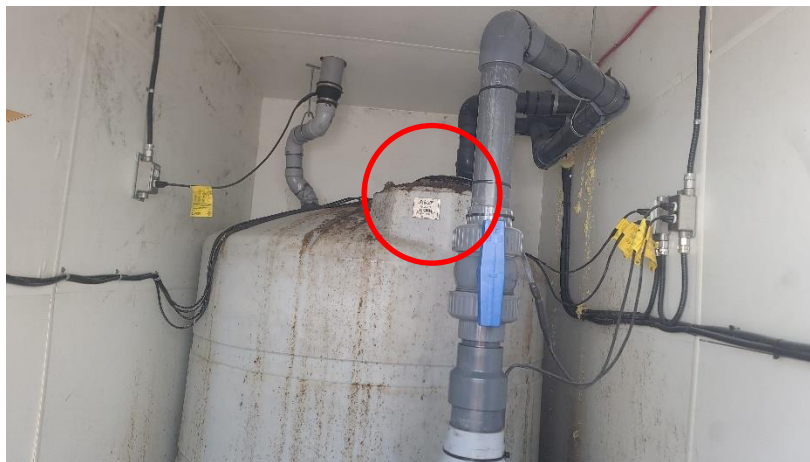
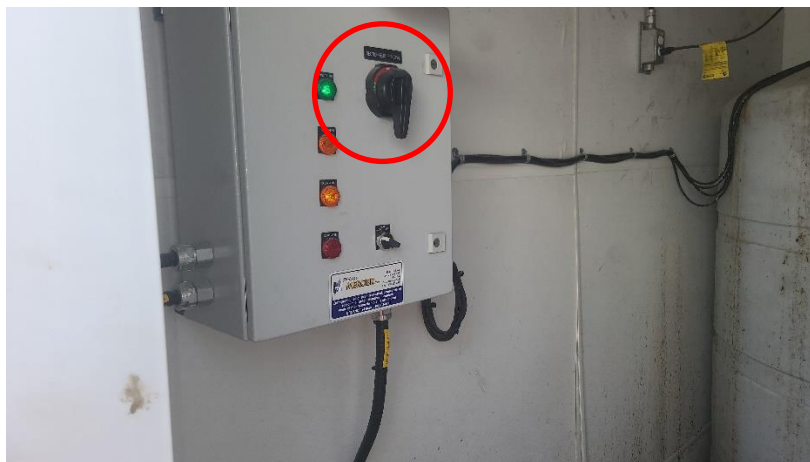
During a routine review inspection of the lift station between wings 24 & 25, an employee noticed a strong odor. Upon investigation the employee found that the lift station holding tank had overflowed. As a result, an estimated 25m<sup>3</sup> of sewage leaked out of the transfer tank filling the floor of the building before ultimately flowing under the camp. Upon investigation the switch that controls the automatic floats & pumps in the transfer tank was left in the off position. This resulted in a build up of pressure in the transfer tank and ultimately the failure of the transfer tank.

Upon discovery workers immediately collected the excess sewage contained in the building and repaired the transfer tank. The contaminated material that was accessible was collected with a sewage truck and disposed of at the Meadowbank tailings area. ~10m<sup>3</sup> of contaminated snow and ice was also disposed of at the Meadowbank tailings area. Due to the location, time and nature of the spill additional remediation work will occur later in the spring when the ground has thawed to allow for better recovery of contaminated material.

Additional alarm systems are being installed on all other transfer tanks that can connect to the on-site HMI system. A high-level alarm with flashing light will also be installed in an area visible to the operators.
