2024-08-01 WTM 70L Diesel Fuel & Coolant

GN reference #: 2024-293

Spill Description

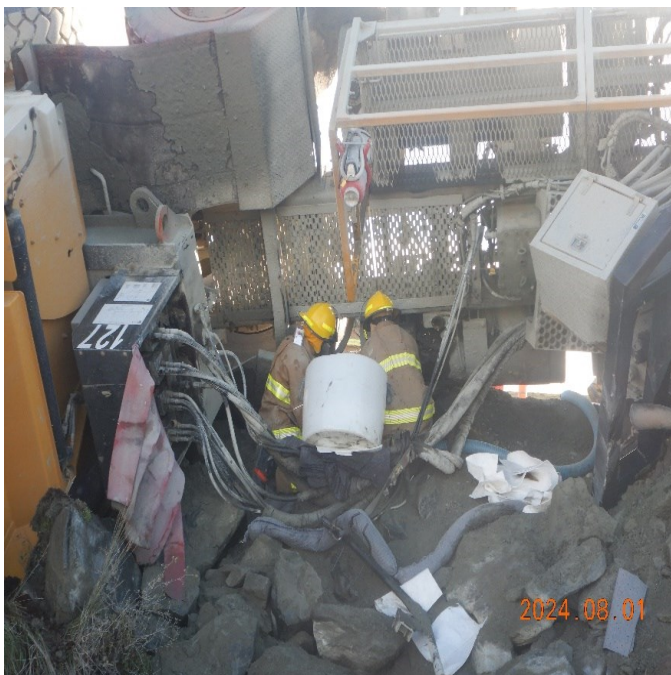
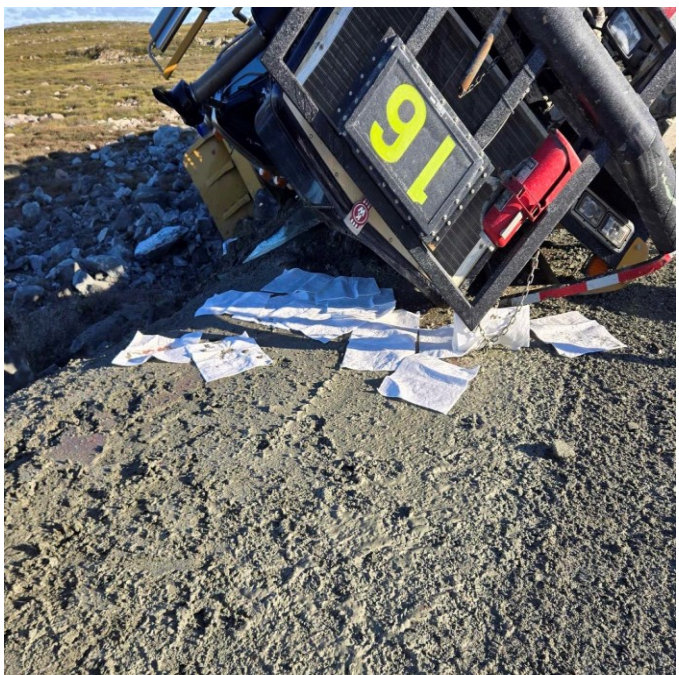
While heading southbound on Whale Tail Haul Road, a long-haul truck tipped over off the road at kilometer 124. A Code 1 was immediately initiated, and the emergency response team (ERT) was deployed. The ERT notified the environment department of a diesel fuel leak from the truck's fuel tanks. Secondary containment was placed under the leak, absorbent material was deployed on the contaminated surface, and a vacuum truck was brought in to collect the liquid. The spilled diesel fuel was contained within the road footprint. Following confirmatory discussion after the event it was determined that only 50L of diesel fuel and 20L of coolant leaked out of the equipment. At the time of the accident, it was calculated the long-haul would contain ~850L of fuel. Following the incident debrief it was discovered the vacuum truck collected a total of 800L of diesel fuel from the fuel tank.

There were no off-site impacts or discharges. Distance to the closest water body is 300m to Pipedream Lake

Following the retrieval of the equipment, material was collected and separated between the ore and the contaminated material. ~1m³ of contaminated material was collected and brought to the Meadowbank landfarm. Absorbents were collected and brought to the Meadowbank hazmat storage area.

Upon completion of an investigation, a review of operating procedures and best practices will be completed during safety meetings for all drivers. The dangers of distractions while driving will also be reviewed. LHT team will identify potential distractions for operators and address them to reduce or eliminate similar events from reoccurring.
