## 2025-01-24 WTM Coolant Diesel Hydraulic Oil

GN reference #: 2025-084

Please find the following information as a follow up to the Spill report submitted January 25<sup>th</sup>, 2025, by Agnico Eagle Meadowbank division. This detailed report is submitted to the Inspector as requested; as due diligence and without prejudice by Agnico Eagle Mines Ltd. and in accordance with the conditions under the Nunavut Water Board License 2AM-WTP1830, Part H, Item 8c.

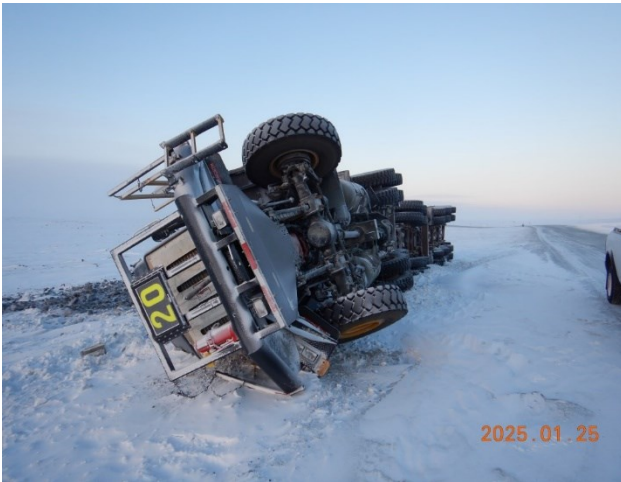
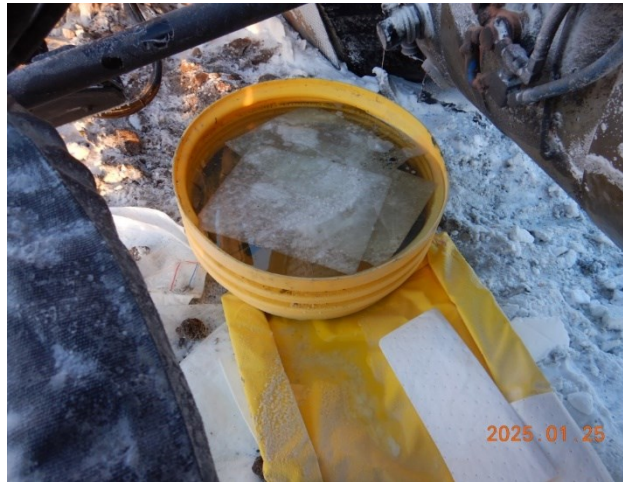
Spill location: 65°19'23.61"N, 96°26'56.77"W on IOL

During operations at Whale Tail Mine, a long-haul truck was travelling southbound along the Whale Tail Haul Road and went off the road at KM163. Environment was advised by ERT that multiple leaks were observed at the scene.

The spill was located along the Whale Tail Haul Road. There were no off-site impacts or discharges. Distance to the closest water body is 170m to an unknown Lake.

Human Error. Operator failed to stop when visibility degraded.

A review of the Whale Tail Haul Road management plan was completed and updated. The updated plan was shared with all LHT operators as well as a site wide communication regarding the procedure.
