## 2025-01-28 WTM 10L Sewage

GN reference #: 2025-088

### Spill Description

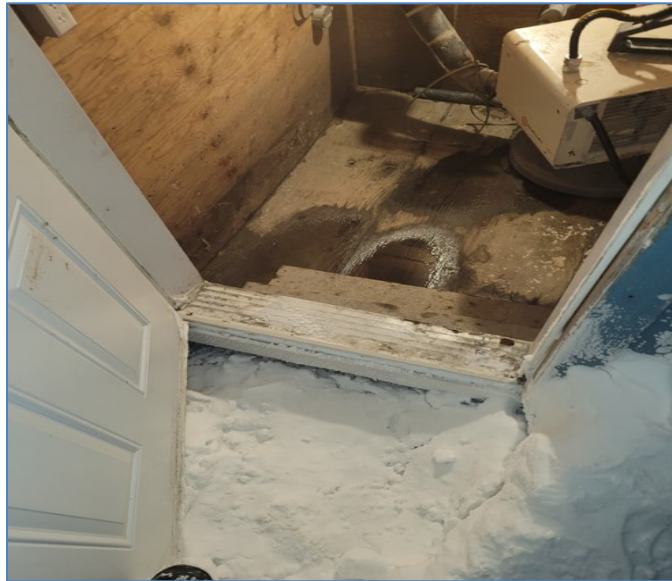
During operations at Whale Tail Mine, a lift station pump became plugged with foreign material (baby wipes). As a result, the lift station containment overflowed into the building and approximately 10L of sewage spilled onto the ground.

Spill Location: 65°01'.51"N 96°09'21"W (on IOL)

The spill remained within the mine footprint. There were no off-site impacts or discharges. Distance to the closest water body is ≈360m to lake A-56.

Human Error – Non-Flushable wipes were improperly disposed of into the septic system.

The foreign objects were removed from the septic system. Lids for lift stations to be secured down after inspections. The contaminated snow and material was collected and placed in a roll off for disposal at the Meadowbank Tailings Storage Facility.

General site reminder to all camp residents of proper hygiene product disposal.
