2025-07-31 WTM 300L Hydraulic Oil

GN reference #: 2025-316

Please find the following information as a follow up to the Spill report submitted August 1st, 2025, by Agnico Eagle Meadowbank division. This detailed report is submitted to the Inspector in compliance with the conditions under the Nunavut Water Board License 2AM-WTP1830, Part H, Item 8c.

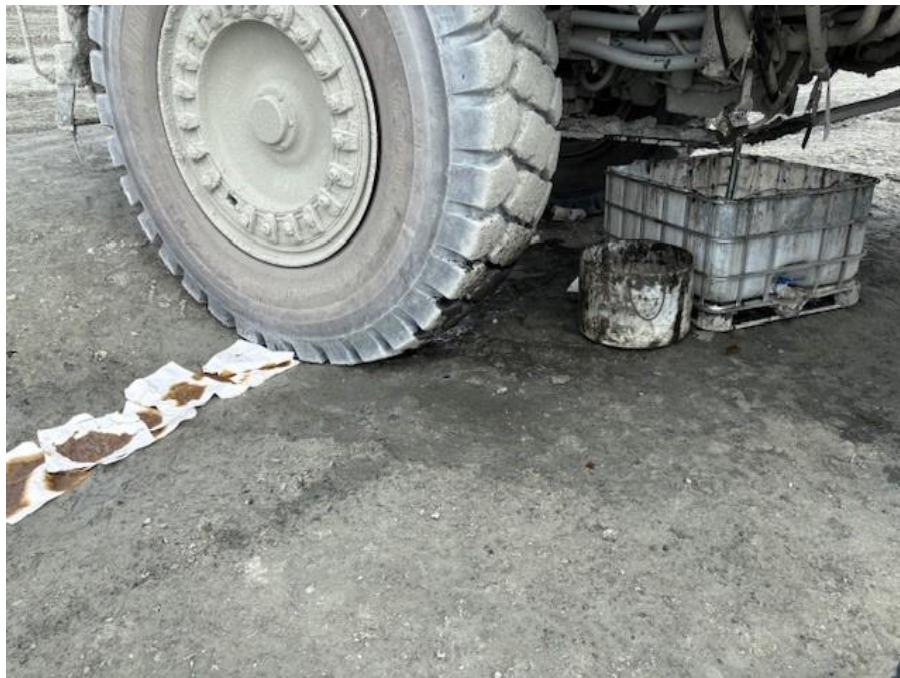
During operations at the Whale Tail Mine, a haul truck was offloading material at the Whale Tail rock facility when a dozer attempted to assist by lifting the truck box using the corner of its blade. During this maneuver, the dozer blade inadvertently struck and damaged the truck's hydraulic tank. Unaware of the damage, the operator drove the truck back to the camp parking area. The hydraulic oil leak was only discovered after the operator returned from lunch, at which point ≈300 liters of hydraulic oil had spilled onto the camp parking area. The spill did not occur in an active excavation or deposition area.

The spill remained within the mine operations footprint. There were no off-site impacts or discharges. Distance to the closest water body is 600m to Lake A55.

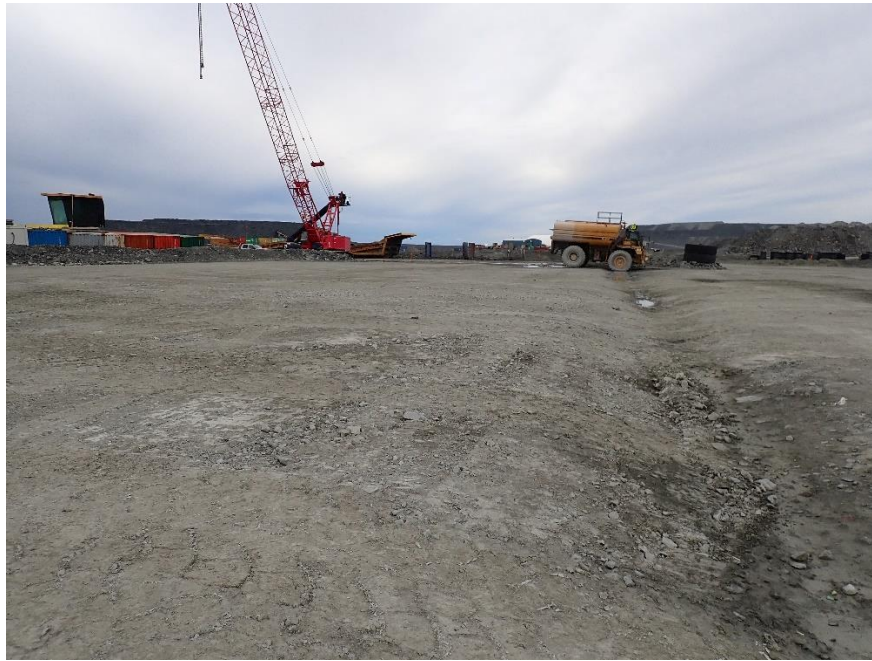
Upon discovering the spill, a secondary containment was placed beneath the equipment to capture the leaking hydraulic oil. A heavy equipment was deployed to scrape the area where the spill occurred. All contaminated material was removed and brought to the Whale Tail Landfarm.

The incident will be reviewed with all operators to reinforce the importance of adhering to established procedures and authorized practices. Additionally, an investigation is underway in collaboration with the Health and Safety department to identify and implement best practices moving forward.
