2025-10-12 WTM 600L Windshield washer fluid

GN reference #:2025-411

Spill Description

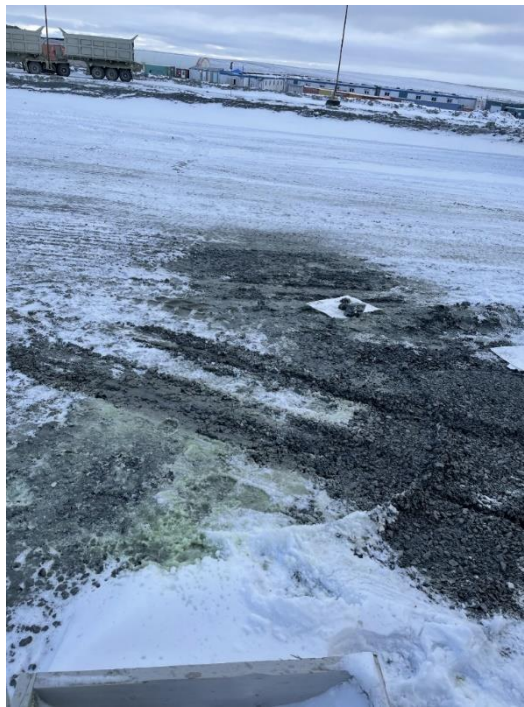
During operations at the Whale Tail Mine, a hose connected to a windshield washer fluid tote was inadvertently left open, resulting in a spill of approximately 600 liters onto the ground at the fuel farm pad. The windshield washer fluid spilled is a methanol-based product.

Spill Location: 65°24'10.0"N 96°39'59.7"W on IOL

The spill remained within the mine operations footprint. There were no off-site impacts or discharges. Distance to the closest water body is approximately 375m to Lake A56.

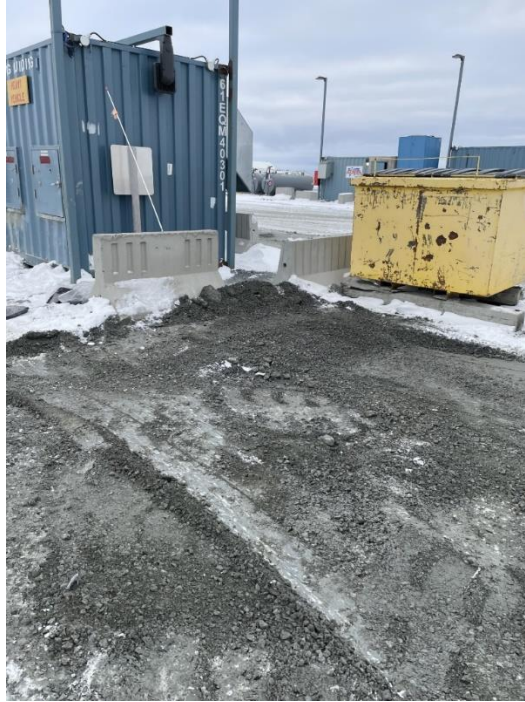
The main valve on the tote was subsequently closed to stop the release. A loader was dispatched to collect the contaminated material, which was transported to the Meadowbank Tailings Storage Facility for disposal.

As a preventive measure, a sign was installed to increase user awareness about closing the valve on the system. Additionally, modifications to the hose support were completed. The design of the windshield washer fluid dispenser will also be reviewed, and appropriate modifications will be implemented if deemed necessary.
