2025-11-05 WTM Coolant Diesel Hydraulic Oil

GN reference #: 2025-431

Spill Description

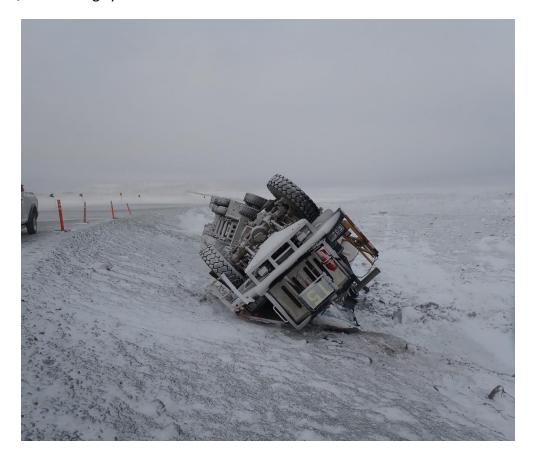
While heading southbound on Whale Tail Haul Road, a long-haul truck left the road at kilometer 177. A Code 1 was immediately initiated, and the emergency response team was deployed. The Environment team also attended to assess the situation. Multiple leaks were observed originating from the diesel fuel reservoir, hydraulic system, and cooling system.

Human Error. Operator failed to stop when visibility degraded.

A health and safety investigation was initiated to identify the root cause of the incident and establish appropriate corrective actions. One corrective measure implemented was the addition of color markers on rebars to clearly delineate the designated area. Furthermore, the incident was reviewed with all drivers to reinforce awareness and prevent recurrence.

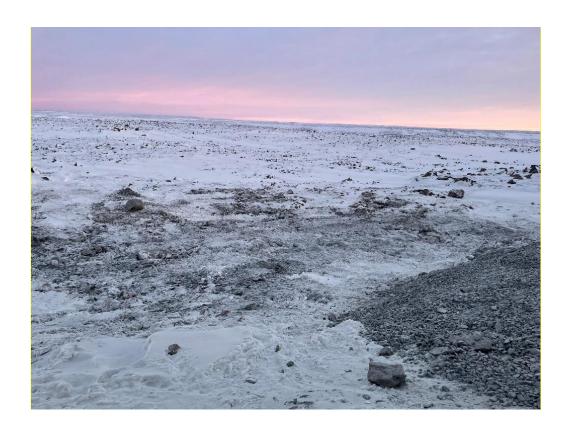
A secondary containment was place under the active leak. After further investigation a total of approximately 350L Diesel, 5L of Hydraulic Oil, and 10L of Coolant spilled from the long haul. Contaminated materials were removed and brought to tailing storage facility at the Meadowbank Complex.
