2025-12-23 WTM DIESEL COOLANT HYDRAULIC OIL

GN reference #: 2025-469

Spill Description

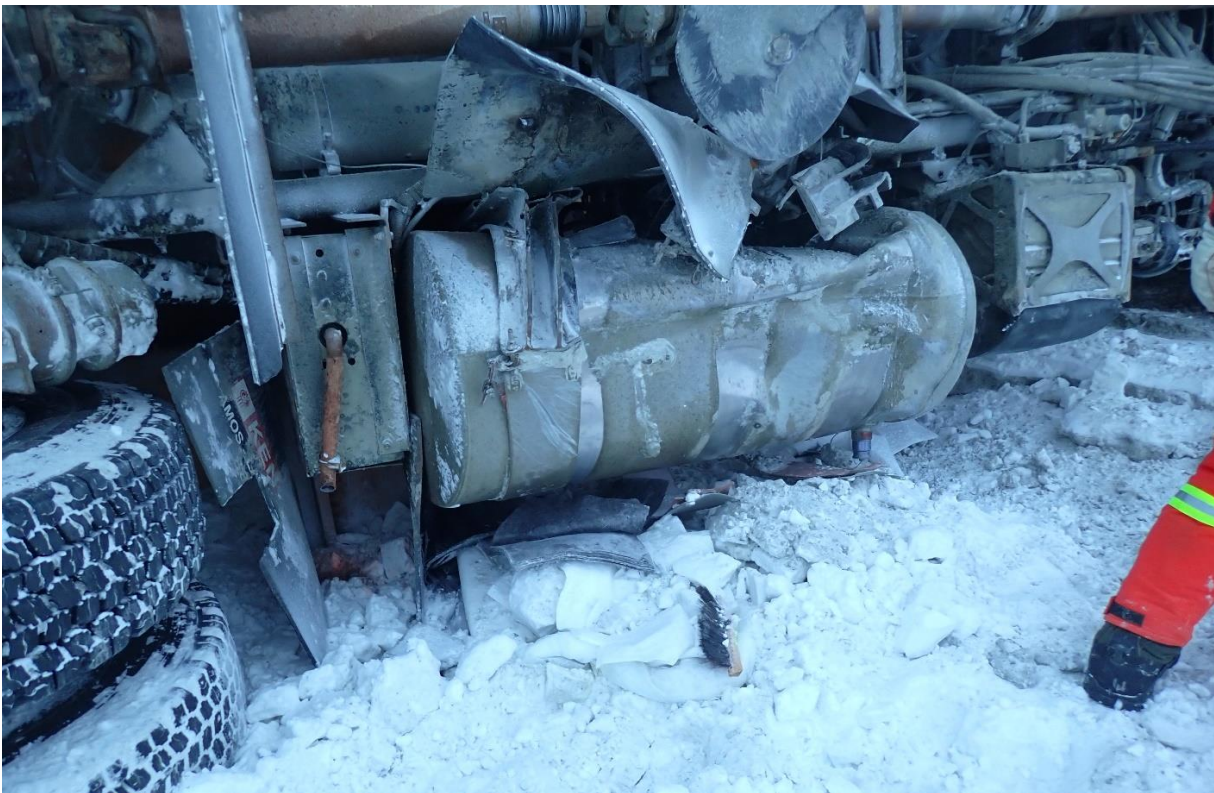
Spill Location: 65°11'28.80 96° 9'43.80

During operations along the Whale Tail Haul Road, a snow plow veered off the roadway at approximately km 132. As a result, an estimated 250L Diesel, 5L of Hydraulic Oil, and 5L of Coolant were released onto the ground.

The spill was located along the Whale Tail Haul Road. There were no off-site impacts or discharges. Distance to the closest water body is ~550m to C25-C26 stream

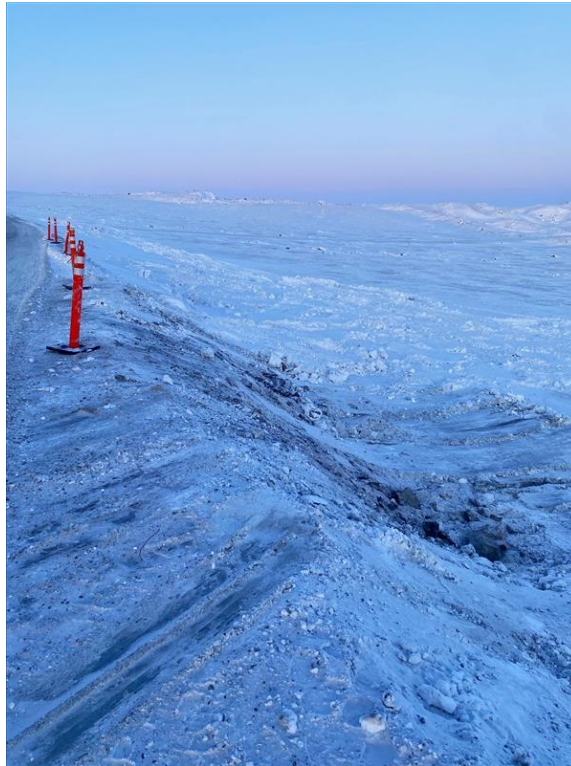
A secondary containment and absorbent pads were placed under the active leaks. After further investigation a total of approximately 250L Diesel, 5L of Hydraulic Oil, and 5L of Coolant spilled from the equipment. Contaminated materials were removed and brought to tailing storage facility at the Meadowbank Complex.

A health and safety investigation was initiated to identify the root cause of the incident and establish appropriate corrective actions. Furthermore, the incident was reviewed with all drivers to reinforce awareness and prevent recurrence.
