WHALE TAIL MINE

# **Monitoring Program Summary Report**

**June 2026**

Type A Water License 2AM-WTP1830

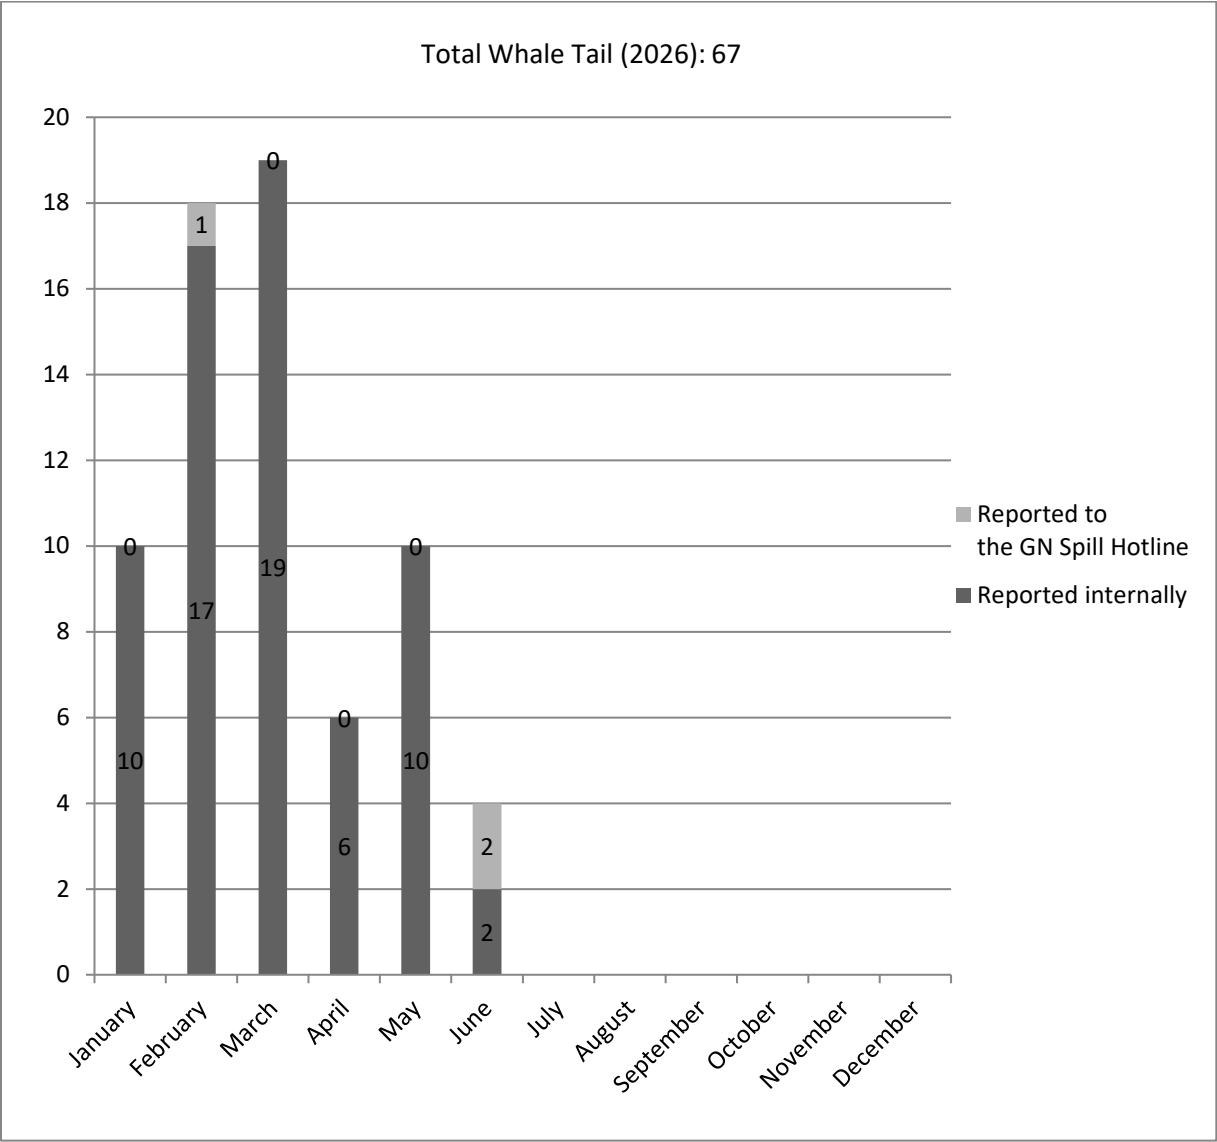
**Figure 3.1 2026 Reported and Non-Reported Spills**

Figure 3.1 shows reported and non-reported spills for 2026 broken down per month and Table 3.1 summarizes Agnico Eagle spill reports for June.

Four (4) spills occurred on site during the month with two (2) reported to regulators. Spills were contained and cleaned, contaminated material was disposed to the appropriate area, and the clean-up actions were monitored closely by the Environment Department.
