Water and Ore/Waste Rock Management Plan for the Boston Site, Hope Bay Project, Nunavut

SRK Consulting (Canada) Inc.
1CT022.009
January 2017

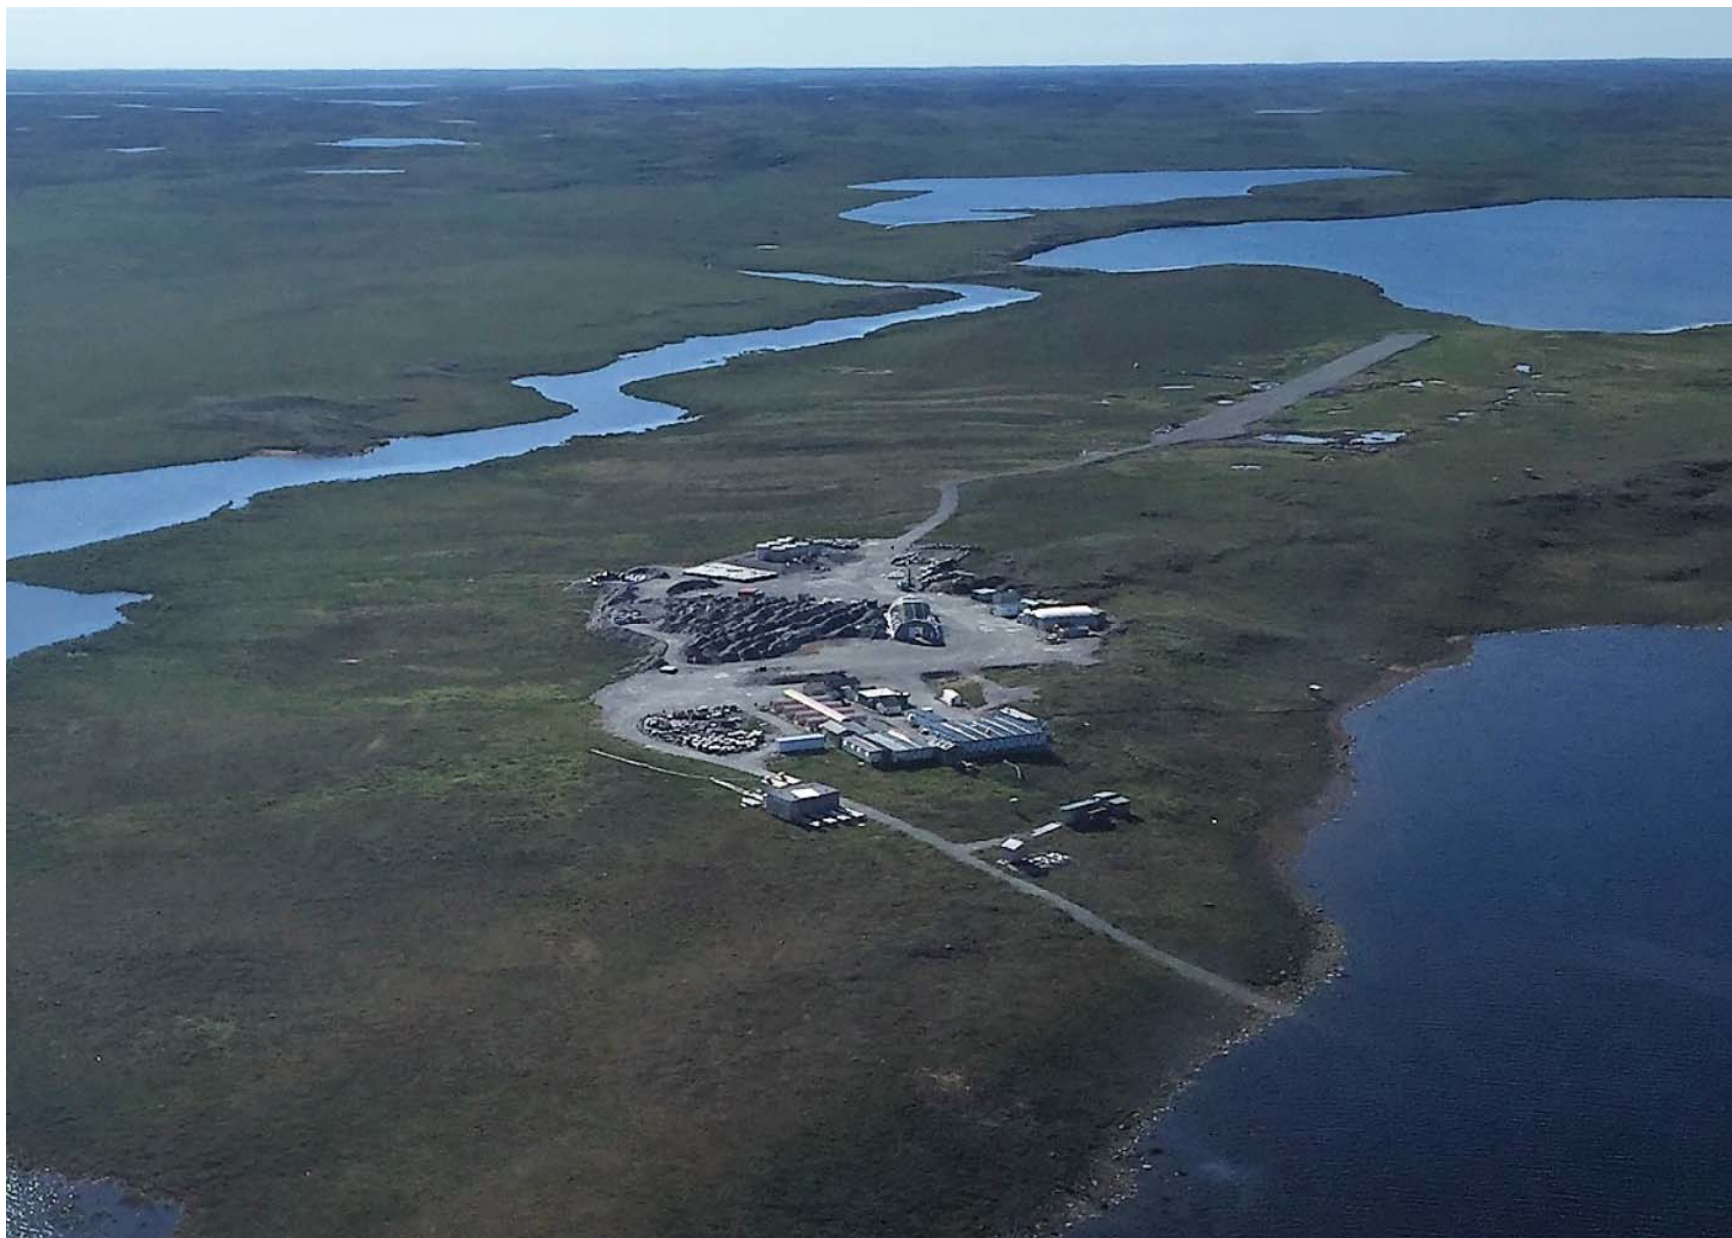
Figure: **2.1**

**Aerial Photograph of
Boston Camp, July 2016**

Aerial photos taken in July 2016 (Figure 2.1) and (Figure 2.2) as well as maps showing the original configuration of the ore stockpiles (Figure 2.3), illustrate the change in stockpiles configuration compared to previous years. A detailed inventory of the ore stockpile area in 2008 indicated the absent stockpiles were mostly ore material from the 1997 campaign (SRK 2009b - Supporting Document A). Volumetric calculations indicate that almost half of ore may have been redistributed to other locations on the site. A substantial portion of this material was used in the construction of the tank farm berm and the remainder has been used as surfacing material.

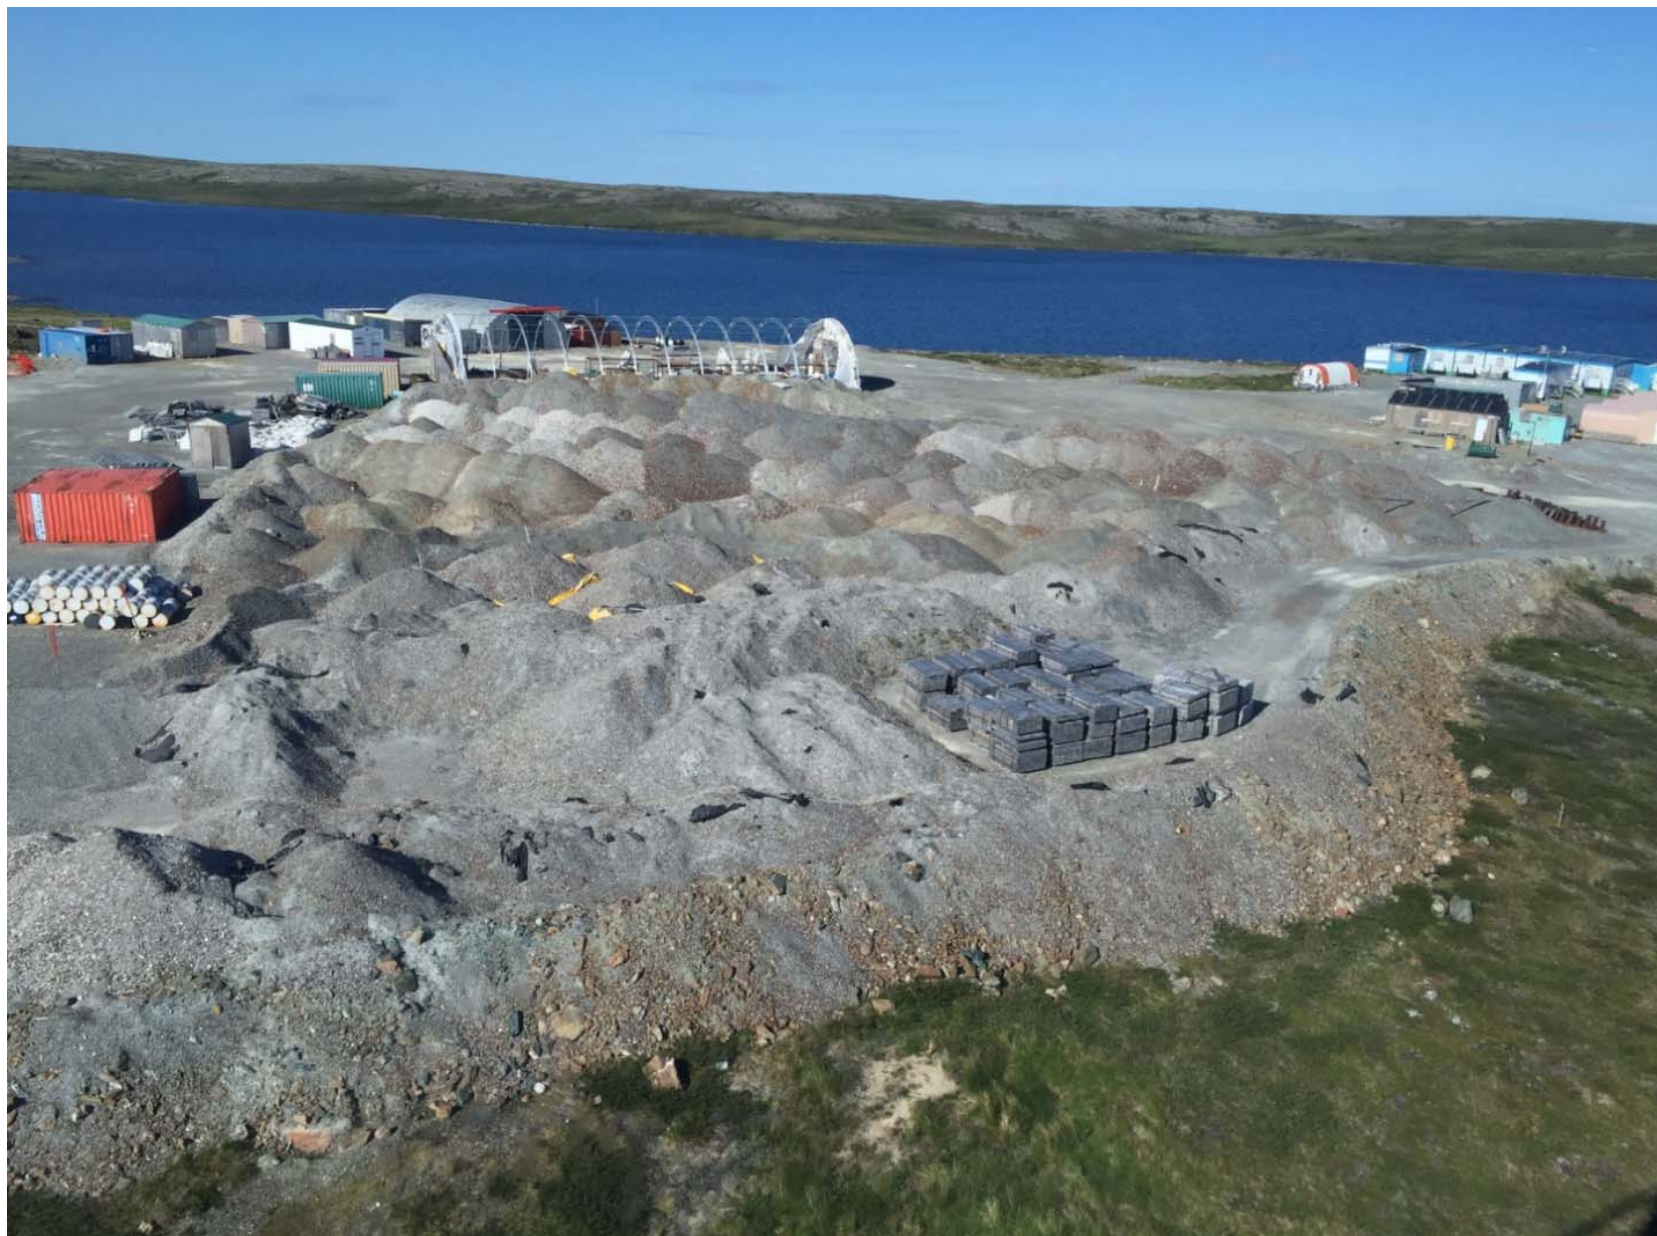
Figure: **2.2**

**Aerial Photograph of
 Boston Camp ore Piles, July 2016**
