NWB1BOS9801

July 11, 2000 Water Licence Inspection - Report

INDUSTRIAL WATER USE INSPECTION REPORT

Date: 2000/07/11 Company Rep.(Name/Title): Hugh Wilson / Manager, Environmental Affairs
Licensee: Miramar Mining / Hope Bay Gold Licence No.: NWB1BOS9801

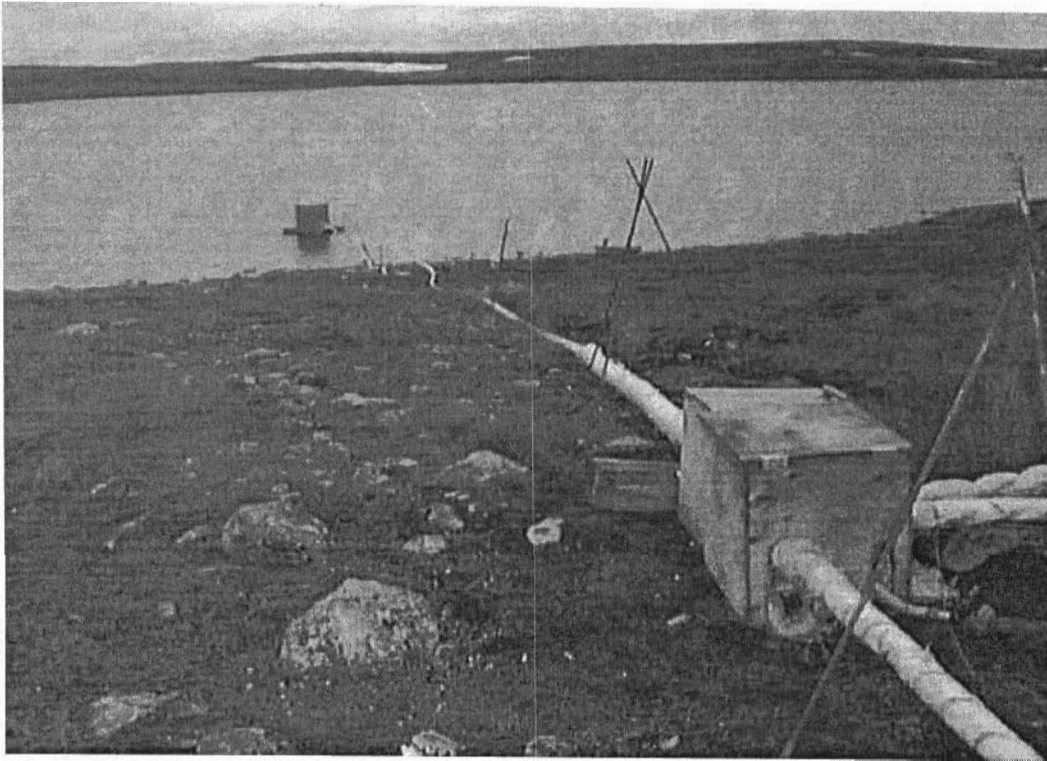
figure 1. Active water intake station; 2000/07/11.

- Water supply: At the time of the inspection, minimal information relating to the temporary modifications of the water intake line (see figure 1) had yet been made available by the Licensee. Since then however, an amendment to the Water licence has been requested, and duly approved. The Inspector also acknowledges that the Licensee intends to install an additional gauging device, thus allowing for distinct domestic and industrial water use measurements. On a side note, the attached analytical results reveal that parameters sampled at Surveillance Network Program (SNP) station 162-1a lie within the *Guidelines for Canadian Drinking Water Quality* standards.

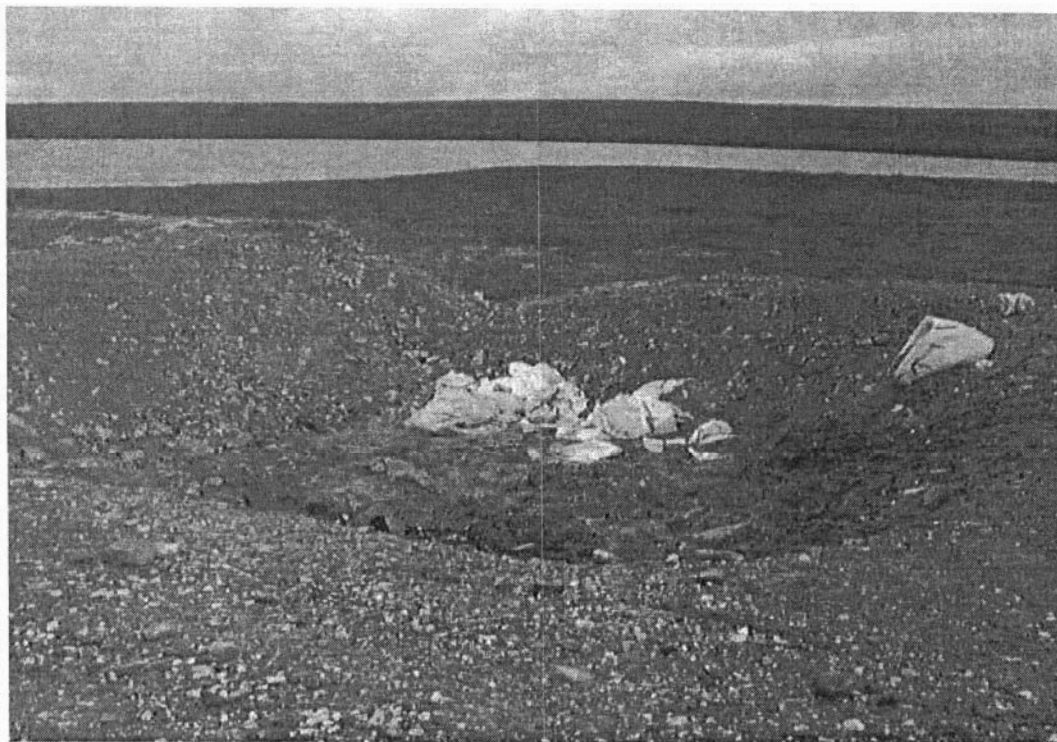
Comments: Sumps in and around the main ore stockpile are in a deteriorated state, and their usage or purpose is unclear. Drill sites by the airstrip show noticeable scarring and protruding drill casings. The incidence, and path of discharge, of water released from the underground workings both require a certain degree of clarification.

figure 2. Unlined sump in periphery of the ore storage pad; 2000/07/11.

- Ore and waste rock stockpiles: The purpose of the three (3) sumps in the vicinity of the main ore stockpile area is at the moment somewhat unclear. Indeed, while the Inspector was informed on-site that both outer sumps, whether unlined (figure 2) or lined (figure 3), were essentially unused or at best only fulfilled a contingency role, other notifications appear to point to slightly more active use. Consequently, the Licensee would eliminate much confusion by outlining the current/planned use of the sumps located at the periphery of the ore storage pad. In parallel, the function of the lined holding pond (figure 4) situated in the middle of the ore storage pad, labelled *Original Pond* on the *Boston Gold Project Site: Land Use Plan*, is equally ambiguous. As such, the Inspector would more than welcome clarifications relating to the nature, and eventual discharge path, of its contents.

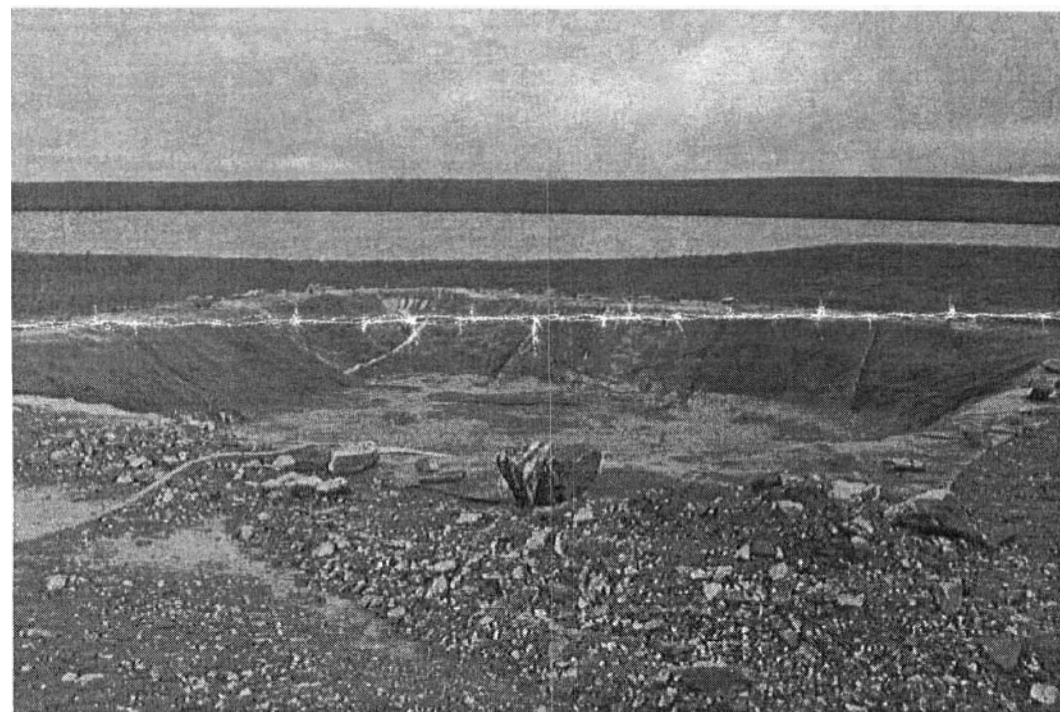
figure 3. Lined sump in periphery of the ore storage pad; 2000/07/11.

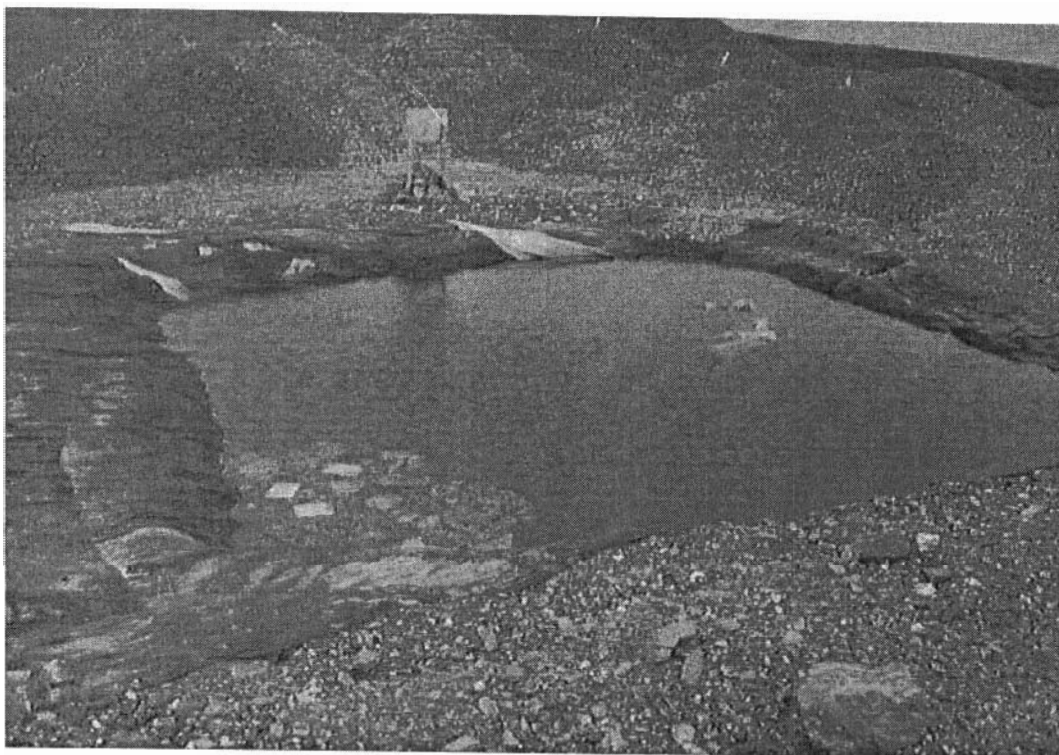
figure 4. Lined sump within the ore pile and ore storage pad areas; 2000/07/11.

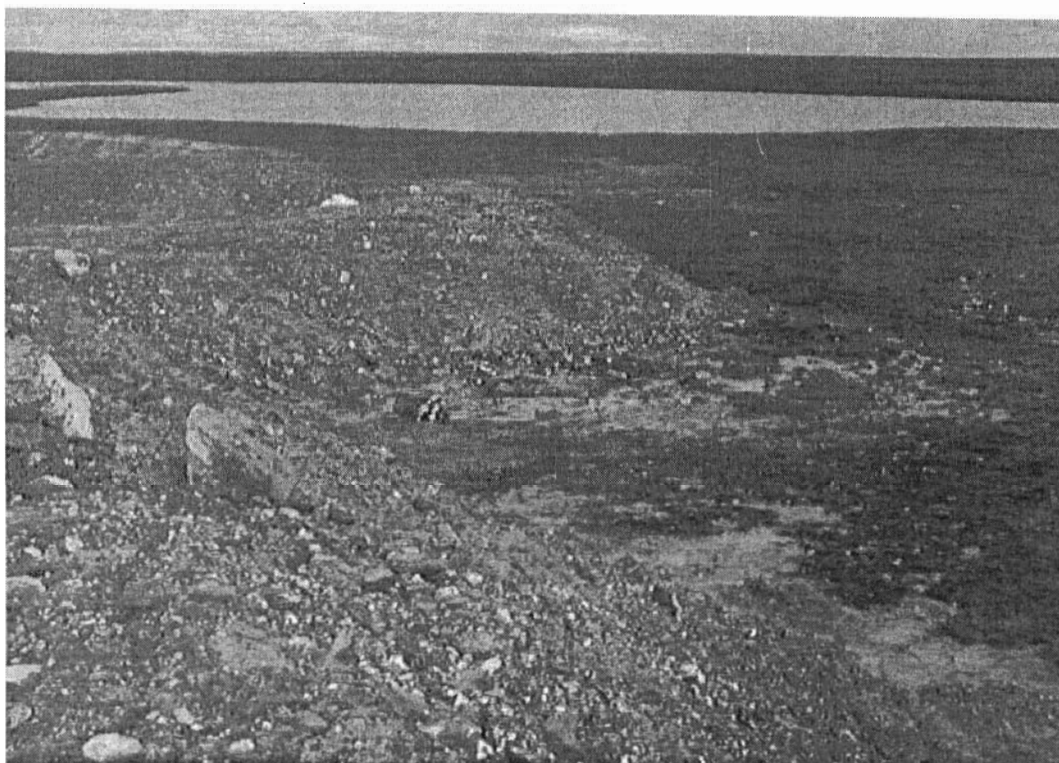
figure 5. Ground conditions downslope of the ore storage pad sumps; 2000/07/11.

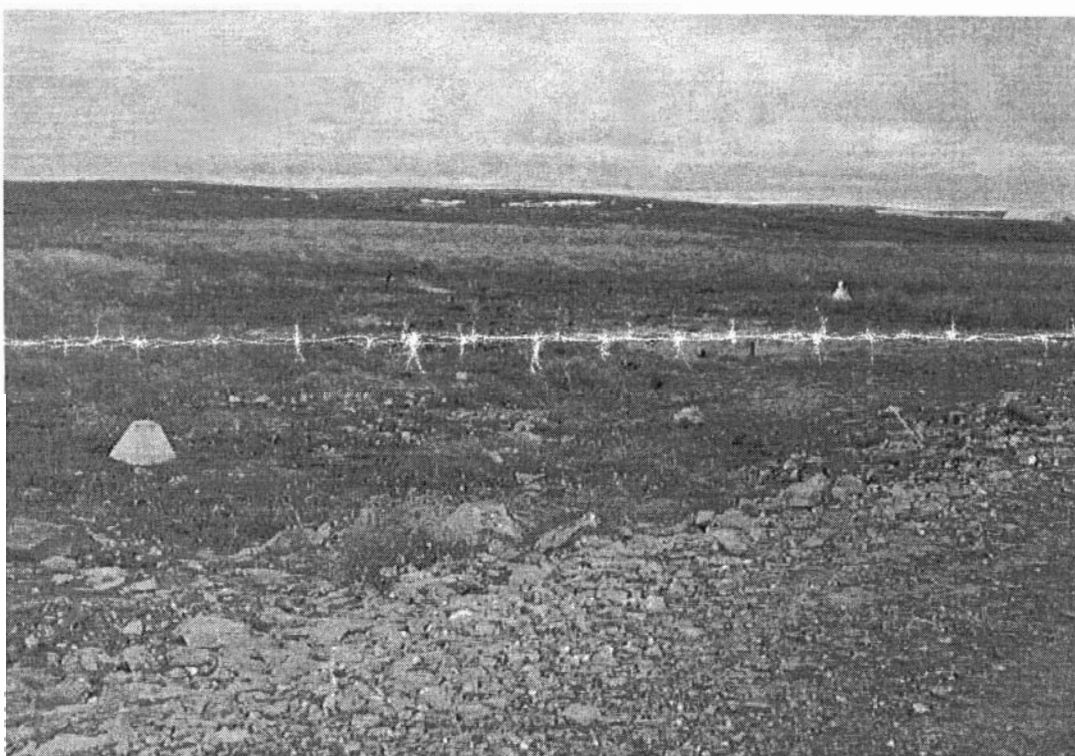
figure 6. Surface scarring and drill casings at a former drill site; 2000/07/11.

- Restoration activities: Several former drill sites by the camp's airstrip show signs of surface scarring centred around the protruding drill casings (figure 6). While the Inspector recognizes that these drilling and various other operations may have taken place under prior management, it is nevertheless hoped that the Licensee will extend its elevated environmental standards to the entirety of reclamation undertakings.

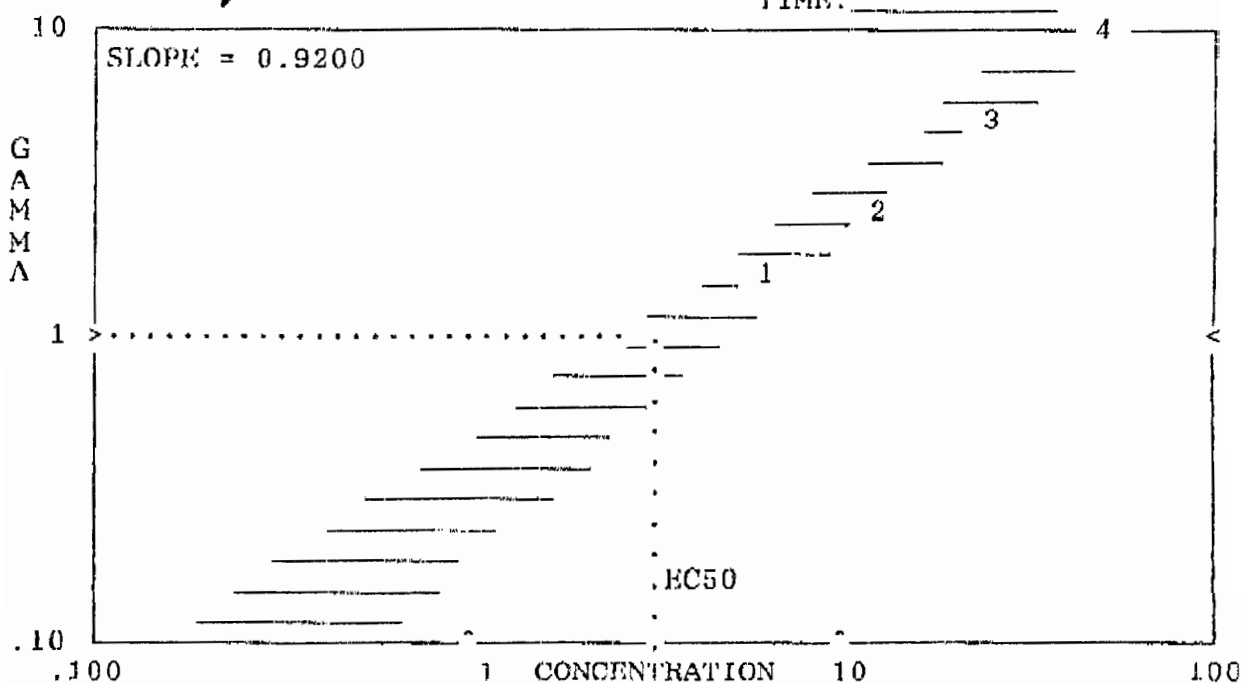
EC50 3.133 mg/L (95% CONFIDENCE RANGE:1.894 TO 5.181)

ESTIMATING EQUATION: $\text{LOG } C = 1.0778 \times \text{LOG } \Gamma + 0.4959$

95% CONFIDENCE FACTOR: 1.65381 FOR EC50

COEFFICIENT OF DETERMINATION: $R^2 = 0.99162$
