NWB1BOS9801

August 12, 2001 Industrial Water Use Inspection - Report

INDUSTRIAL WATER USE INSPECTION REPORT

Licensee: Miramar Hope Bay / Hope Bay Gold, Boston Licence No.: NWB1BOS9801

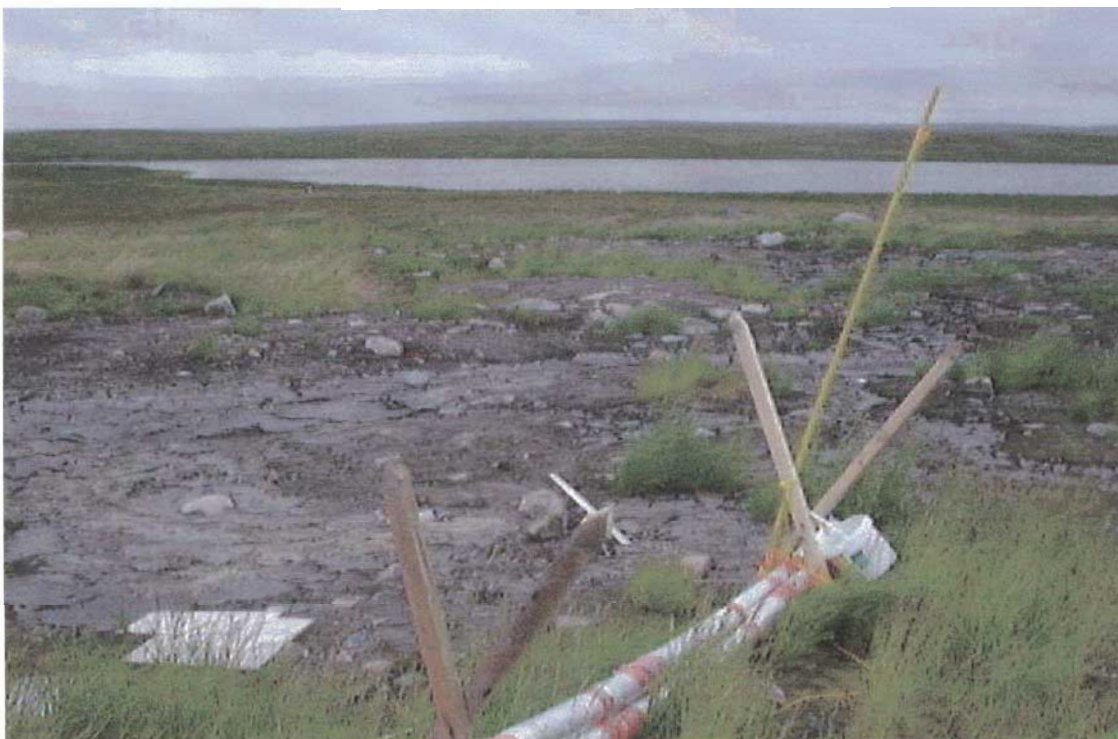
- **Sewage disposal:** At the time of the inspection, the camp was unoccupied and the facilities therefore inactive. However, a substantial amount of dried matter could be observed in the immediate vicinity of the sewage effluent discharge point, Surveillance Network Program (SNP) station 1652-3 (figure 1). Therefore, the Licensee may wish to ensure that the effluent discharged contains as little solids as possible in order to limit the extent of the impacted area along the path of discharge, and its potential effect on receiving waters. In parallel, the Inspector points out that SNP stations 1652-4 and 1652-5 correspond to the effluent discharged into the lake, and not to the receiving waters at the point of effluent discharge.

figure 1. Sewage effluent discharge point, SNP station 1652-3; 2001/08/12.

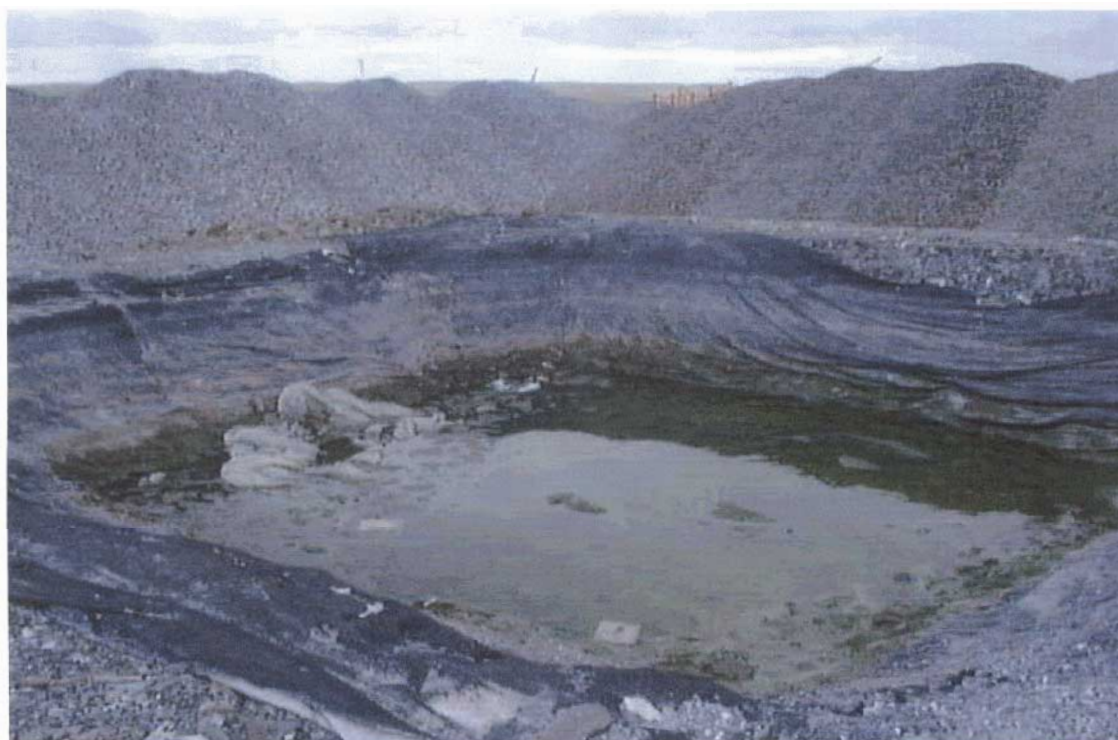
In related matters, it was mentioned during the inspection that sewage sludges had in the past been disposed into the lined sump in the middle of the ore pad (figure 2). With this in mind, coupled to the fact that the sump has required emptying for the last two consecutive years, the Inspector recommends that the Nunavut Water Board (NWB) add a SNP sampling requirement prior to discharge. Considering the general location of the sump and its past contents, analysis requirements should combine those of SNP stations 1652-2 and 1652-3. This being said, the attached analytical results relating to the contents of the central pond meet the licence thresholds but exceed the *Canadian Water Quality Guidelines for the Protection of Freshwater Aquatic Life* in regards to concentrations of ammonia (41.8 mg/L vs 2.2 mg/L), arsenic (468 µg/L vs 5 µg/L), cadmium (0.4 µg/L vs 0.017 µg/L), copper (19 µg/L vs 4 µg/L), iron (666 µg/L vs 300 µg/L), nickel (723 µg/L vs 150 µg/L), and zinc (188 µg/L vs 30 µg/L).

In addition, the Microtox sample, which constitutes a reliable toxicity indicator (IC_{50}), did not attribute toxicity to the sump's contents. Concerning the Licensee's plans to dispose of sewage sludge over impacted sites along the airstrip, the Inspector reiterates the need for NWB prior approval.

figure 2. Lined sump in the ore pad area, dubbed central holding pond; 2001/08/12.

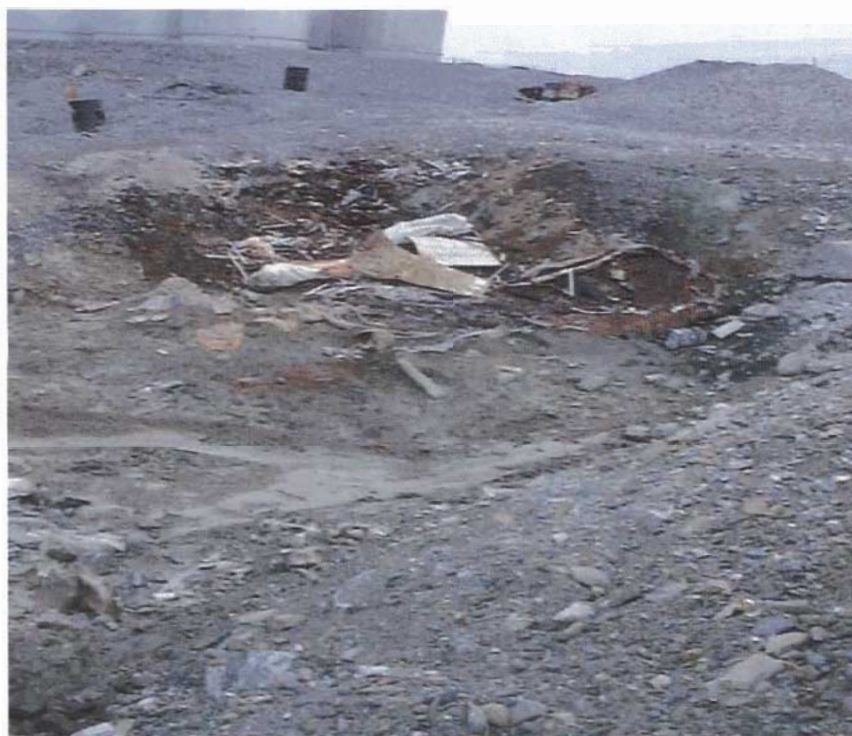
- **Solid waste disposal:** Contrary to directions given to the Licensee during the previous year, the disposal of solid wastes into the unlined sump in periphery of the ore storage pad does not appear to have been discontinued (figure 3). Moreover, past assessments of the area have pointed out that the sumps in periphery of the ore storage pad were never intended to be used as disposal sites. Consequently, in light of the potential of leachate from a solid waste disposal facility to reach waters, the Inspector again points out that licenced terms and conditions (part E, item 4) outline the need for NWB prior approval of solid waste disposal.

figure 3. Unlined sump in the periphery of the ore storage pad; 2001/08/12.

In addition, solid waste is being deposited in the unlined sump in periphery of the ore storage pad without prior NWB approval, contrary to licenced conditions (part E, item 4) and to the Inspector's 2000/12/20 recommendation. The Inspector trusts that the Licensee will not require further prompting before complying with this clause relating to the potential deposit of waste into waters. Lastly, although Water licence NWB1BOS9801 has lapsed into expiry since 2001/07/31, the Inspector acknowledges that the Licensee has provided the NWB with a licence renewal application.

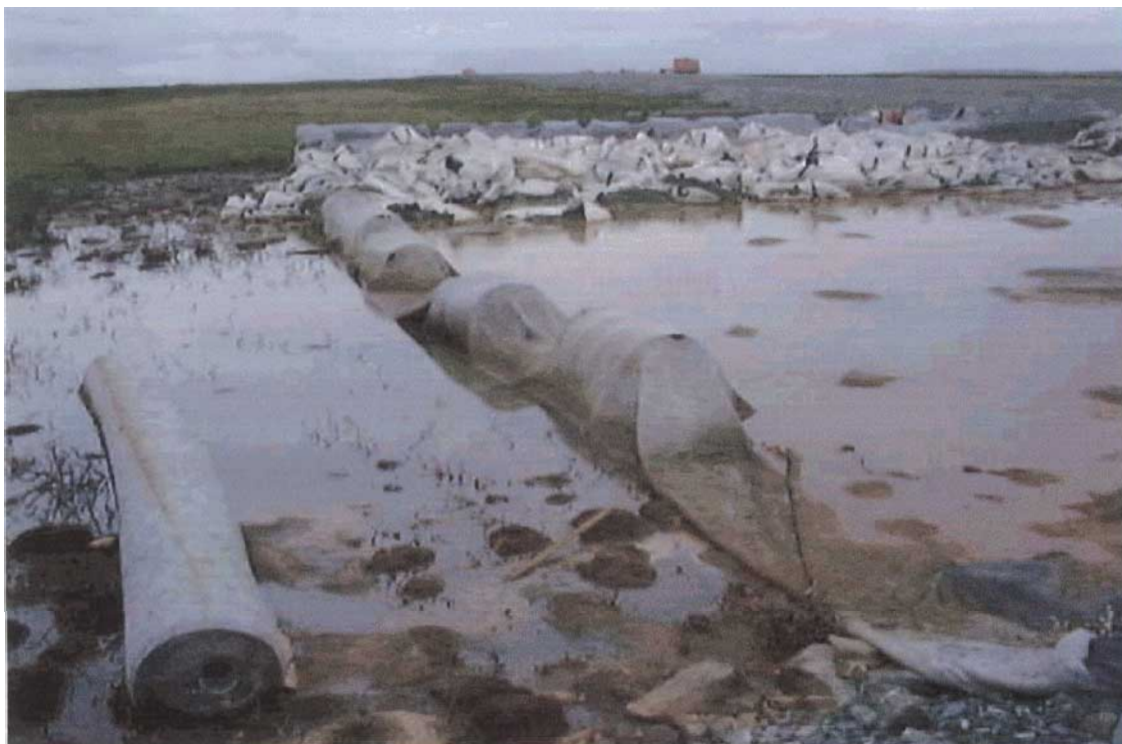
In related matters, a notable volume of water pooled within the drill cuttings impoundment structure was noted beyond its ineffective retention berms (figure 4). In fact, a conspicuous path of runoff from the facility was noted (figure 5). As such, although at first glimpse an on land drill cuttings disposal site can appear to strictly be a land use issue, a concrete potential for the deposit of waste into waters arises from this particular facility. Indeed, the attached analytical results relating to a sampled collected downslope of the facility reveal elevated levels of calcium, chloride and conductivity, as well as concentrations of arsenic ($23.1 \mu\text{g/L}$ vs $5 \mu\text{g/L}$), copper ($6 \mu\text{g/L}$ vs $4 \mu\text{g/L}$), and mostly iron (14.5 mg/L vs 0.3 mg/L) exceeding the *Canadian Water Quality Guidelines for the Protection of Freshwater Aquatic Life*, but nonetheless meeting licenced thresholds; the Microtox sample did not denote toxicity. Accordingly, the Inspector requests that the Licensee provide the NWB with plans relating to the drill cuttings impoundment structure, and await their approval before proceeding with further deposit of drill cuttings.

figure 4. Drill cuttings impoundment structure by the airstrip; 2001/08/12.

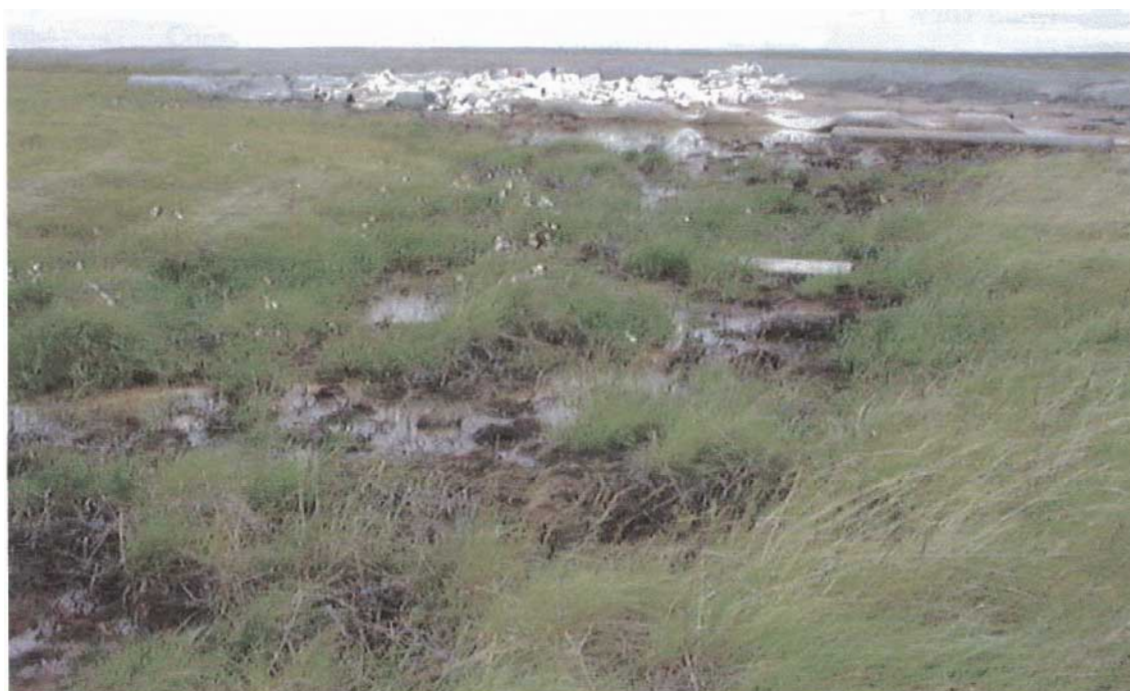
figure 5. Runoff from the drill cuttings impoundment structure; 2001/08/12.

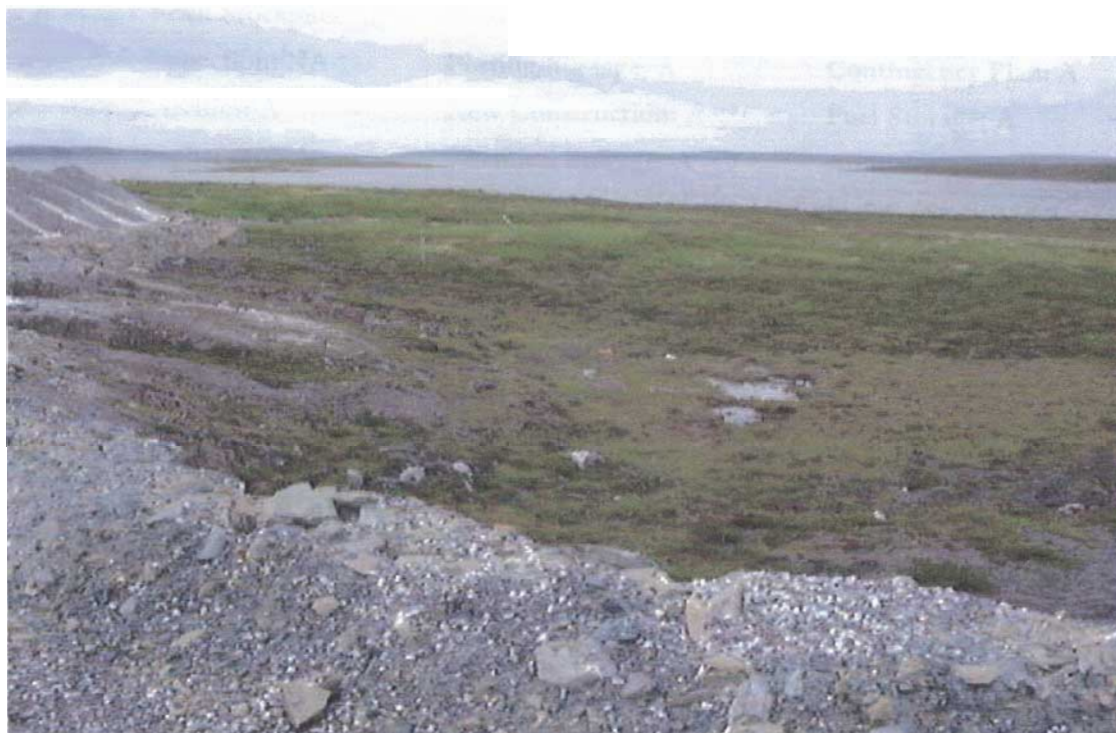
- **Ore and waste rock stockpiles:** In response to potential acid rock drainage (ARD) concerns raised by various parties, three (3) samples were taken during the inspection of surface water in the area downslope of the ore storage pad (figure 6). While the attached analytical results show that the northernmost (pad 1 sample) and central (pad 2 sample) samples proved comparable and relatively benign, the sample collected in the vicinity of the unlined sump (pad 3 sample) warrants additional attention. Thus, the attached analytical results reveal elevated levels of calcium, chloride and conductivity, as well as concentrations of arsenic (2.4 mg/L vs 1.0 mg/L) and particularly nickel (47.2 mg/L vs 1.0 mg/L) breaching the waste discharge effluent quality standards (part D, item 7) of Water licence NWB1BOS9801. This would seem to substantiate past assessments of the site coming to the conclusion that arsenic and nickel were expected to leach out preferentially from Boston rock under neutral conditions, and that measures should be undertaken to minimize infiltration and to prevent local drainage from reaching Aimoaktak Lake. Therefore, the Inspector suggests that the NWB consider establishing additional measures and/or SNP station(s) in order to minimize runoff from the ore storage pad area, and ensure that the leachate still produced can be collected and monitored.

Comments: Areas of pooled water present downslope of the exposed ore storage pad; no visible runoff/drainage diversion efforts. New bulk fuel storage facility built within lined berms.

figure 6. Pooled water downslope of the ore storage pad; 2001/08/12.

- **Non-compliance of Act or Licence:** A surface water sample in the likely path of runoff from the unlined sump in the periphery of the ore storage pad breached the licenced effluent quality standards (part D, item 7) for arsenic and nickel. Accordingly, the Inspector recommends that drainage prevention and leachate collection measures be undertaken at the site.
