WATER LICENCE INSPECTION FORM

Licensee		Licensee Representative	
TMAC Resources		Sarah Warnock	
Licence No. / Expiry		Representative's Title	
2BB-BOS1217 / 2BB-BOS1727		Environmental Coordinator	
Land / Other Authorizations		Land / Other Authorizations	
Date of Inspection		Inspector	
10 July 2017 and 20 Aug 2017		Eva Paul	
Activities Inspected			
<input checked="" type="checkbox"/> Camp	<input checked="" type="checkbox"/> Drilling	<input type="checkbox"/> Mining	<input type="checkbox"/> Construction
<input type="checkbox"/> Roads/Hauling	<input type="checkbox"/> Other:	<input type="checkbox"/> Other:	<input checked="" type="checkbox"/> Reclamation
<input checked="" type="checkbox"/> Fuel Storage

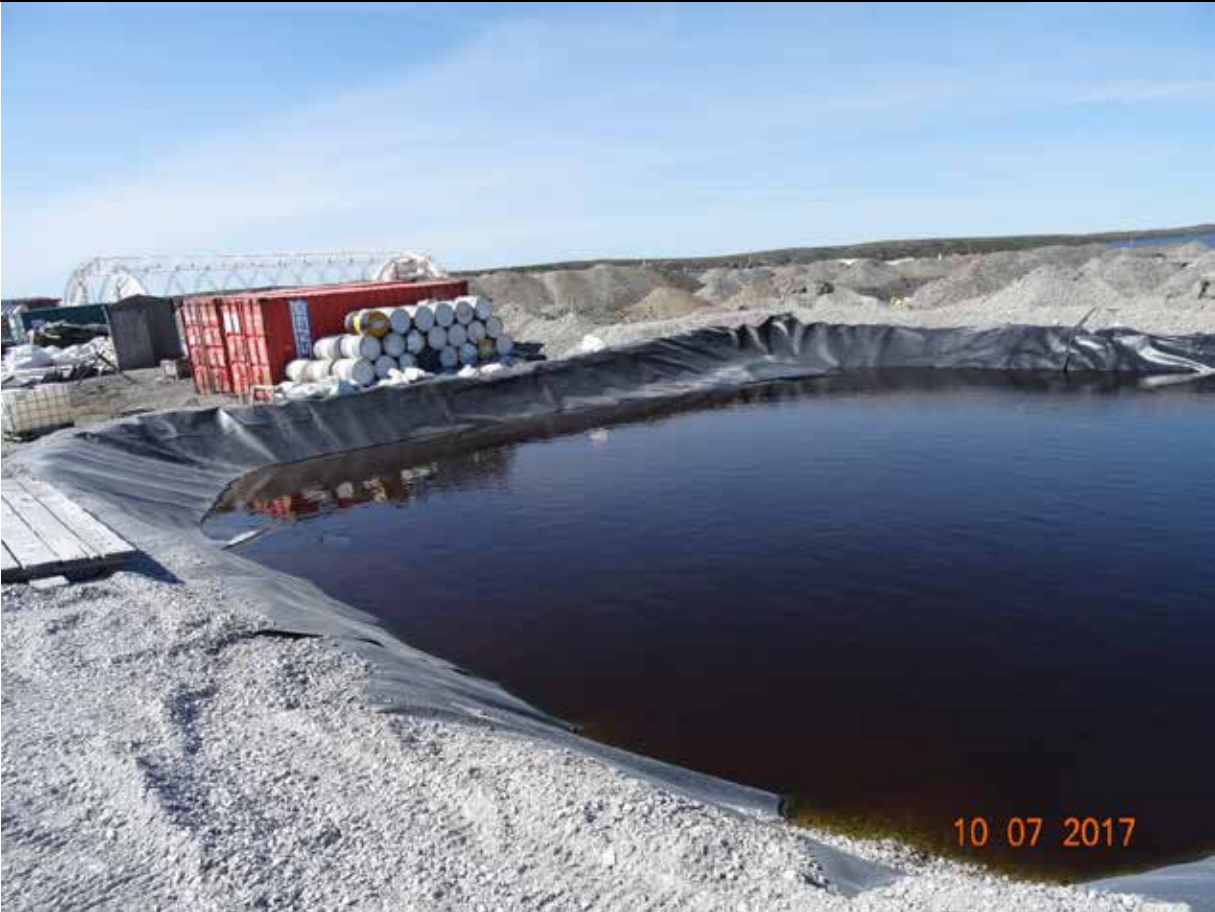
Date	Camera	Inspector	Authorization
July 10 2017	SONY DSC-HX50V	Eva Paul	2BB-BOS1217
Photo Log # 1		Location (NAD 83 DD MM SS.SS)	
Photo DSC07222		N69 39 28.9	W106 23 01.6

Description: Temporary lined sump for storage of effluent from STF.

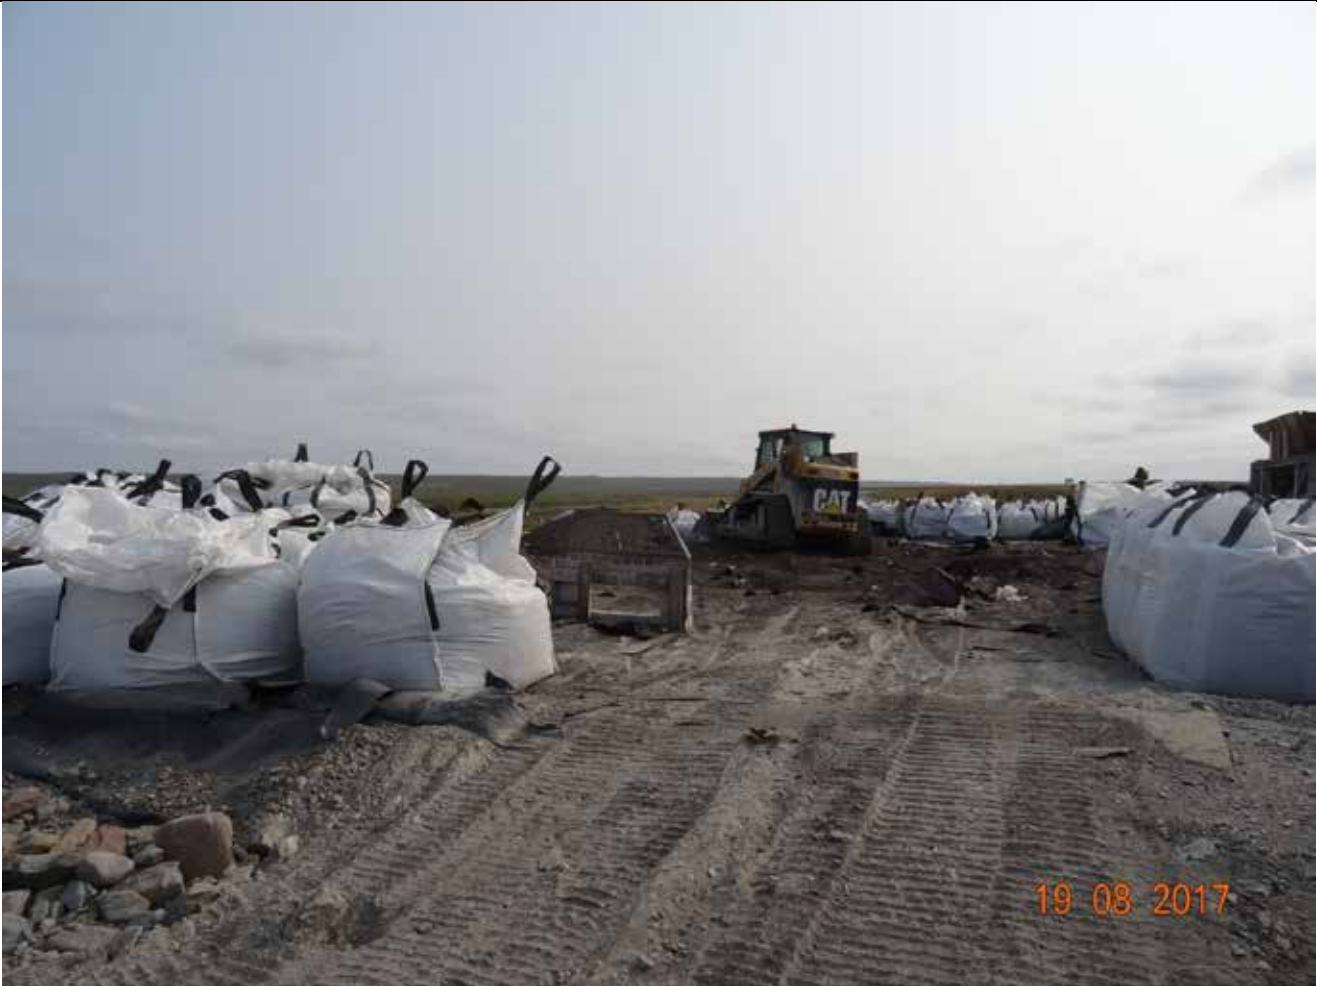
Photo Log # 6	Location (NAD 83 DD MM SS.SS)	
Photo DSC07969	N67 39 26.4	W106 23 04.7

Description: Landfarm contents being bagged for winter backhaul to Doris.

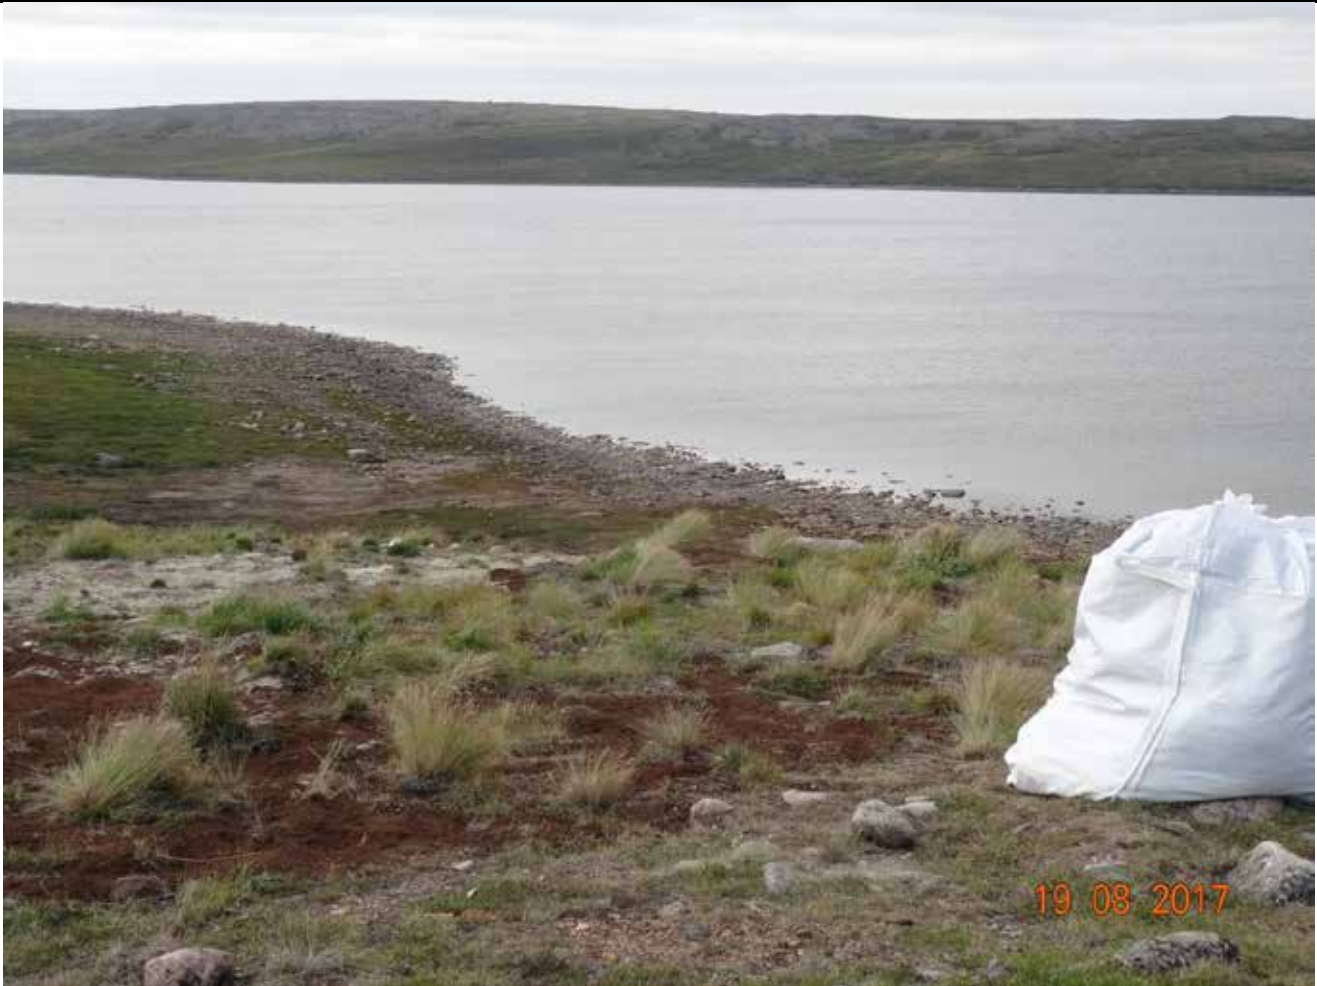
Photo Log # 7	Location (NAD 83 DD MM SS.SS)	
Photo DSC07988	N	W (not recorded)

Description: Bagged waste at reclaimed drill site.
