Windy Lake Exploration Camp
June 16 2004 Spill Updated Progressive Report
Spill Number 04-388

MIRAMAR HOPE BAY LIMITED

Revised document – February 27, 2005

Document # MHBLENV-04-2005
February 2005

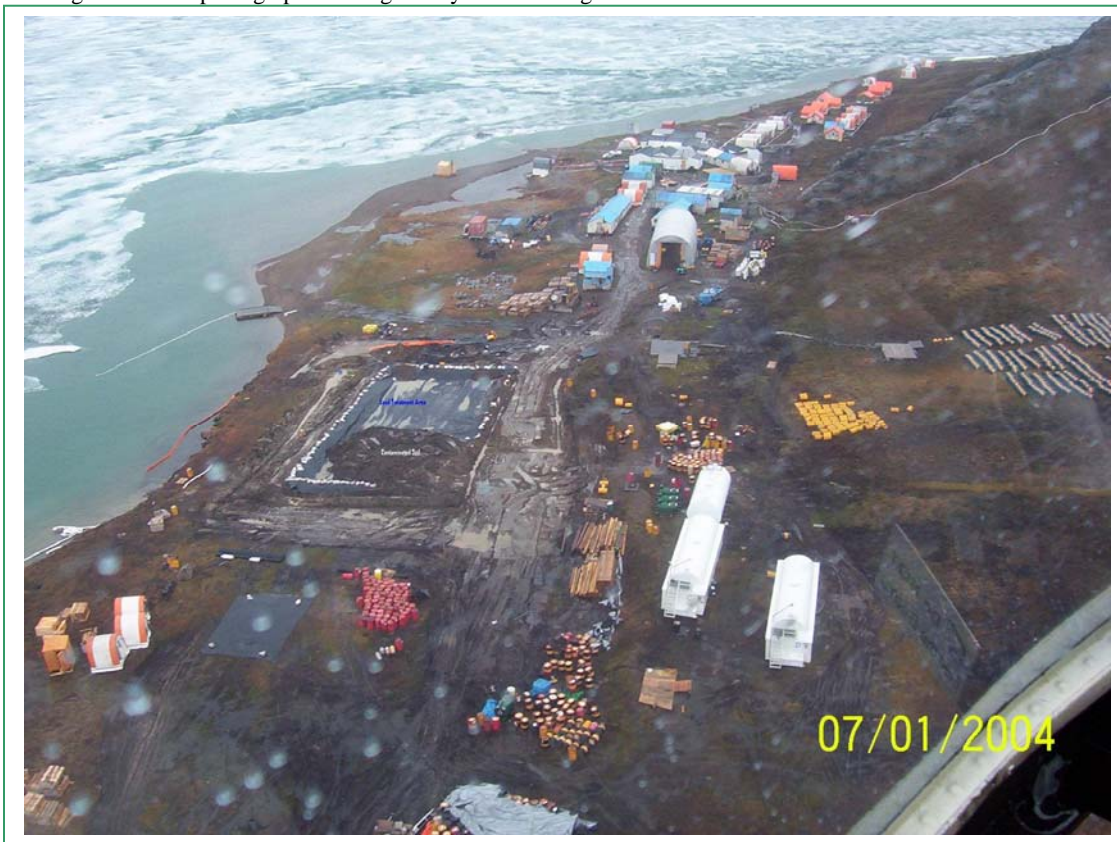
Figure 1 Aerial photograph showing Windy Lake looking east to west.

Figure 1 shows photograph of the camp with the layout show in Appendix C of this report. The northern portion of the camp consists of a series of tents and wooden structures that comprise the sleeping and eating quarters. The camp has the capacity to accommodate approximately 100 personnel. Located immediately south of the sleeping quarters are a series of tents and wooden structures used for offices and a core logging area. Three aboveground storage tanks (AST), containing diesel fuel, are located south of the offices and have a capacity of 50,000 and 70,000 litres. A barrel storage area (approximately 200 drums of Jet-B fuel) is located to the northeast (upslope) of the ASTs. A second area, southeast of the ASTs, is used for storage of 60 barrels of gasoline.

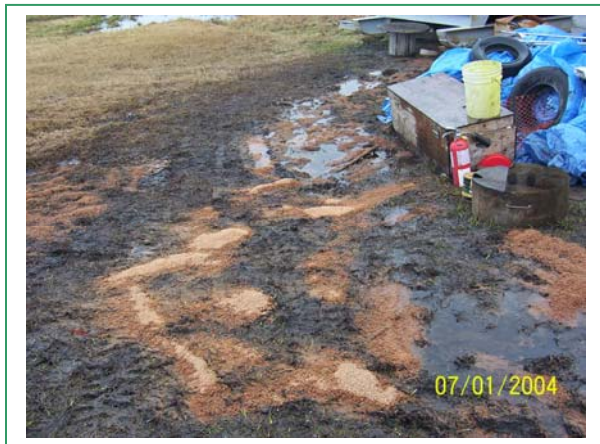
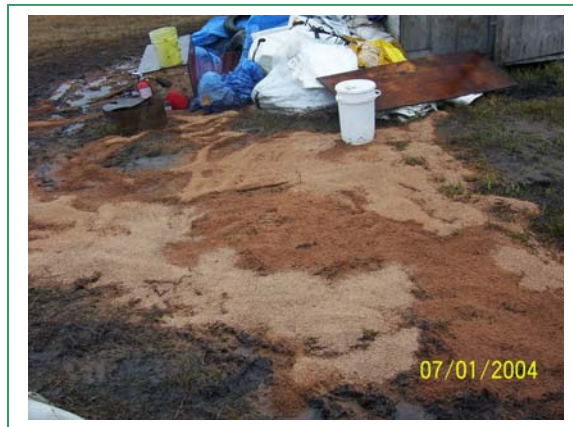
Biodegradable peat moss grains were spread over areas that were contaminated either directly or indirectly by spillage. The objective was to utilize other products that have been environmentally proven in such clean up and absorb the petroleum products in the soil where absorbent pads were no longer effective. Once individual grain was saturated, new peat moss grains were added until the peat moss grains were visibly not saturated anymore (see photos below). Peat moss was effective in removing petroleum products.

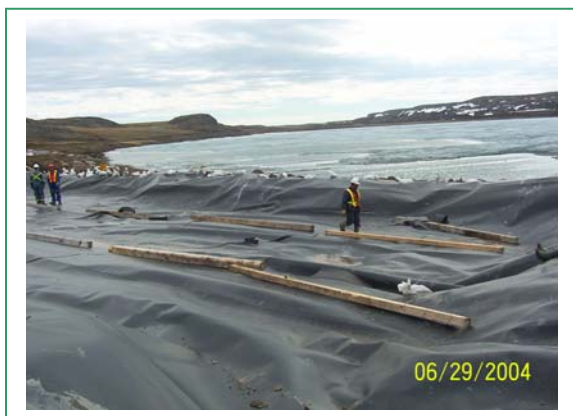
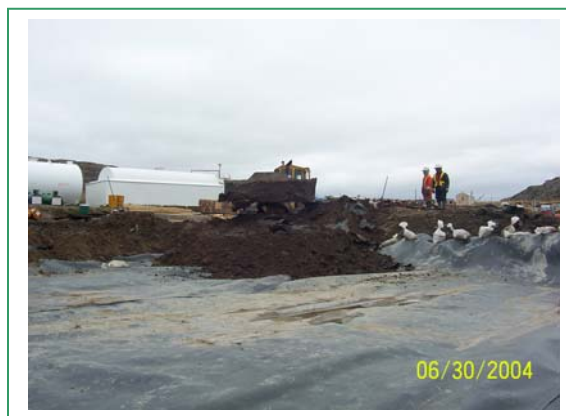
The LTA was constructed using a 60-mil high-density polyethylene (HDPE) liner underlain by native soil consisting of silt sand. The liner was put into place on June 29, 2004 and the contaminated soil spread over on June 30 as shown in the photographs below. The surficial area of the land treatment area (inside corners used for measurement) is 600 m².

The area topographically down gradient of the storage tanks was the primary location of hydrocarbon impacts to the soil. The impacted soil was stripped from the areas where hydrocarbon odours and staining were detected. The soil was stripped using a D5 CAT Dozer to an approximate depth of 10 cm below surface grade where frozen ground was encountered.

The whole area surrounding the lined LTA is designated as a contaminated site until such time that MHLB is satisfied with the on-going remediation. The area is cleared of any debris or any other solid wastes. The estimated volume of contaminated soil currently placed into the lined LTA is approximately 100 m³.
