| <b>INSPECTION/REQUESTS (DIAND, NWB &amp; KIA)</b> | Field visit conducted by Scott Stewart, Water Resource Inspector, DIAND |
| <b>SITE/WUP LICENSE NUMBERS</b> | Windy Lake (NWB2HOP0207) & Boston (NWB1BOS0106) |
| <b>REPORTING YEAR</b> | 2005 |

This is a brief summary report highlighting status of work undertaken in addressing concerns raised by regulatory authorities, in particular – field visits to Windy and Boston Camps by Scott Stewart, Water Resource Inspector DIAND during 2005 exploration program season. The inspections were carried out on July 22 2005 with a copy received on the same day.

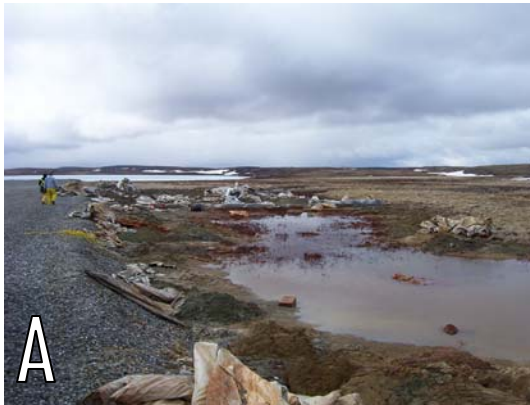
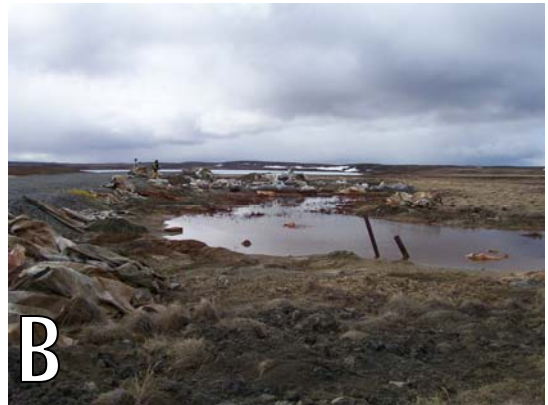
Appendix 1: Initial stage of Boston drill cuttings cleanup of the lay down area along the airstrip.

Photographs A & B: Pictures showing mega bags containing drill cuttings lay down area along the airstrip at Boston camp. These pictures taken after initial work done and therefore do not show all previous exposed bags.

- In the short period at Boston, environmental work focused on solid waste management. This involved removing drill-cutting mega bags from the lay down site along the airstrip. Approximately 200 empty bags disposed off in the burn pit on site. (See pictures in Appendix 1).

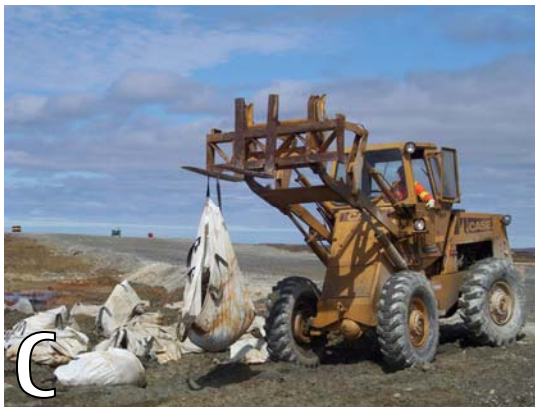
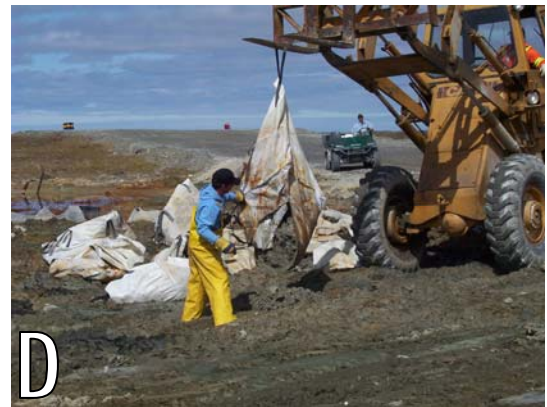
Photographs C & D: Picture C showing a mega bag lifted by the front loader, while picture D showing the bag sliced open to let the drilling cuttings out of the bag.

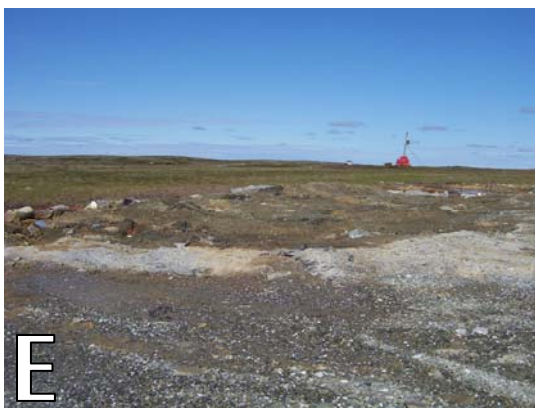
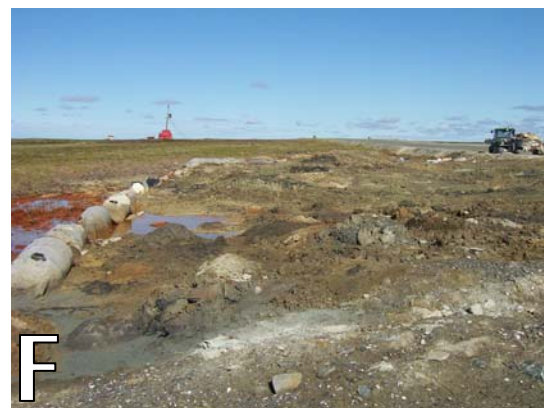
Photographs E & F: Pictures E & F showing the current outlook of the drill cutting lay down area along the airstrip. Approximately 200 mega bags were sliced in 3 half days of work. A much-desired view on the area.

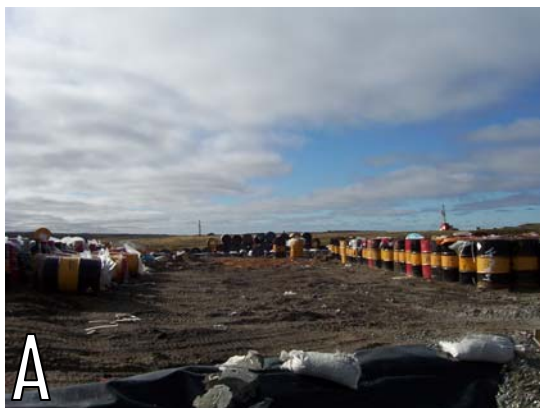
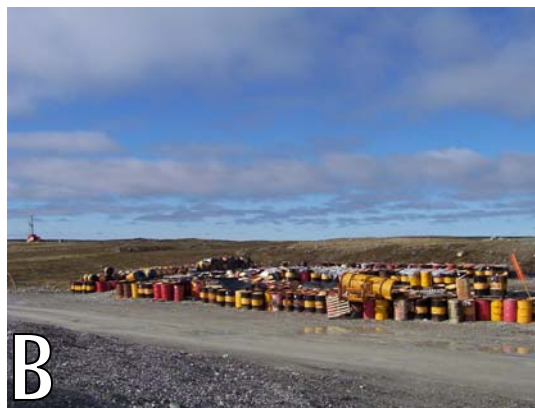
Appendix 2: Solid waste management – Drum crushing and storage and LTA soil turning

Photographs A & B showing 45-gal drums containing non-combustible solids wastes mixed with drums containing hazardous petroleum products and other refuse used during previous spills clean-ups activities.

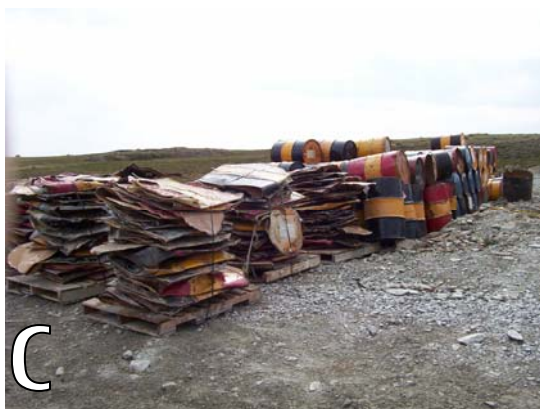
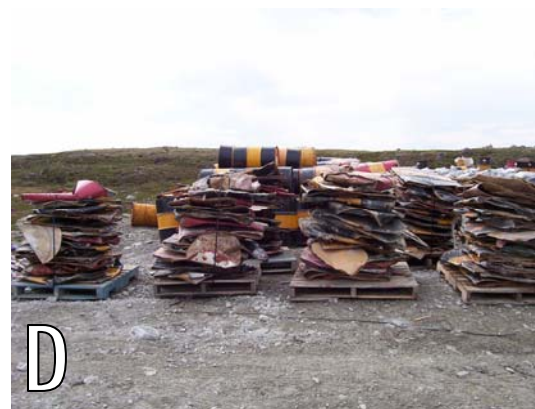
Photographs C & D showing 45-gal drums crushed and packed on pallets ready for shipment out of property.

- Empty 45-gal drums stored on property is a challenge. Most drums were opened as a means to store solid wastes generated around the camps and drilling sites. Approximately 147 empty drums crushed and packed on pallets (See pictures in Appendix 2: C-D).

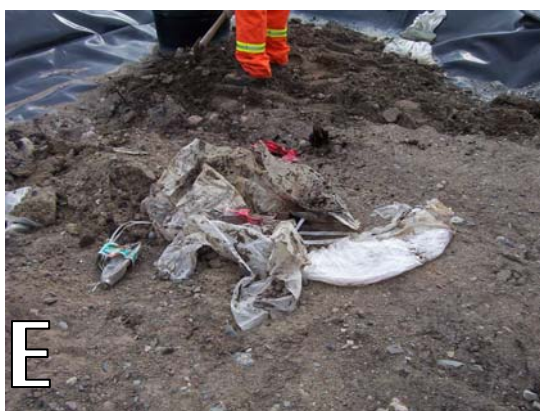
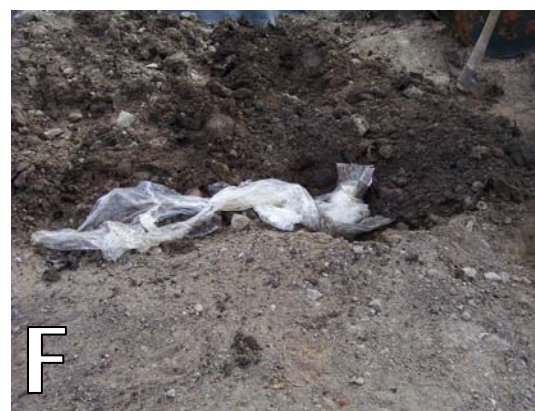
Photographs E & F showing non-biodegradable materials recovered during turning of the contaminated soil stored in the LTA at Boston Camp. Most of these products were plastics and absorbent pads.

- *Hazardous Water (Petroleum Contaminated Topsoil)*: - Turning of the contaminated soil in the LTA was by hand. This process was very slow in achieving a desired outcome. Lack of proper equipment hampered completion of this task. What was observed during turning of the soil showed non-biodegradable materials placed together with the contaminated soil and therefore absorbed the petroleum products leached from the soil (See Appendix 2: E-F). The photographs show only a small portion of the non-biodegradable materials found while turning the soil.

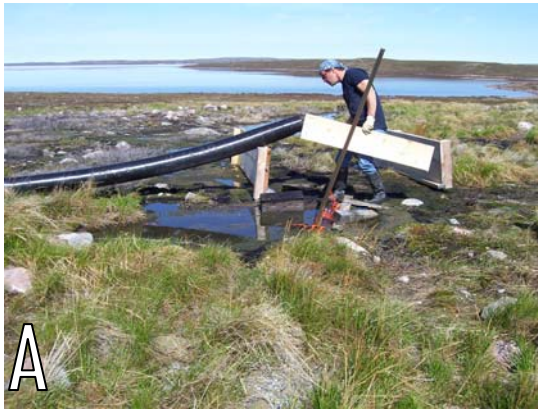
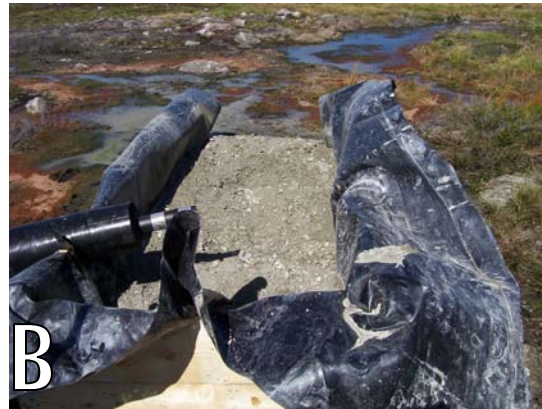
Appendix 3: Sewer Waster Management – construction of the filter system

Photographs A & B: Photograph A showing construction of a filter system intended to help reduce the level of total and faecal coliform at the end of the discharge line at Boston camp. Photograph B shows gravel placed in the filter system.

- To help in reducing the numbers to comply with regulatory requirements, a natural filter system using gravel, sand, and peat moss/corncobs was constructed to aid in removal of nutrients and microbiological organisms from the release greywater effluent. As the installation was done at the end of the exploration, no effluent samples were collected to test the process. Testing will be done in 2006. If the system proves satisfactory, a similar method will be employed at Windy Lake. Photographs of the system are shown in Appendix 3.

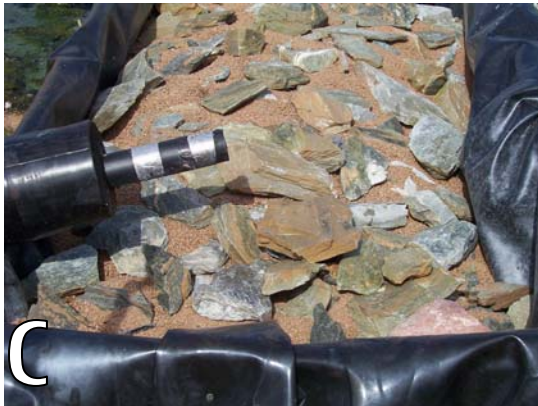
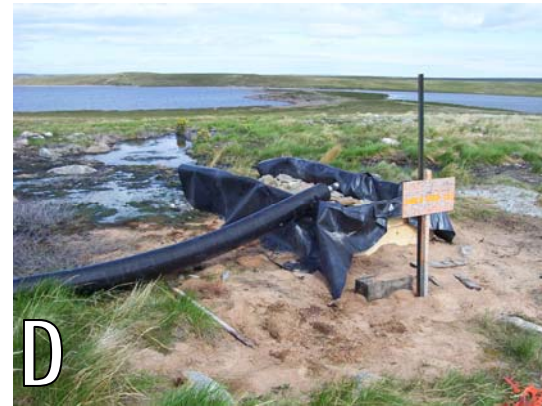
Photographs C & D: Photo C showing peat moss and corncobs laid over the gravel bed. Rocks were then placed on the peat moss and corncobs. Photo D showing the general location with corncobs spread to absorb sludge and remove odour emitting from the discharge area. The application was effective in reducing foul odour.

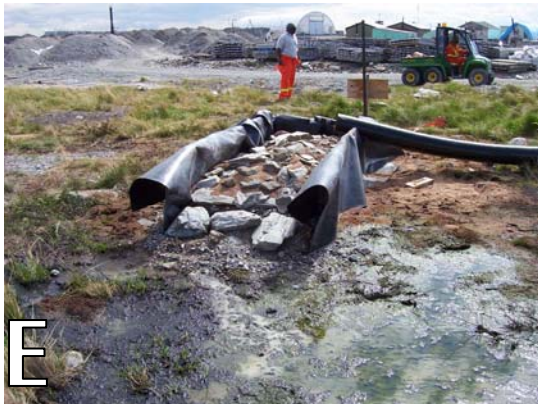
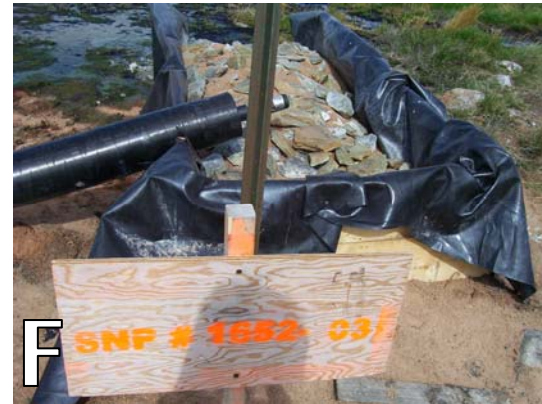
Photographs E & F: Photographs showing the final discharge area. Testing of the system was not possible due to less loading entering into the system.

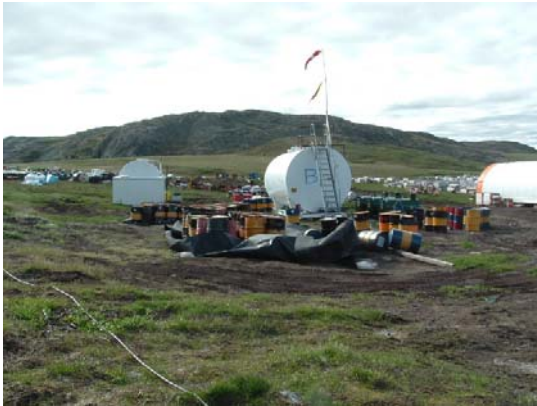
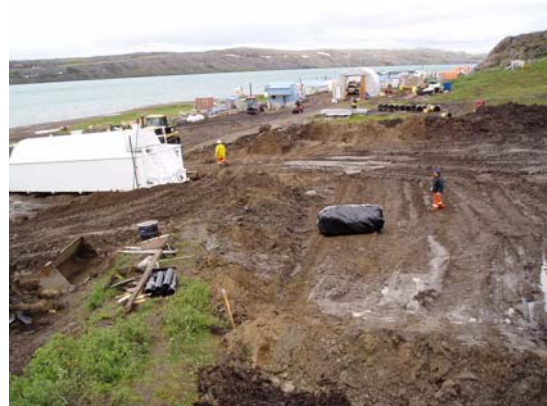
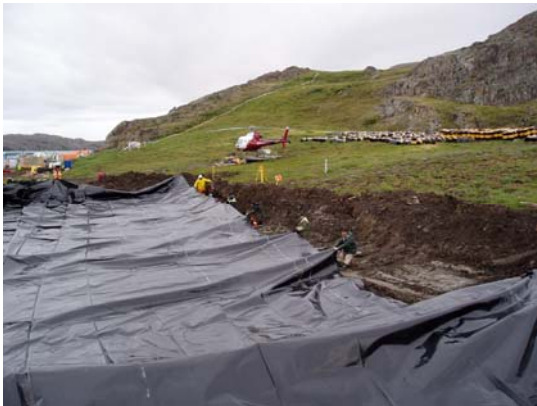
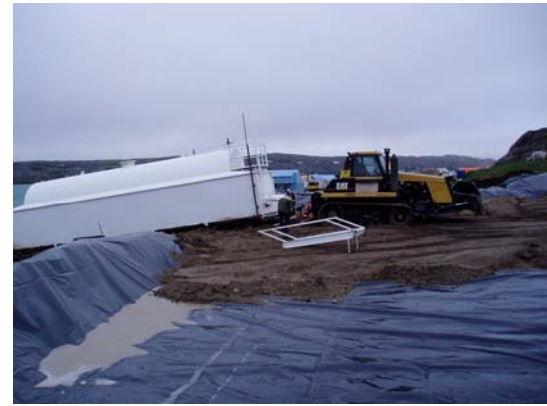
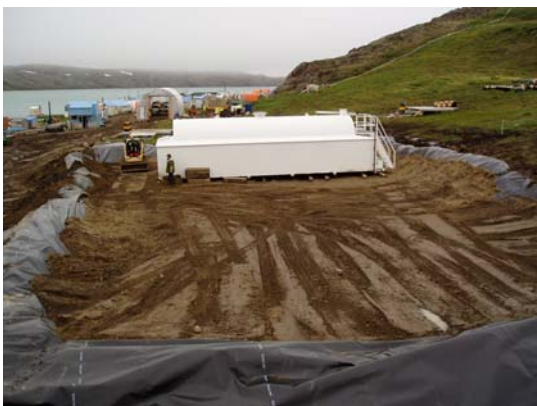
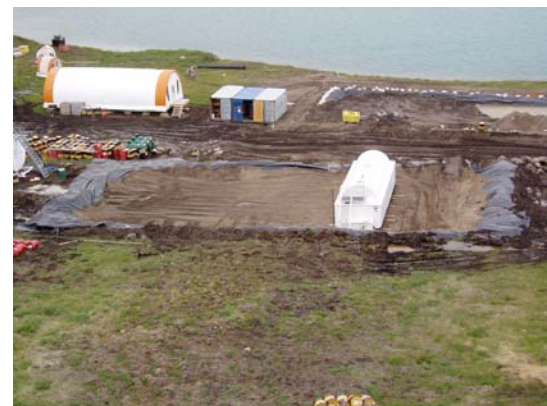
Appendix 4: Windy Lake Lined Secondary Berm Construction

- Construction at Windy immediately (see pictures in Appendix 4). Kitnuna Construction personnel supervised by Biogenie Consulting engineers carried out the construction.

- After completion of the farm, the 70,000 L AST tank was placed inside the berm. The empty 50,000 L AST tank will be re-located to Patch Lake during winter of 2006 (see pictures in Appendix 4).

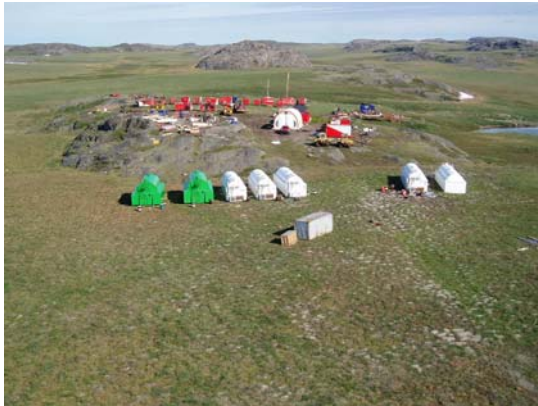
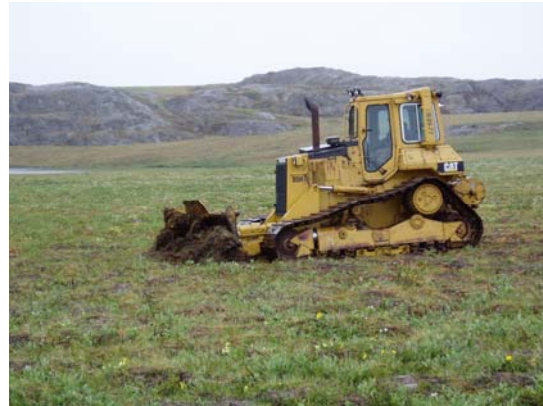
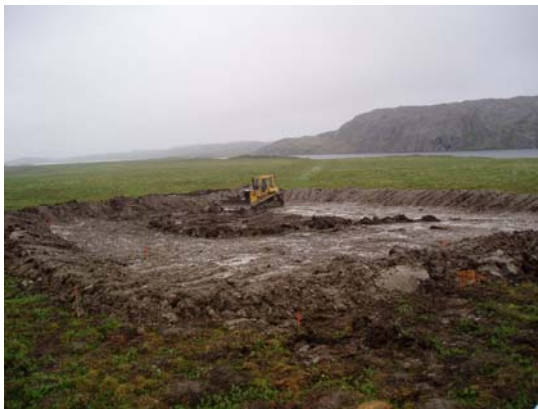
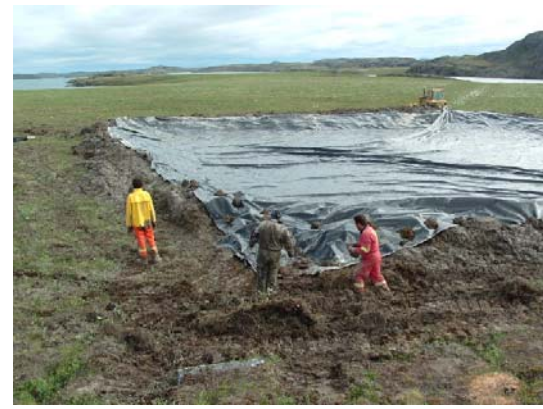
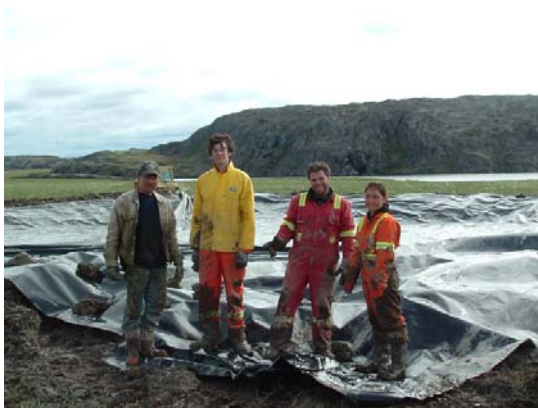
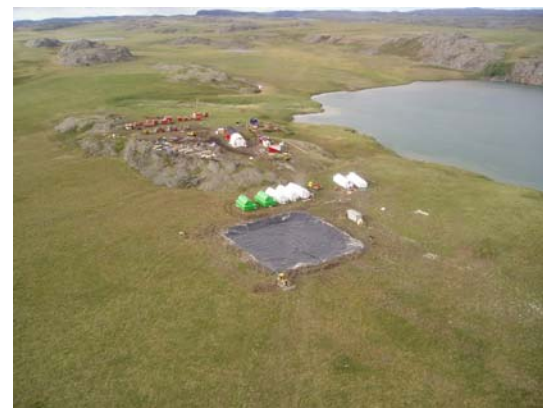
Appendix 5: Patch Lake Lined Secondary Berm Construction

- Environmental work at Patch Lake focused on building the lined secondary containment berm (see pictures in Appendix 5). Major Drilling personnel supervised by Biogenie Consulting engineers carried out the construction.
- It took approximately 3 days to complete construction of the berm. However, progress was slow due to the bad weather that lasted for a couple of days during the earth-moving period. A more challenging issue was to find enough cover material for the protection of the liner before eight (8) AST tanks can be moved into the lined berm. During construction, it was observed that not enough materials would be generated for both the walls and cover. Operations personnel are currently looking at various options for cover material to complete the task.

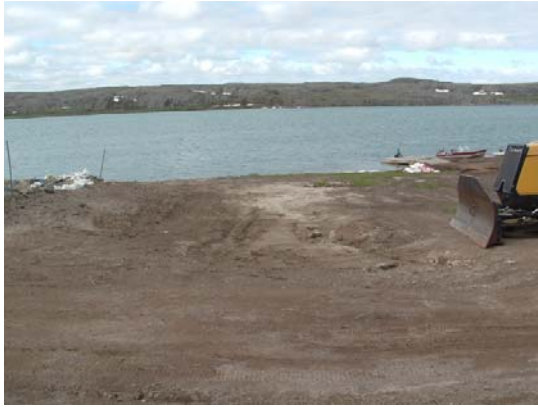
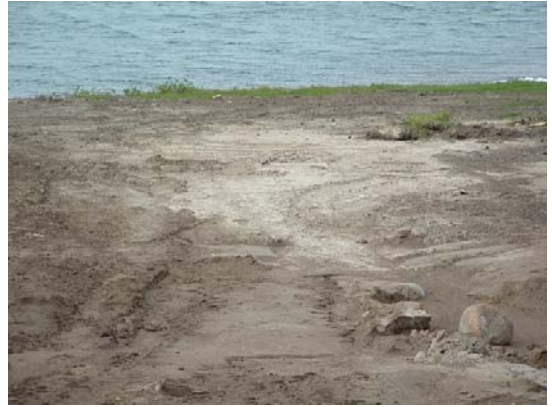
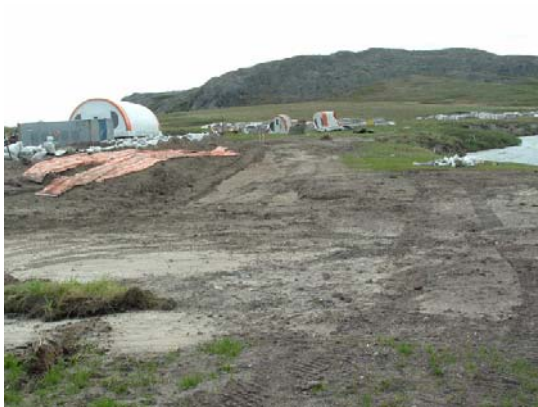
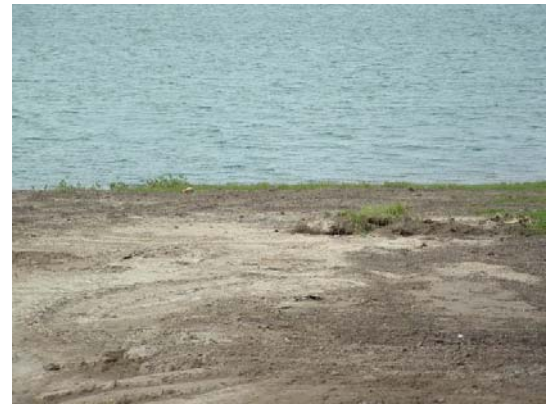
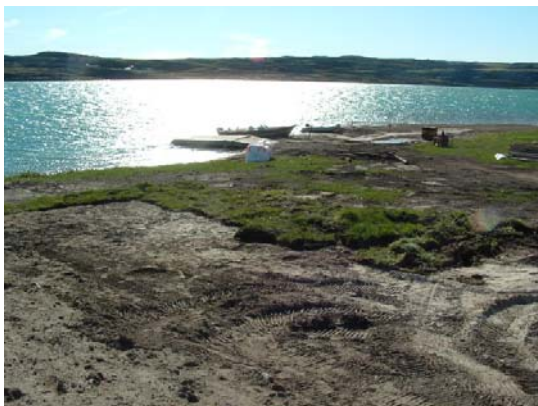
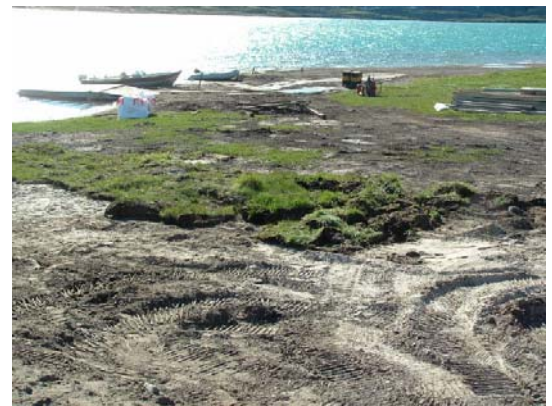
Appendix 6: Topsoil erosion/sedimentation runoff control using local grass cover

- Clean up of impacted areas as a result of the June spill, building of the LTA in 2004, moving AST tanks and building of a lined secondary in July 2005 disturbed many areas. Activities in summer of 2005 concentrated on use of native grass species to help with slope stabilisation and erosion control. This work was carried in high sediment areas to slow down the rate of run offs into Windy Lake. To prevent further disturbances, barricades were set up to prevent vehicles from entering onto the reclaimed disturbed areas. Pictures in Appendix 6 show what was done in areas of concern.

- To manage this challenge, grass cover materials removed from the construction site was placed along areas identified as being sensitive north of the LTA. The objective was to form a natural barrier with materials locally available to: (i) slow down sediment runoffs (see photos in Appendix 6); (ii) apply corncobs and peat moss over the natural barrier to absorb any petroleum products carried by the runoffs; and (iii) utilize natural grass and shrubs as a means for erosion mitigation process. The natural barrier was effective in achieving the above objectives.
