**HYDROCARBON SPILL ASSESSMENT
AND REMEDIATION
BOSTON CAMP, NUNAVUT**

PROJECT NUMBER 1740065

EBA Engineering Consultants Ltd.

**HYDROCARBON SPILL INVESTIGATION
AND
INITIAL REMEDIAL MEASURES
BOSTON CAMP, NUNAVUT
67° 39.41' North, 106° 23.04' West**

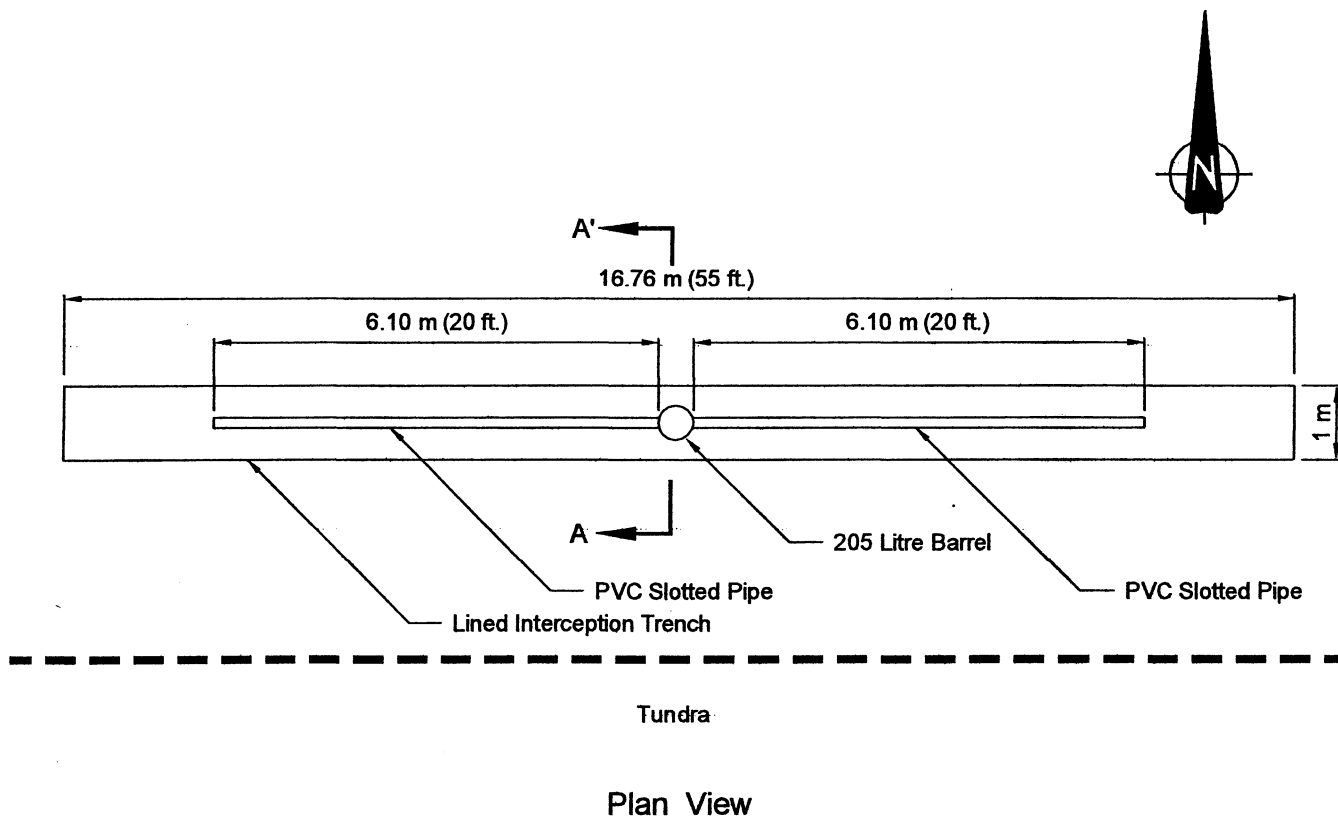
Figure 7
As Built of Maintenance Building
Interception Trench

The second interception trench was placed along the south and west edge of the maintenance shop to prevent further hydrocarbon migration onto the tundra and ultimately into Spyder Lake. The trench was excavated to a depth of approximately 1.5 meters below surface grade, the depth at which permafrost was encountered. The trench bottom and west wall were lined with a HDPE liner surrounded by Bentomax™ matting (as protection for the HDPE liner) as shown in Figure 7. A 205 liter catch basin was installed in the trench with an approximate length of 14 meters of 55 mm schedule 40 slotted PVC pipe extending along the trench bottom. The liner will prevent hydrocarbon migration from the source area (i.e.: beneath the generator) onto the tundra while the basin will allow for the removal for treatment purposes of hydrocarbon impacted water migrating from the source area (i.e. underneath the generator) during periods of flow.

NOTE:
Bentomax Liners and HDPE Material shown separated for clarity.

Cross-Section A-A'

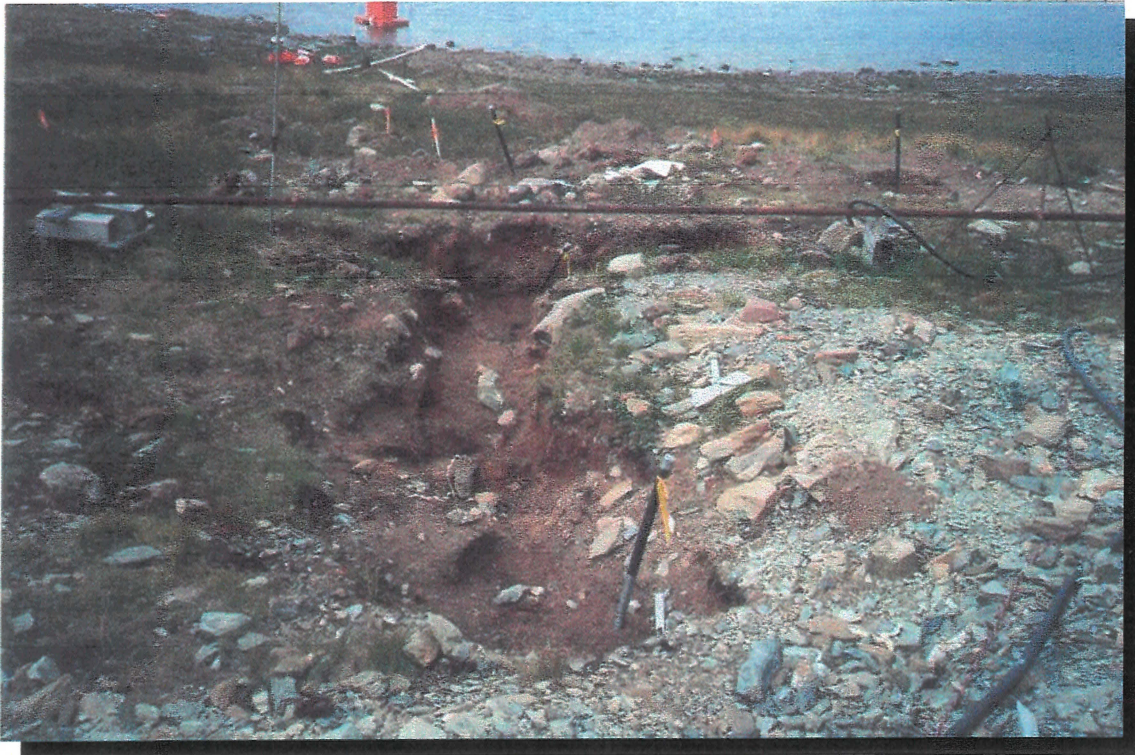
Photo 4

Photograph of hand excavated trench completed by Miramar staff following the discovery of the fuel spill. Looking east.

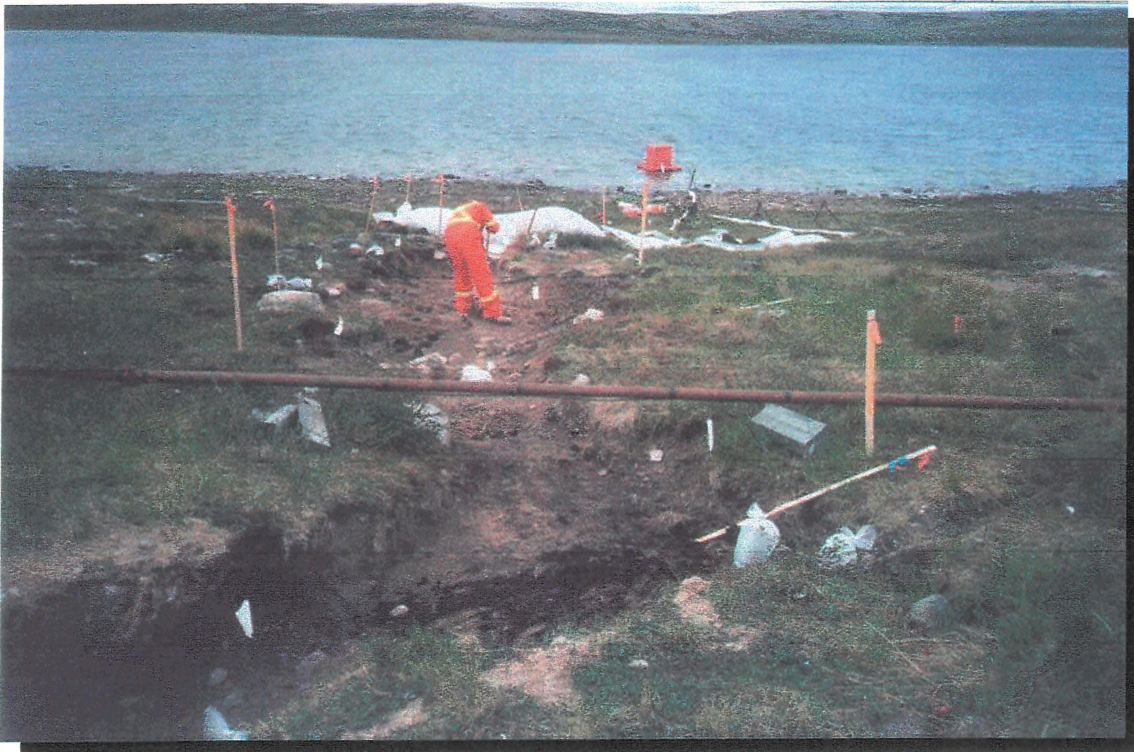
Photo 5

Photograph of hand excavated trench completed by Miramar staff following the discovery of the fuel spill. Looking east.

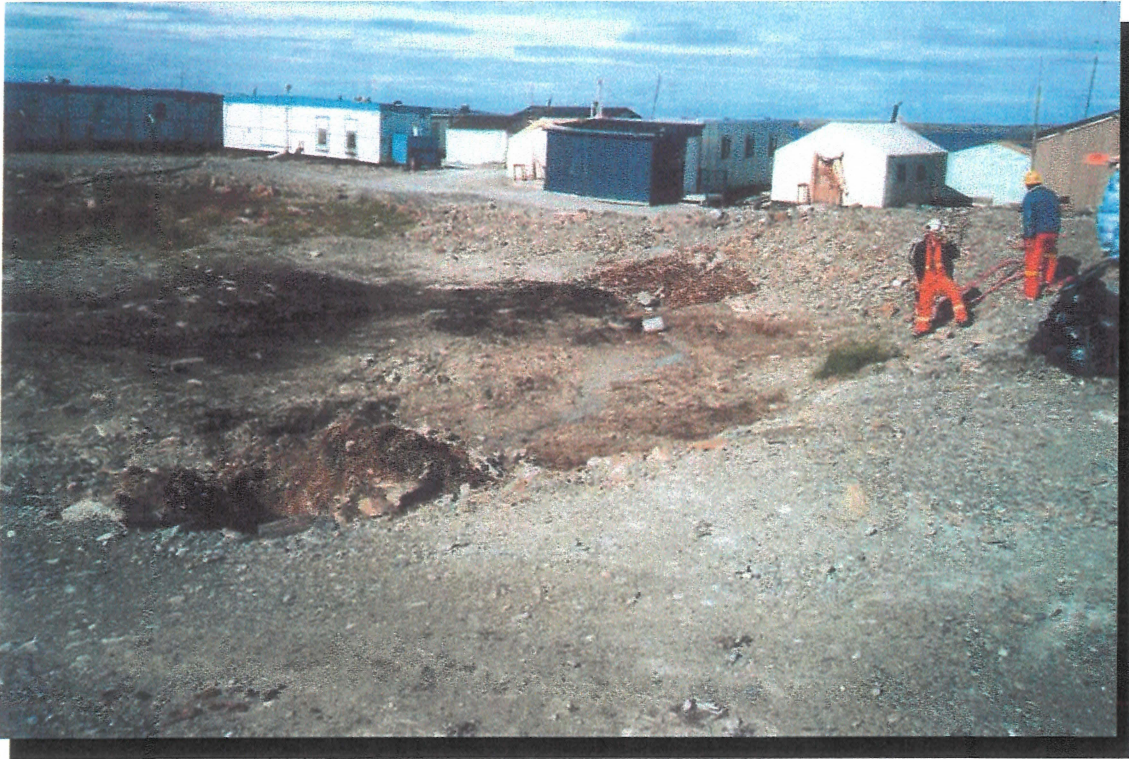
**Photo 6**

Photograph of helipad interception trench pre-construction. Looking south.

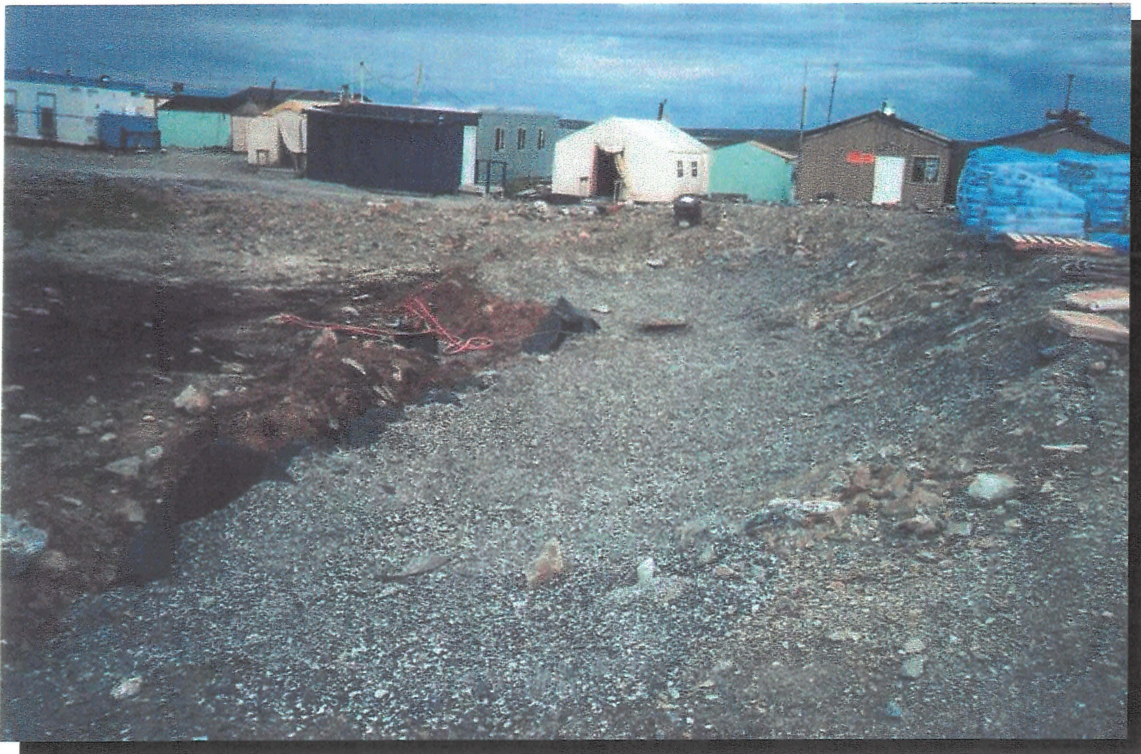
**Photo 7**

Photograph of helipad interception trench post-construction. Looking south.

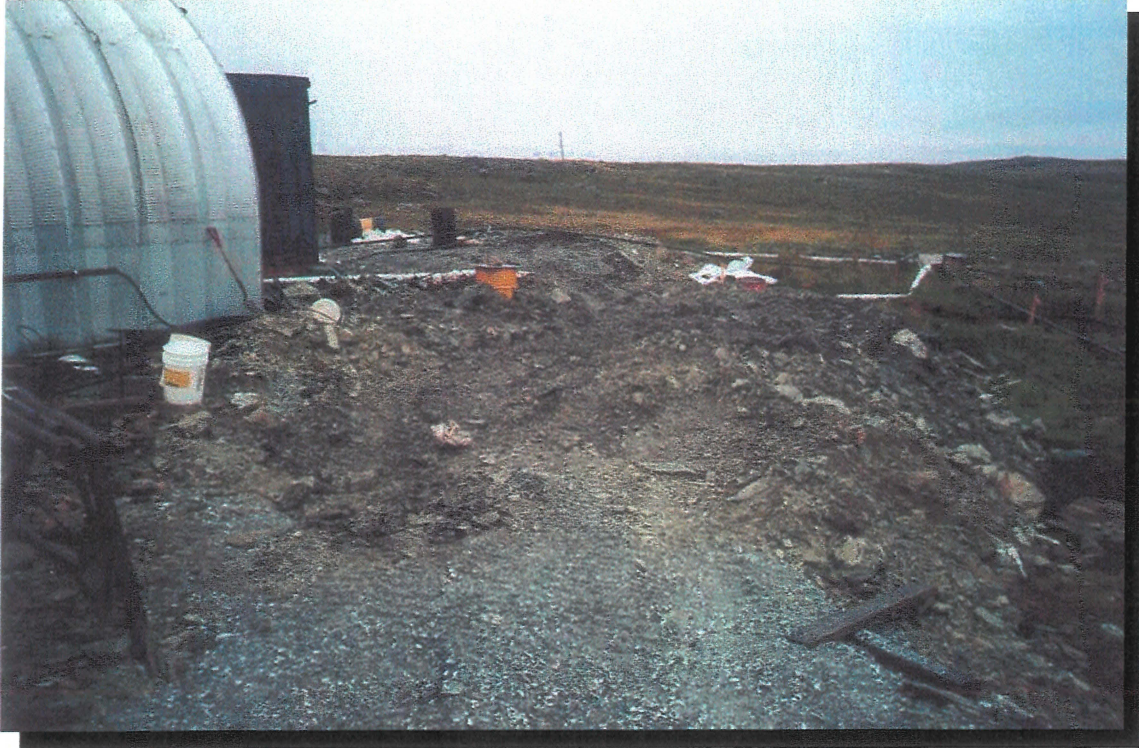
**Photo 8**

Photograph of maintenance shop interception trench post construction. Looking south.

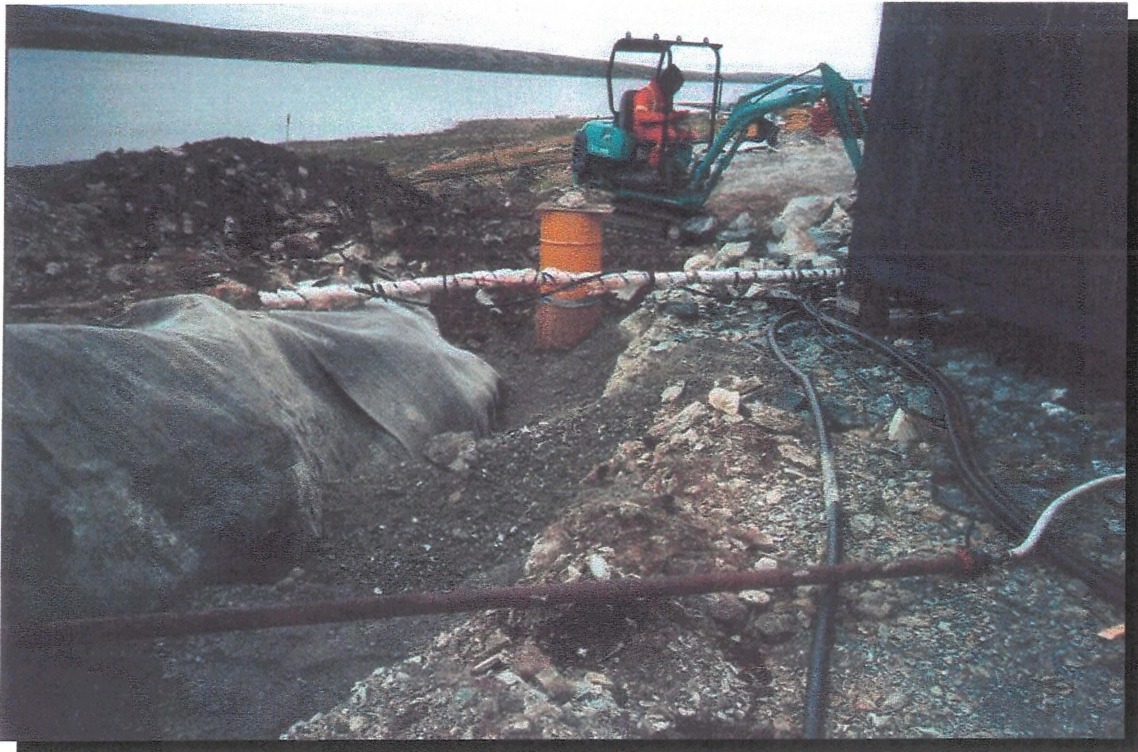
**Photo 9**

Photograph of backfill material used in maintenance shop interception trench. Looking north.

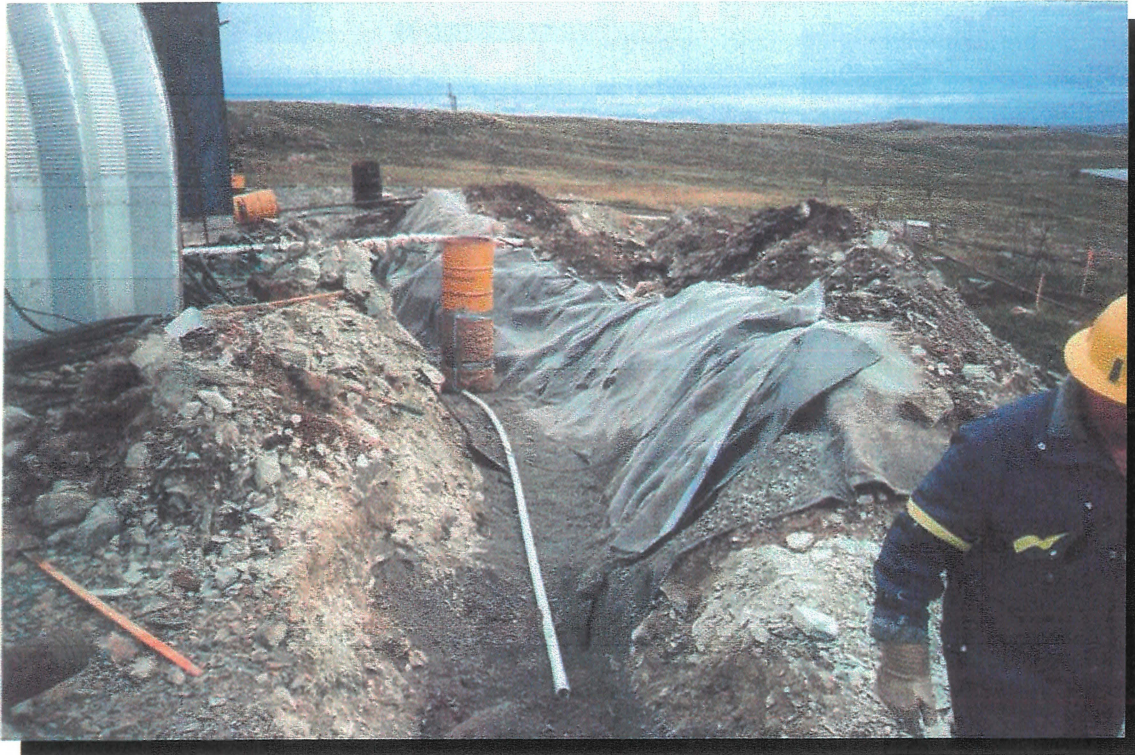
Photo 10

Photograph of catch barrel and piping used in maintenance shop interception trench. Looking south.

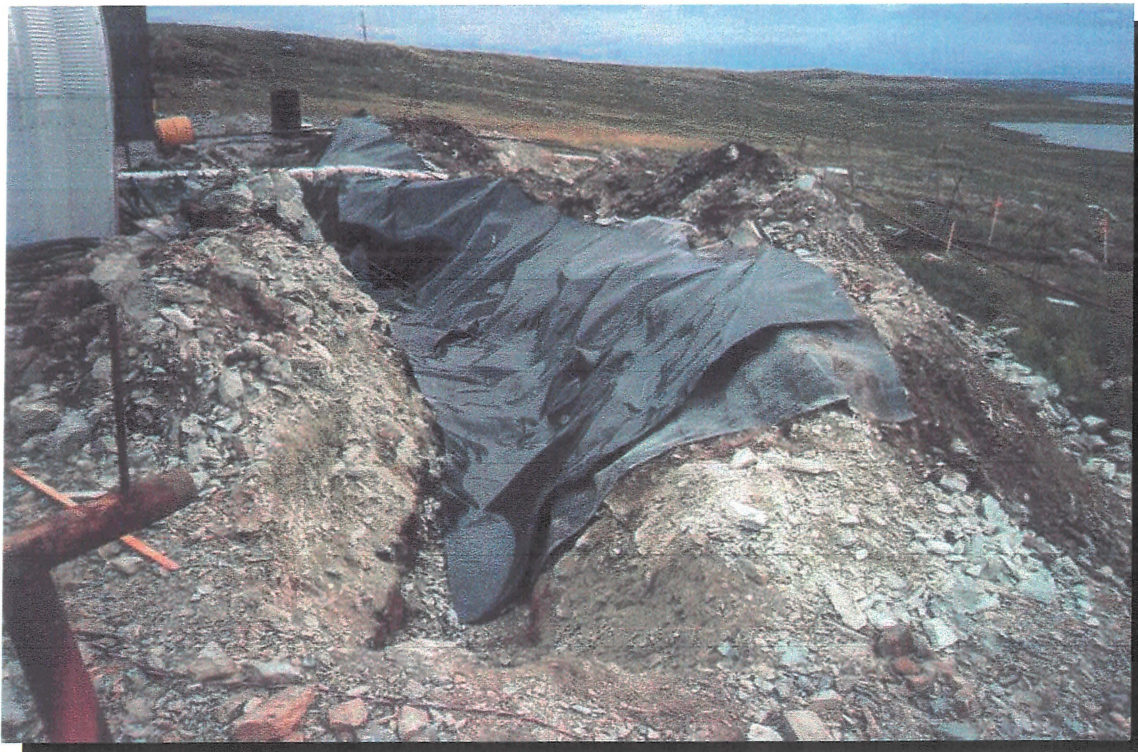
Photo 11

Photograph of HDPE liner used in maintenance shop interception trench. Looking south.

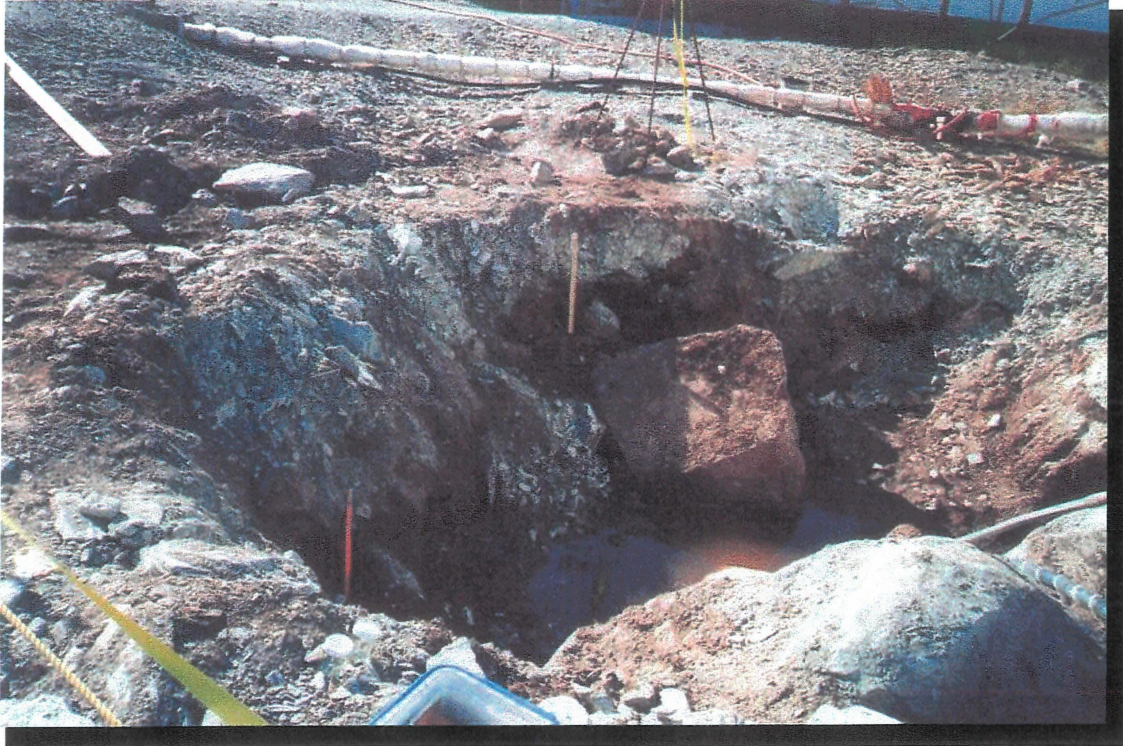
Photo 20
South wall of excavation.

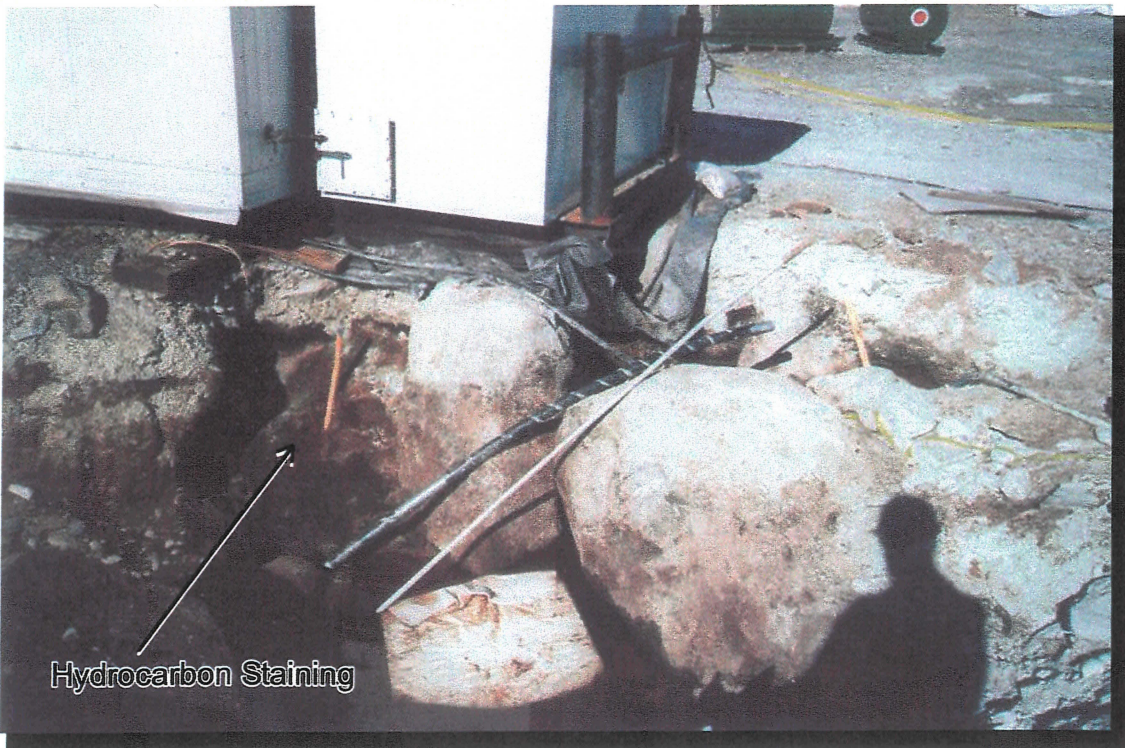
Hydrocarbon impacts exist along the north wall, beneath the generator structure. Further excavation of stained soil was not possible towards the north due to the presence of the generator structure.

Black staining and hydrocarbon odour were noted along the north wall during the excavation inspection. The staining is likely a result of microbial activity within the soil utilizing the diesel as a nutrient source. The microbial degradation process is generally slow; taking years in colder, less active climates to produce the amount of observed staining indicating that the spill is likely a result of a historic event.

Photo 21
North wall of excavation.

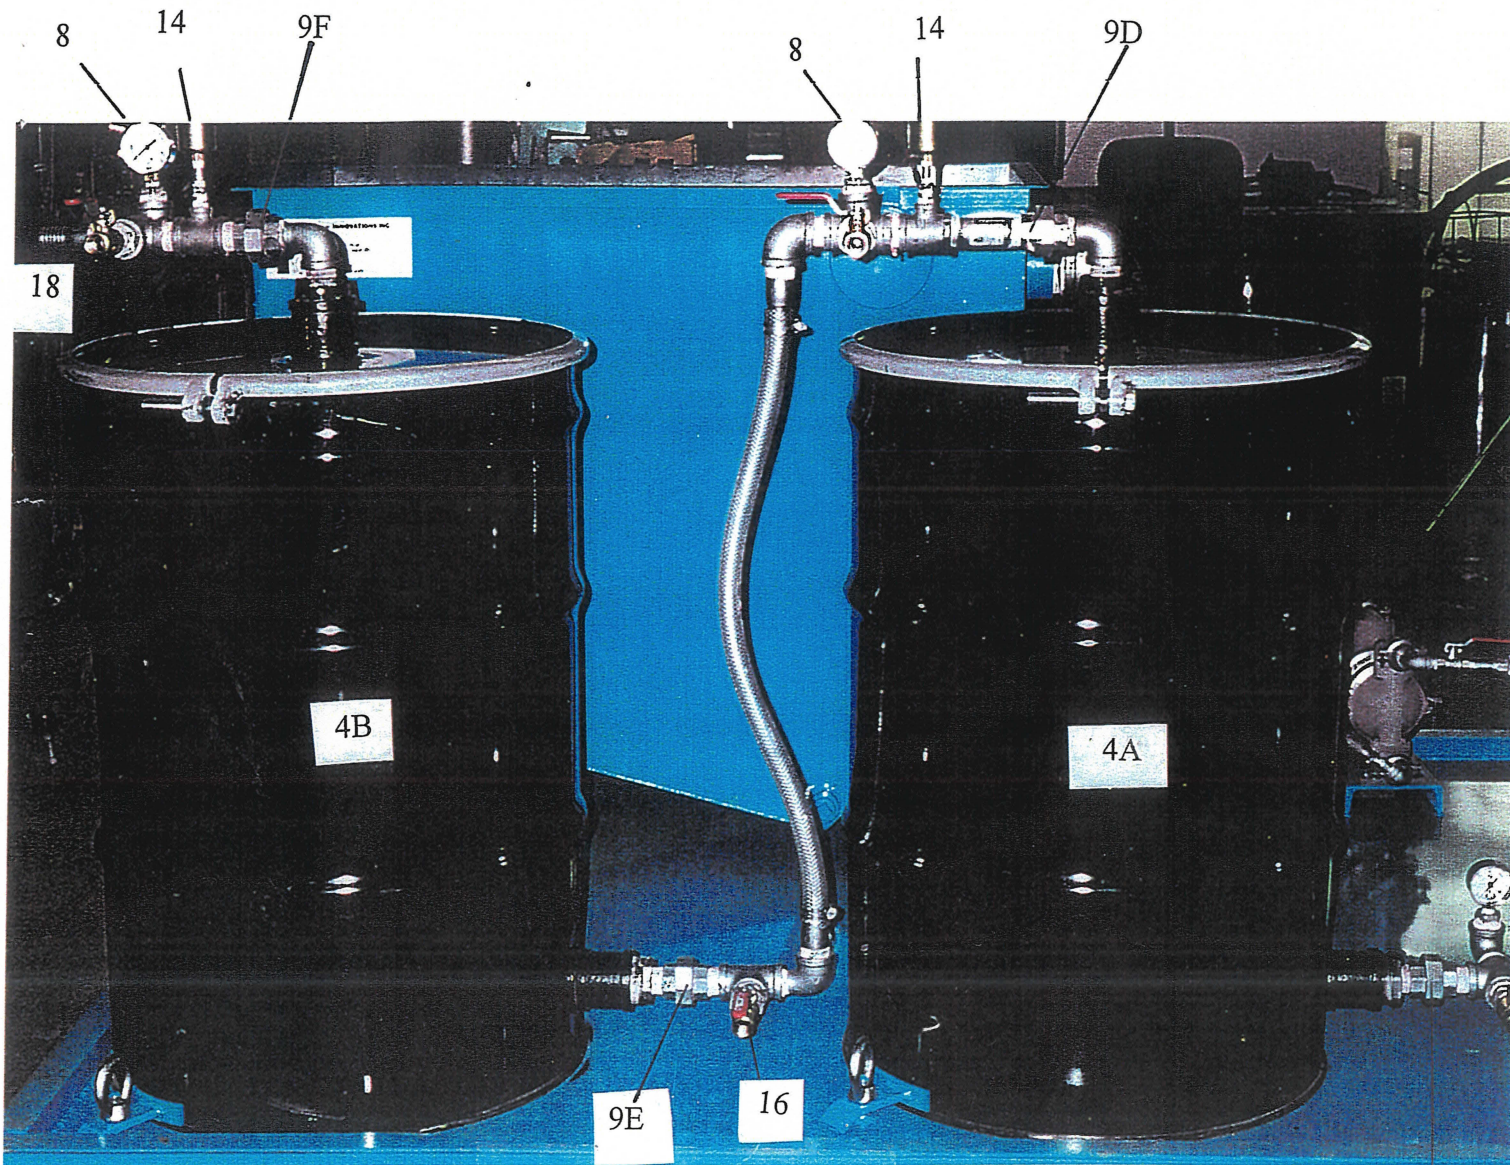
Pictorial #7 – Interconnecting Piping Carbon-Carbon

4A	1 st Carbon Drum
4B	2 nd Carbon Drum
8	Pressure Gauge
9C	Union
9D	Outlet Piping 1 st Drum
9E	Inlet Piping 2 nd Drum
9F	Outlet Piping 2 nd Drum
14	Air Eliminator
16	Drain Valve
18	Effluent/Discharge Sample Valve
