FUEL TANK FARM CONSTRUCTION
AS-BUILT REPORT
BOSTON PROPERTY, NUNAVUT

HOPE BAY JOINT VENTURE
VANCOUVER, BRITISH COLUMBIA

EBA ENGINEERING CONSULTANTS LTD.
EDMONTON, ALBERTA

Project No. 0101-00-14839.002

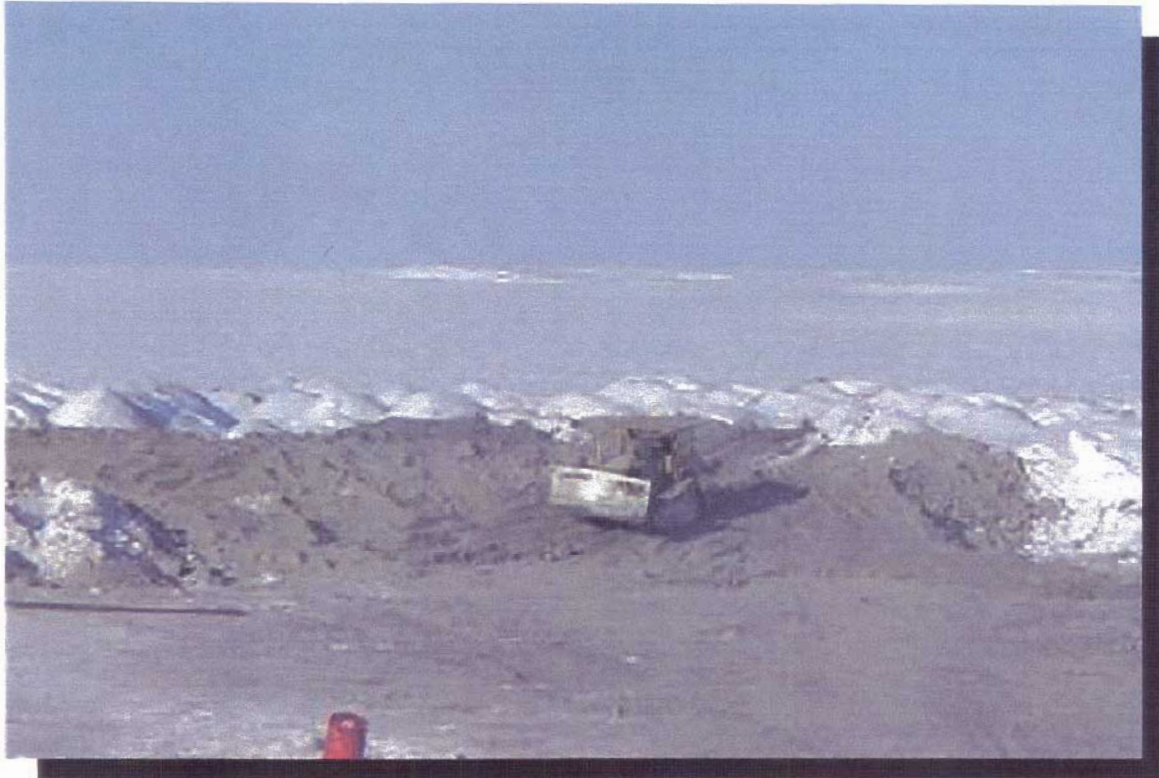
**Photo 1**

The 40 mm Crush contained sufficient fines and moisture content that the material was frozen within the small stockpiles and had to be ripped and repeatedly driven over with the dozer before it could be placed (Photograph Nos. 1 and 2, Appendix D). This required considerable time. Often, frozen chunks could not be broken down and the larger pieces were removed, as best as possible, from the stockpile either by hand or using the Kubota loader (Photograph No. 3).

40 mm Crush stockpiles immediately north of fuel tank farm location, as viewed from the south.

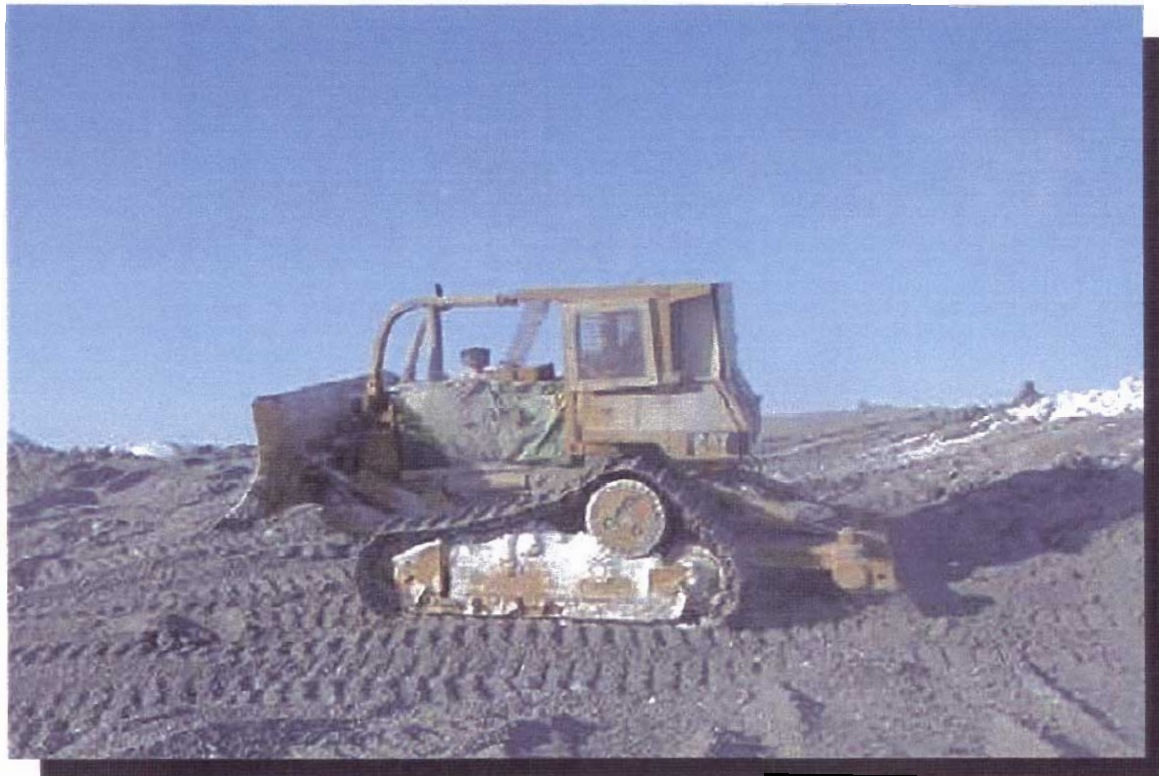
**Photo 2**

Caterpillar D5H Dozer ripping and breaking down the 40 mm Crush stockpiles.

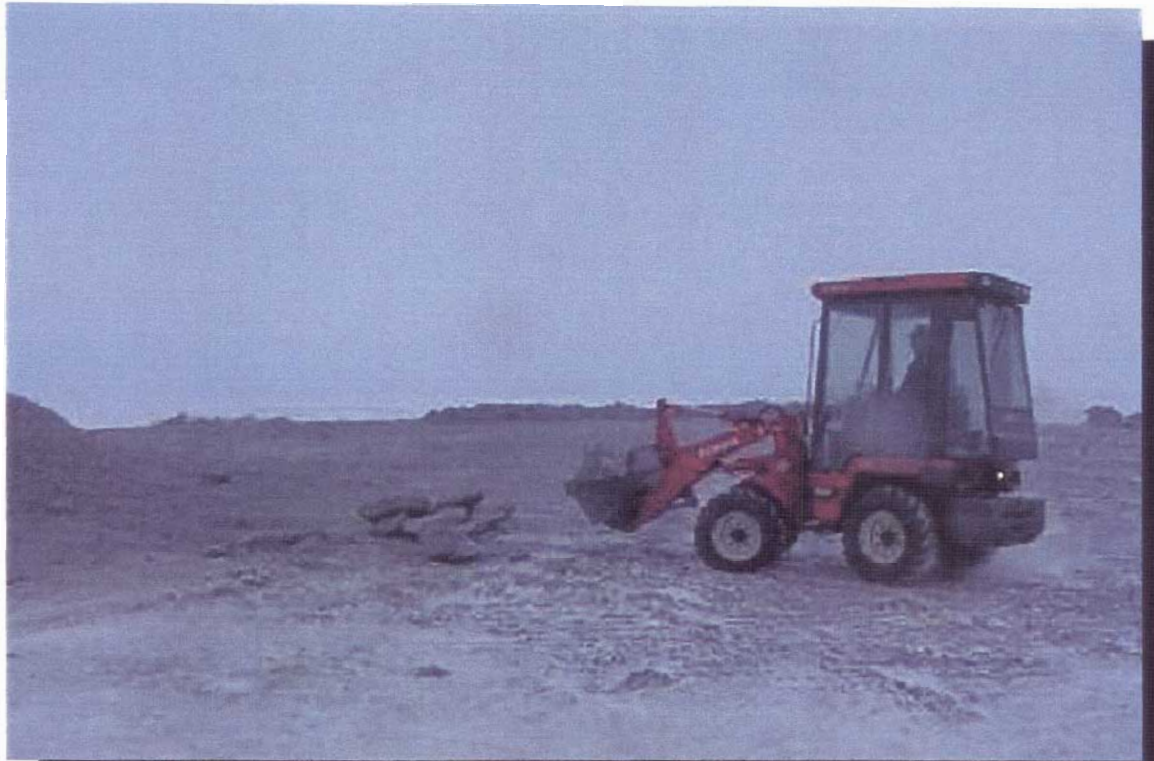
**Photo 3**

Removing large frozen chunks from the 40 mm Crush stockpile.

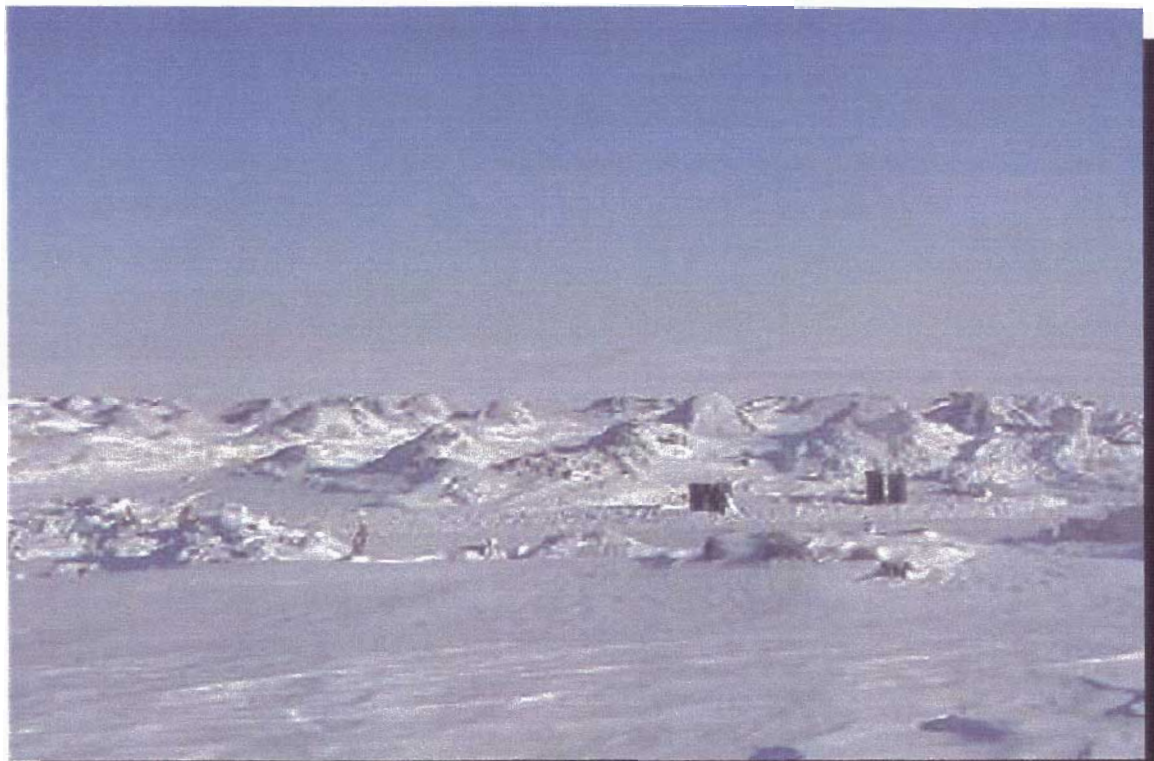
**Photo 4**

Rough grading and site preparation was conducted between March 14 and 16, 2001 prior to EBA's arrival on the site. Photograph No. 4 shows the condition of the site prior to construction of the fuel tank farm. Photograph No. 5 shows the site preparation and grading work that was done. EBA inspected the rough graded area on March 17, 2001. Overall, the condition of the pad appeared adequate.

Site conditions prior to construction of fuel tank farm, as viewed from the west.

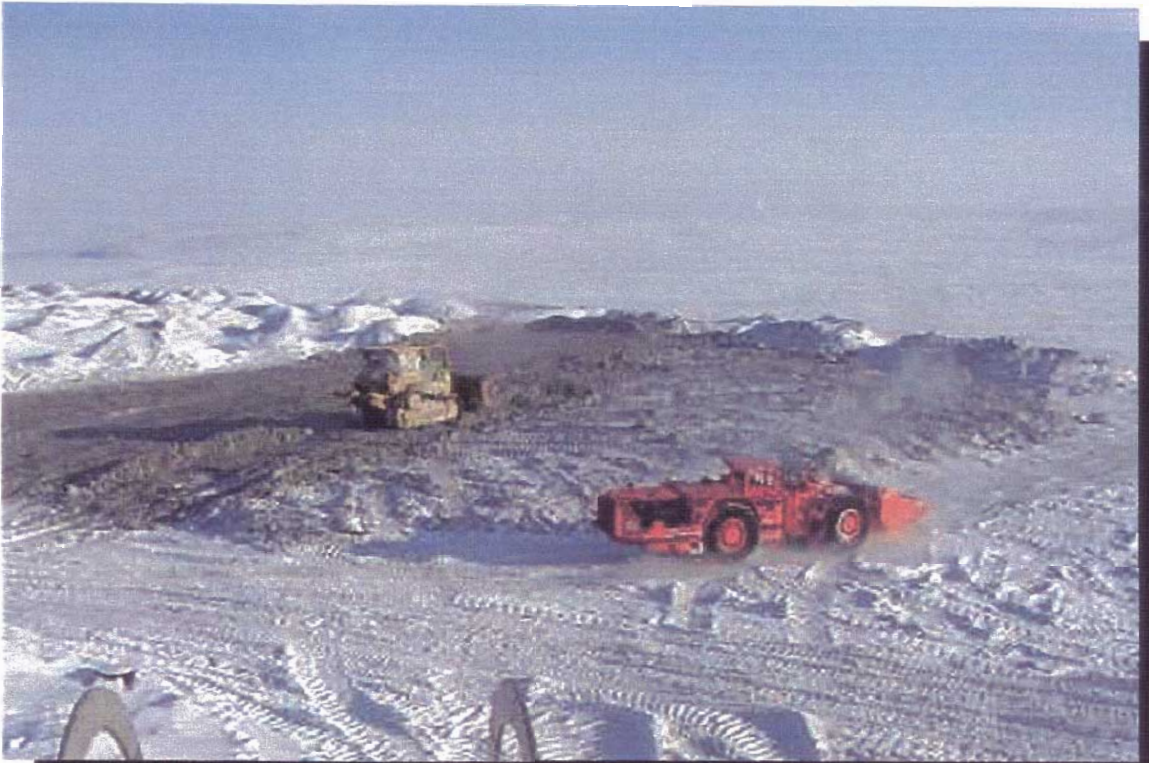
Photo 5

Site preparation and grading work being done prior to EBA's arrival on site.

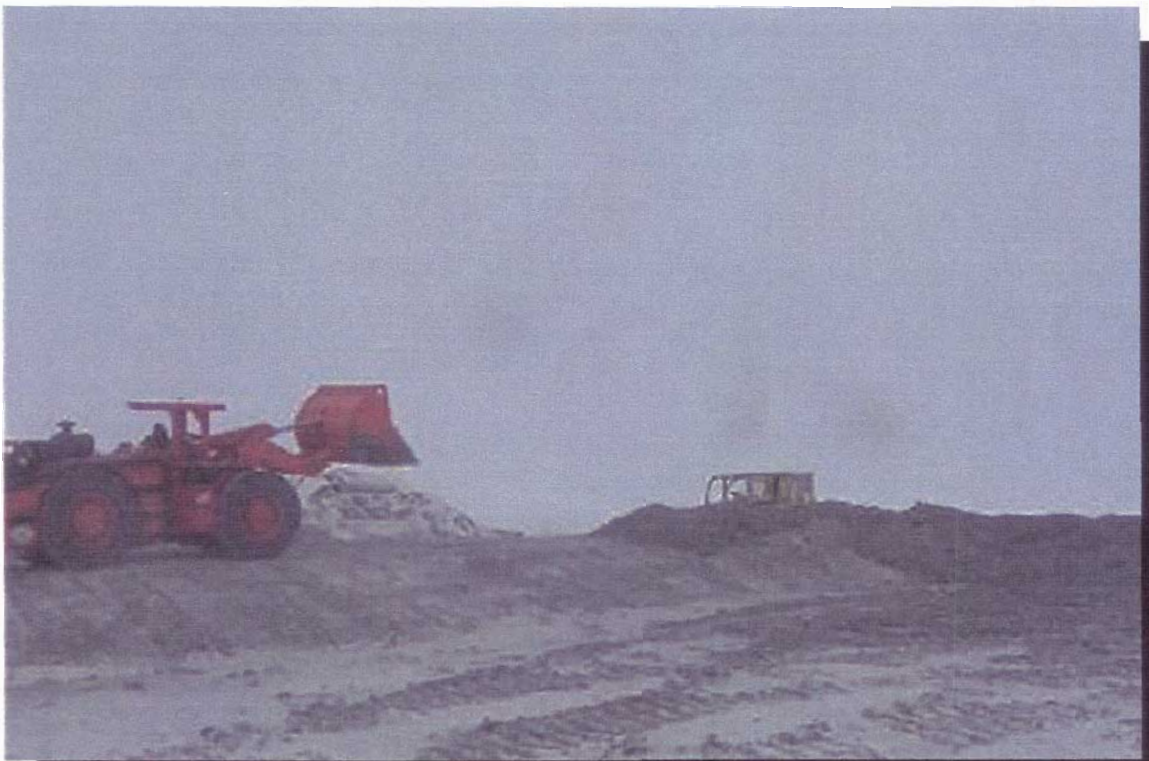
Photo 6

JS250 Scoop placing 40 mm Crush along north berm.

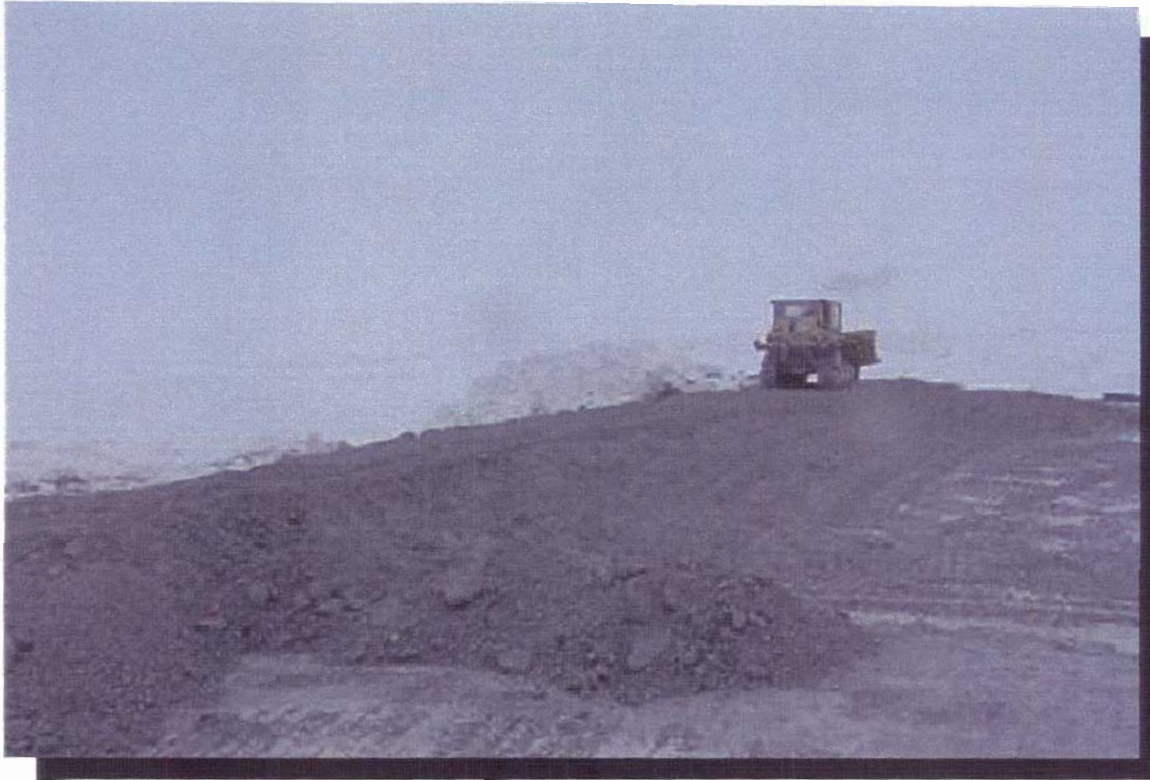
Photo 7
D5H Dozer spreading 40 mm Crush along north berm.

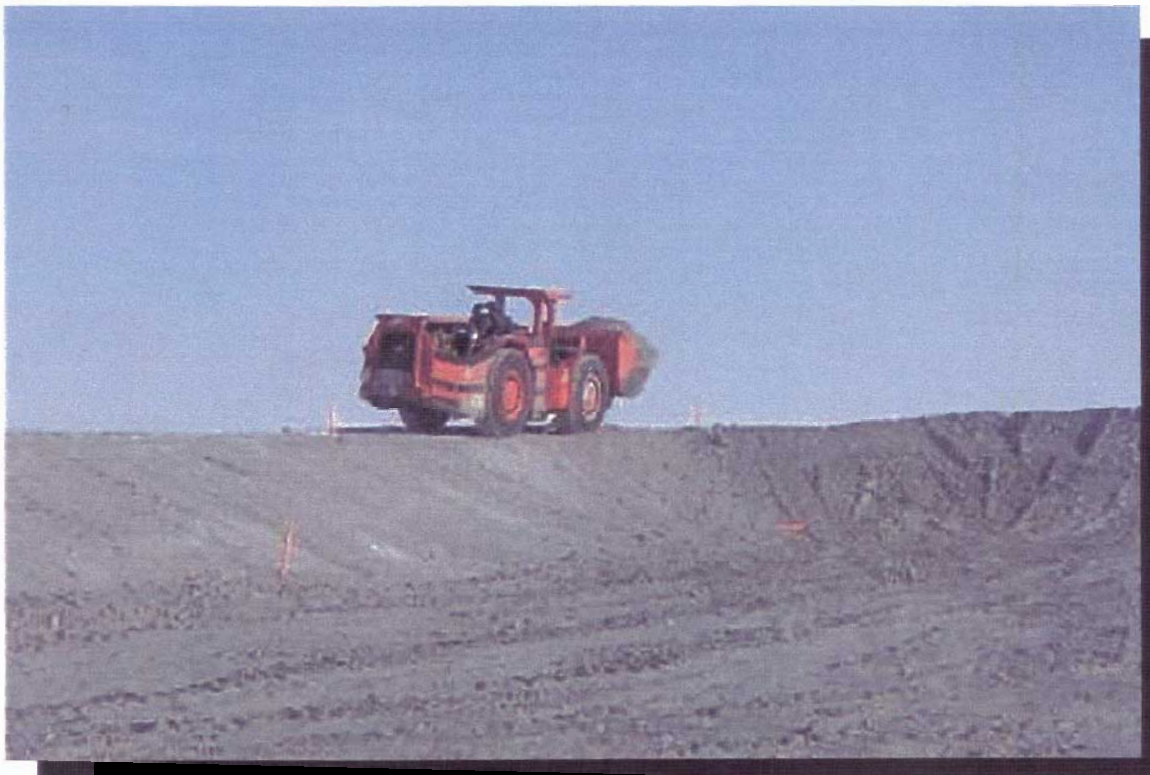
over the fill using a Scoop with a bucket full of material (Photograph No. 8). No other compaction equipment was available. Ideally, the material should have been compacted to a minimum of 95% maximum dry density as determined by the Standard Proctor Test. However, given that there was no conventional compaction equipment on site and that the material contained moisture and was frozen, the desired compaction standard could not be achieved.

Photo 8
JS250 Scoop with bucket full of material compacting 40 mm Crush along north berm.

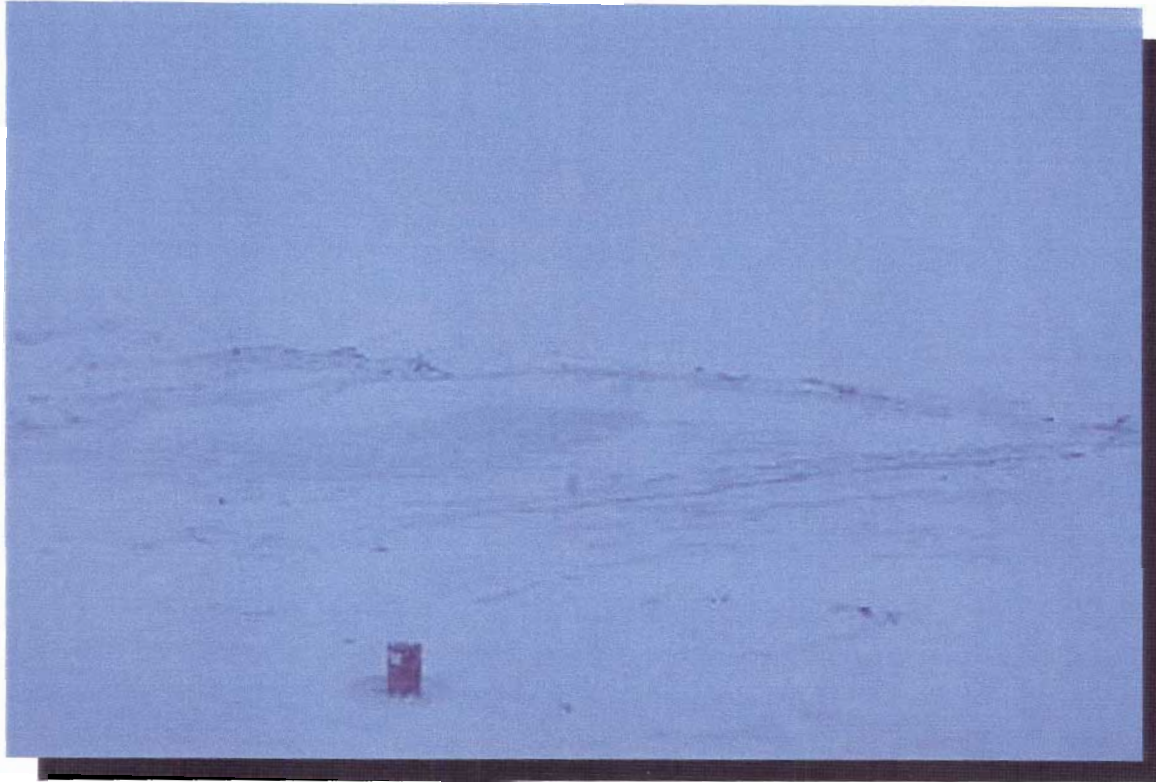
Photo 9

Snowfall on March 19 and 20 caused some construction delays because the snow accumulations had to be cleared off of the berms and pad before additional material could be placed. Photograph Nos. 9 and 10 show the snowfall accumulations on the morning of March 20 and 21, respectively.

Snowfall and wind blown snow accumulations.
Photo taken on the morning of March 20, 2001.

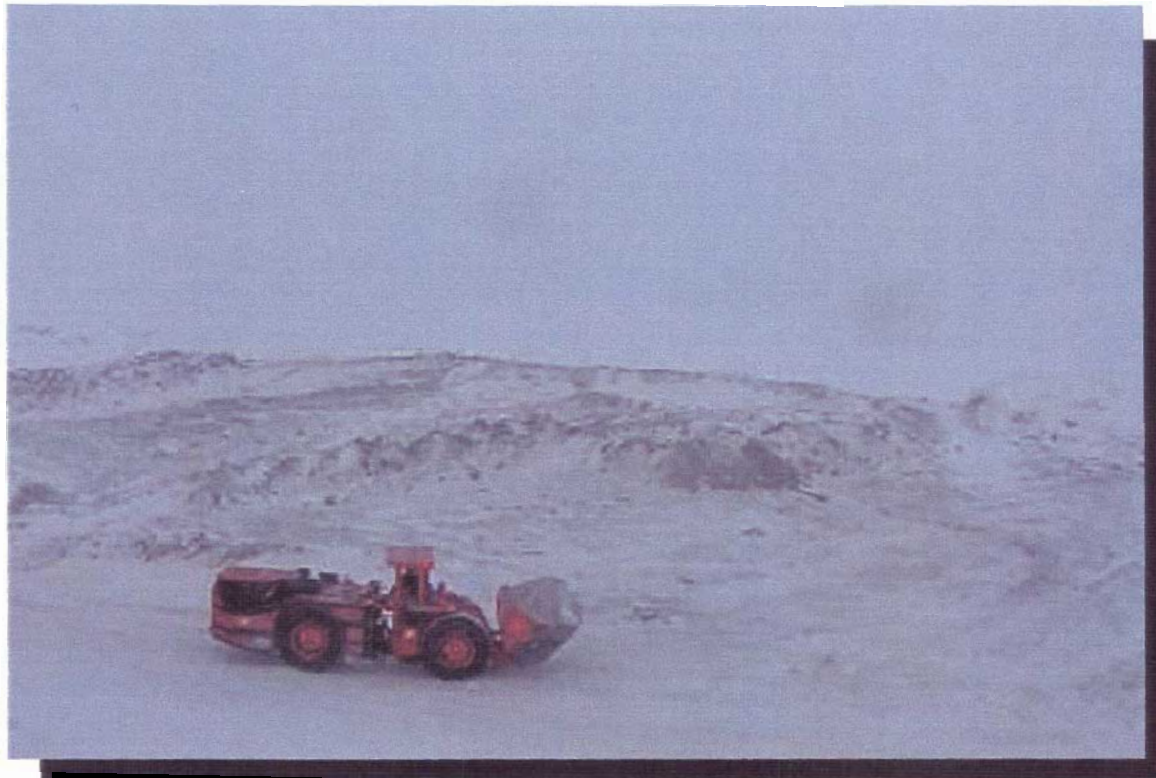
Photo 10

Snowfall and wind blown snow accumulations.
Photo taken on the morning of March 21, 2001.

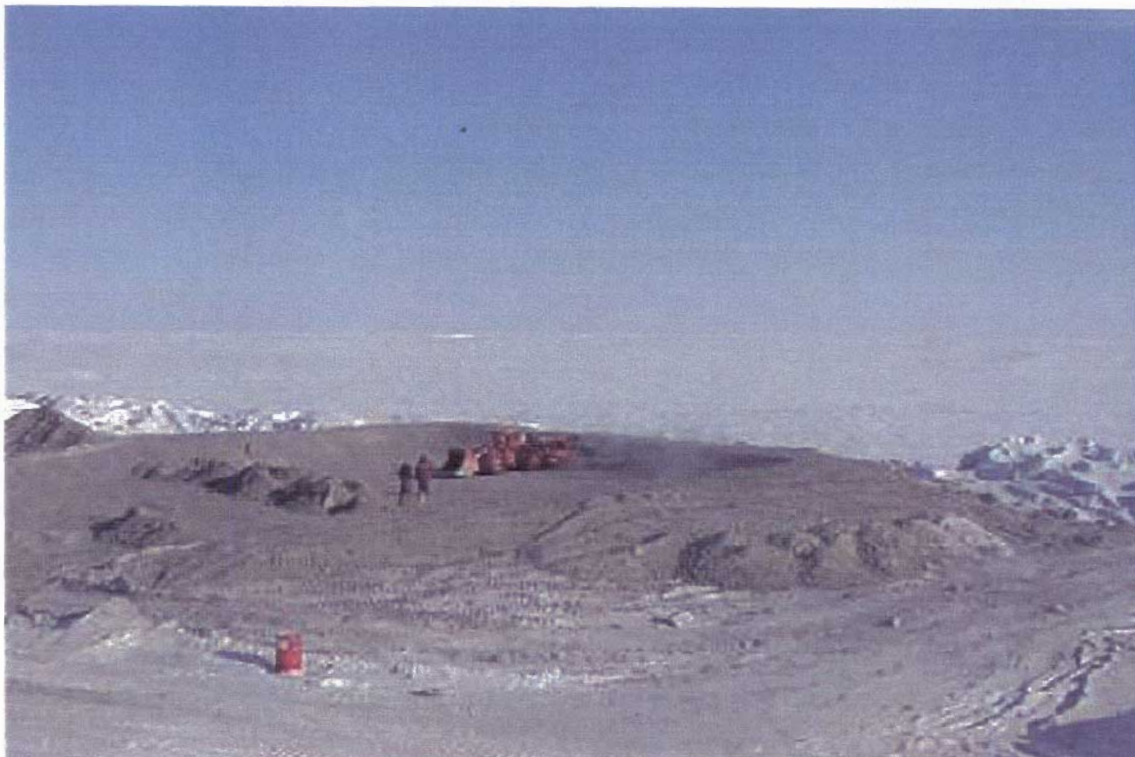
**Photo 11**

Three berms were constructed simultaneously to allow easier access for the construction equipment and the fourth (west) berm was constructed last (Photograph No. 11). Photograph 12 shows the berms ready for liner installation. Photograph 13 shows the condition of the base of the fuel tank farm prior to liner installation.

JS250 Scoop placing 40 mm Crush along west berm alignment. Ramp along south berm under construction.

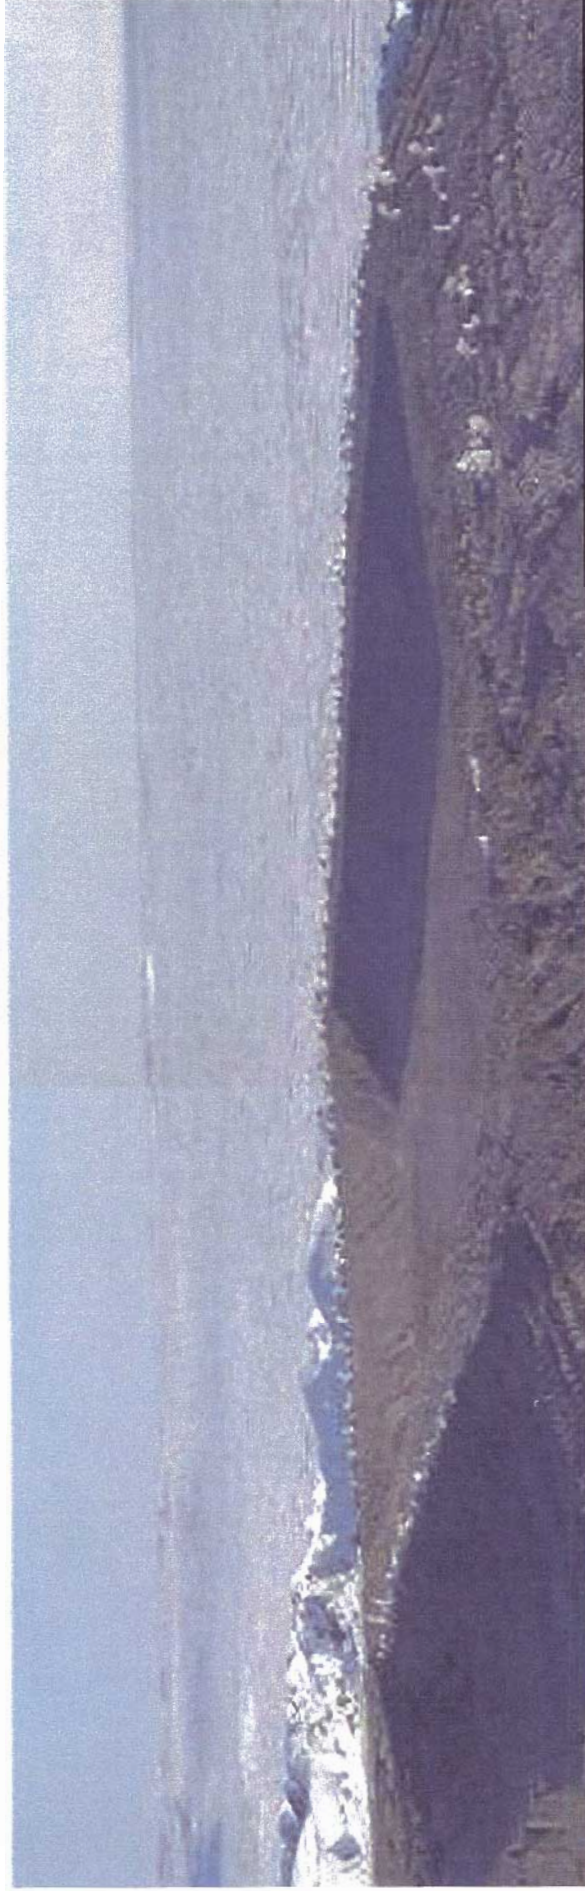
Photo 12

Tank farm ready for liner installation, as viewed from the southwest (March 24, 2001).

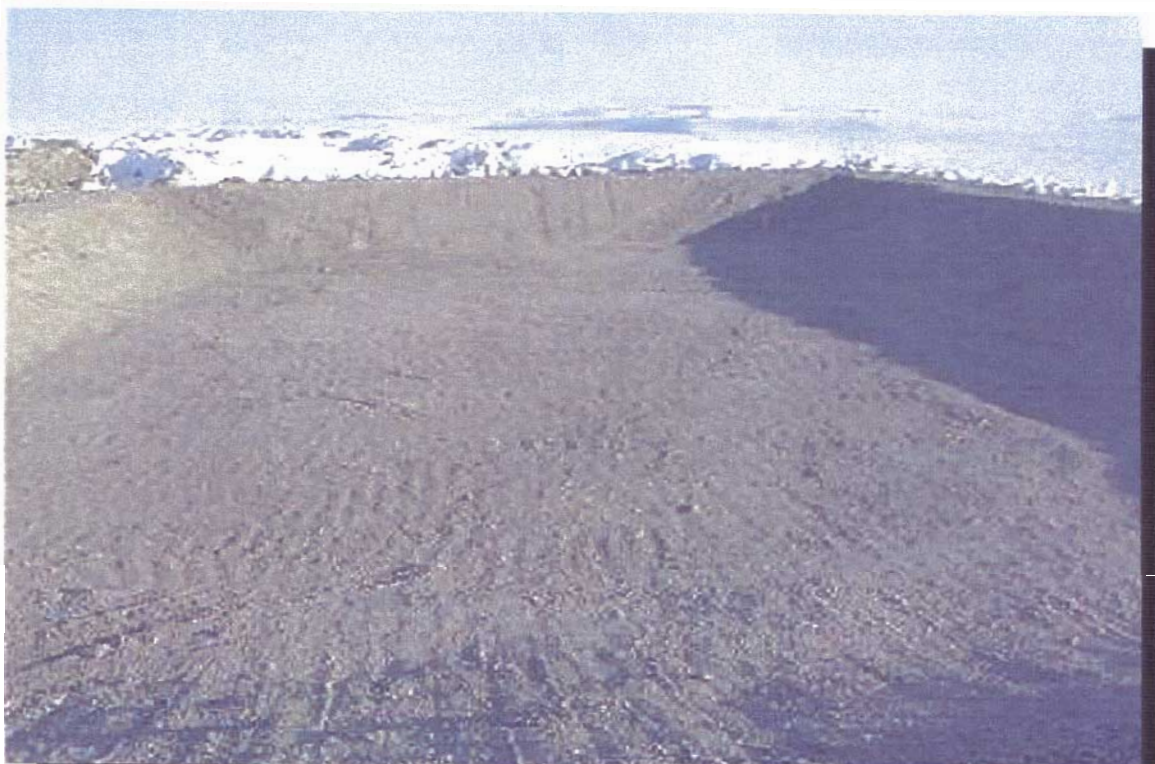
Photo 13

Base of tank farm within containment berms prior to liner installation.

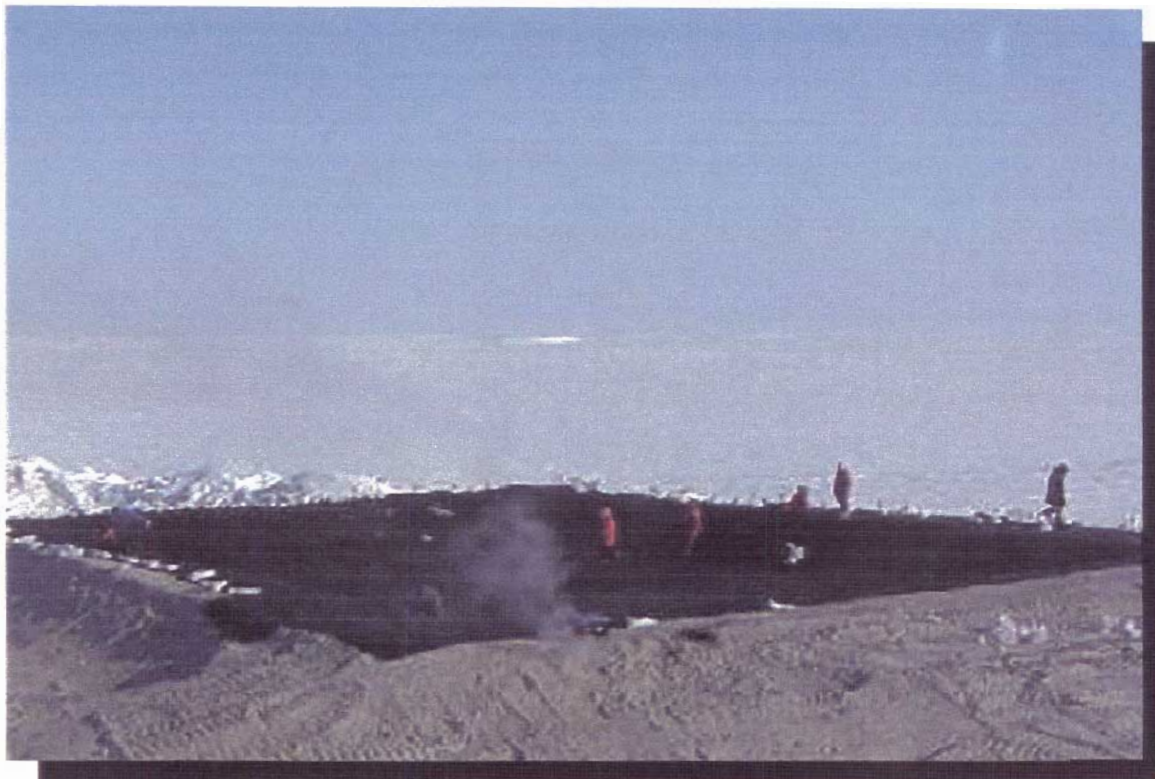
Photo 14

Deployed non-woven geotextile, preparing for HDPE liner installation.

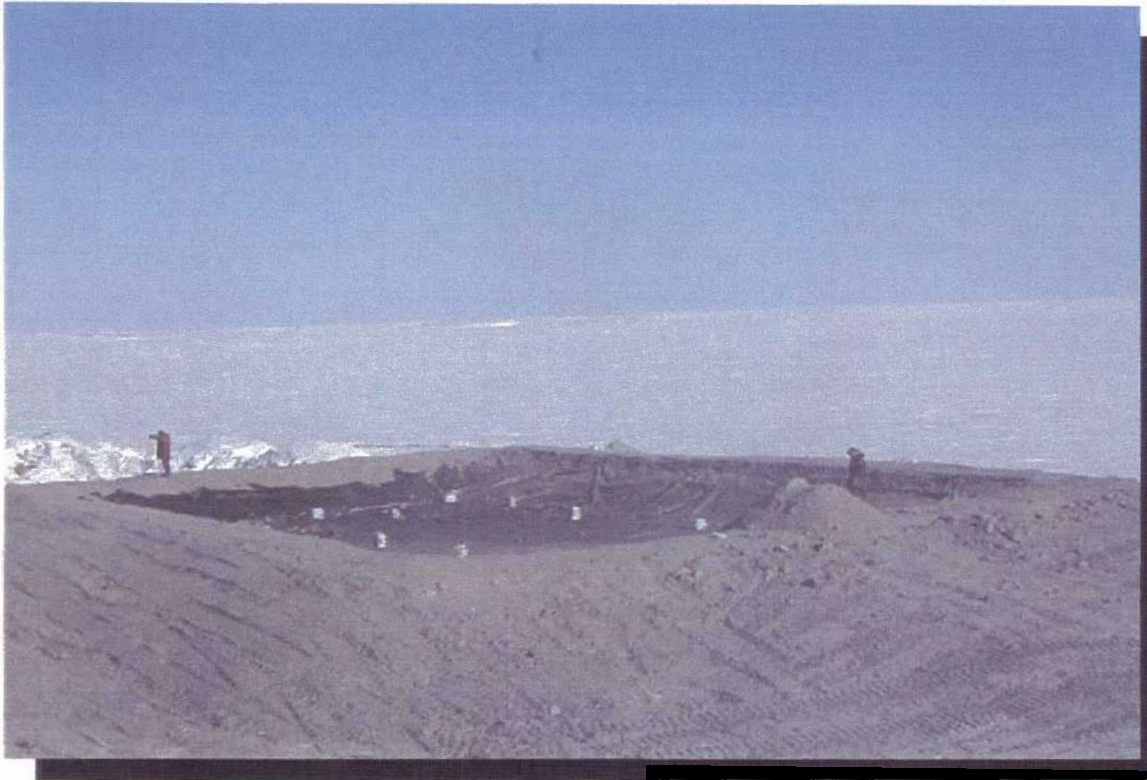
**Photo 17**

Liner system installed and crest of berms covered with 40 mm Crush, as viewed from the southwest (March 25, 2001).

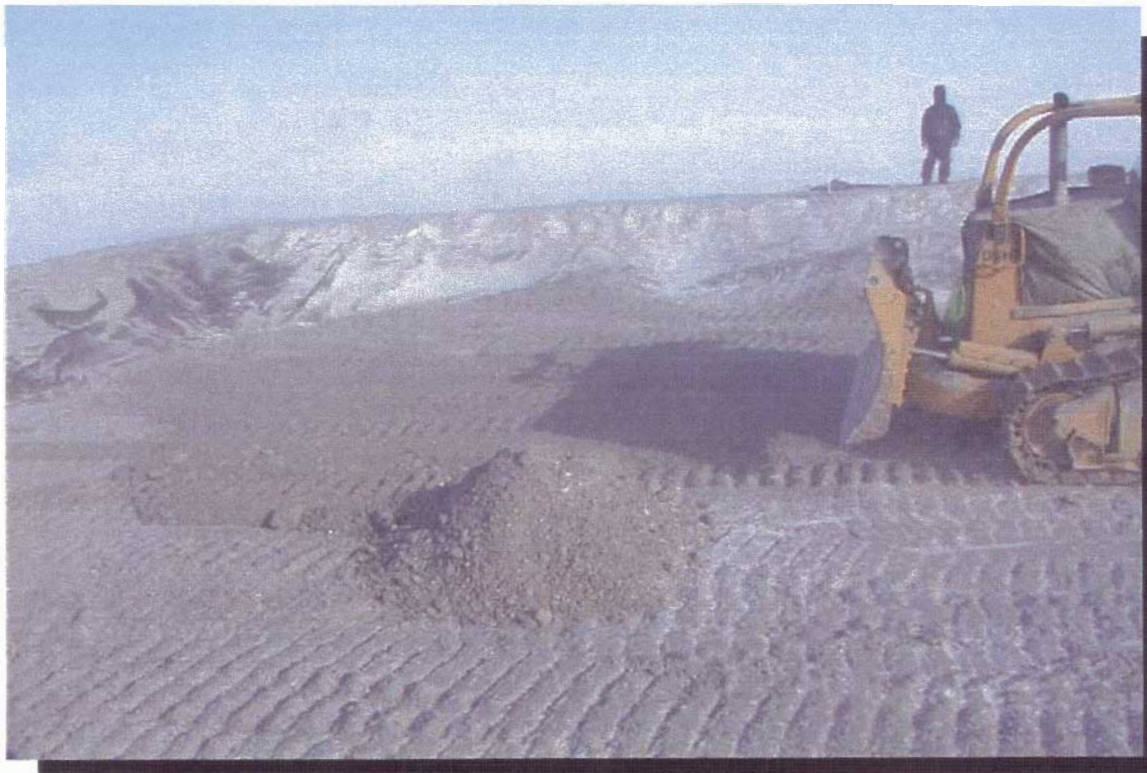
**Photo 18**

D5H Dozer spreading 40 mm Crush along base of tank farm. Photo taken by HBJV.

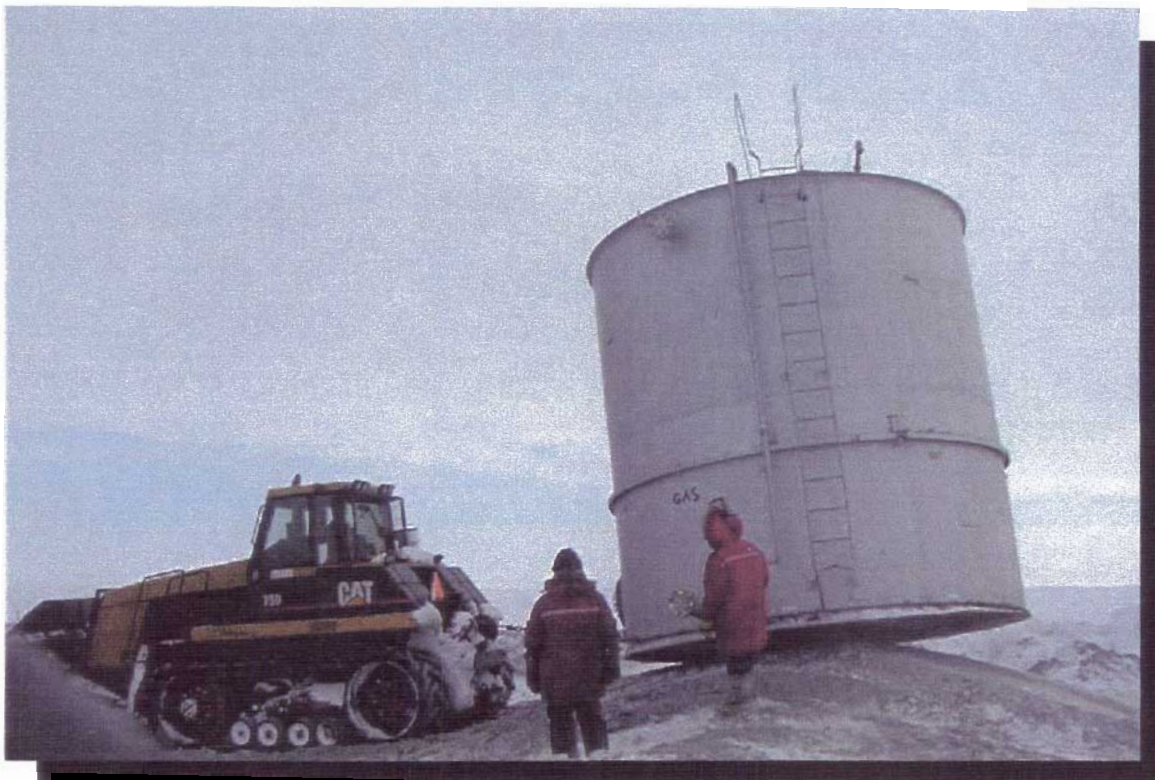
**Photo 20**

Challenger 75D skidding fuel tank over south berm. Photo taken by HBJV.

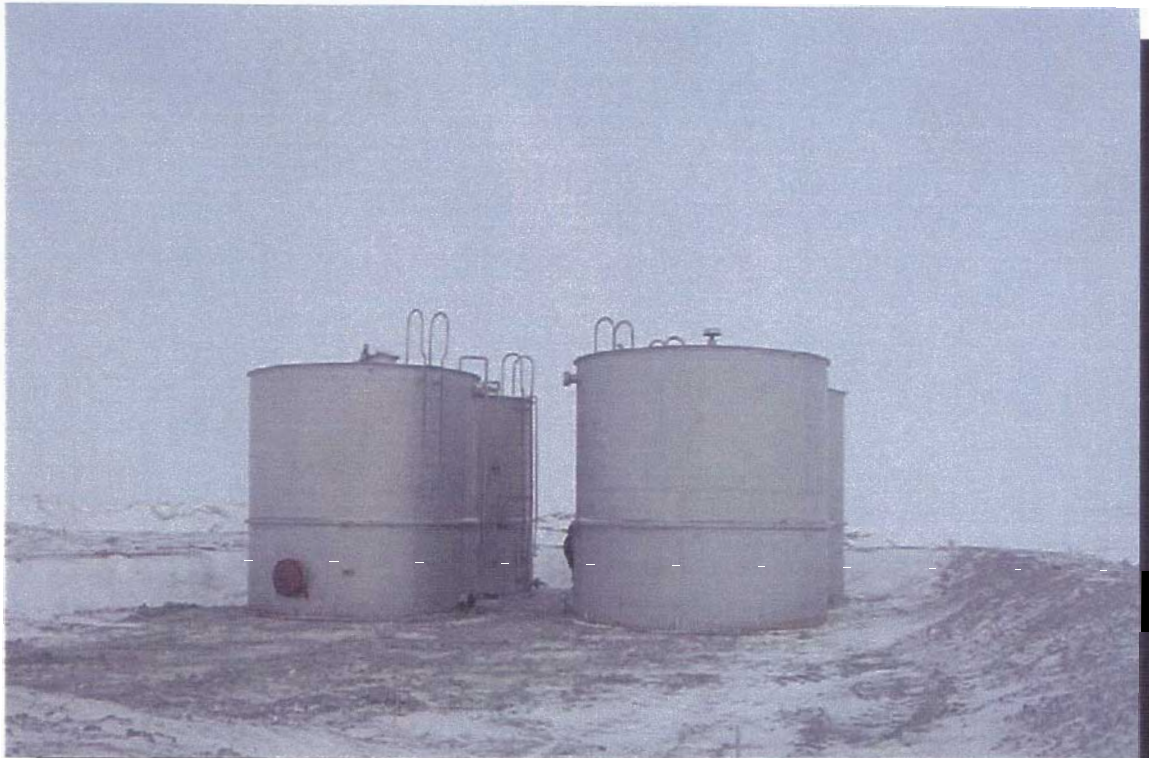
**Photo 21**

Four fuel tanks in position, as viewed from the south. Photo taken by HBJV.

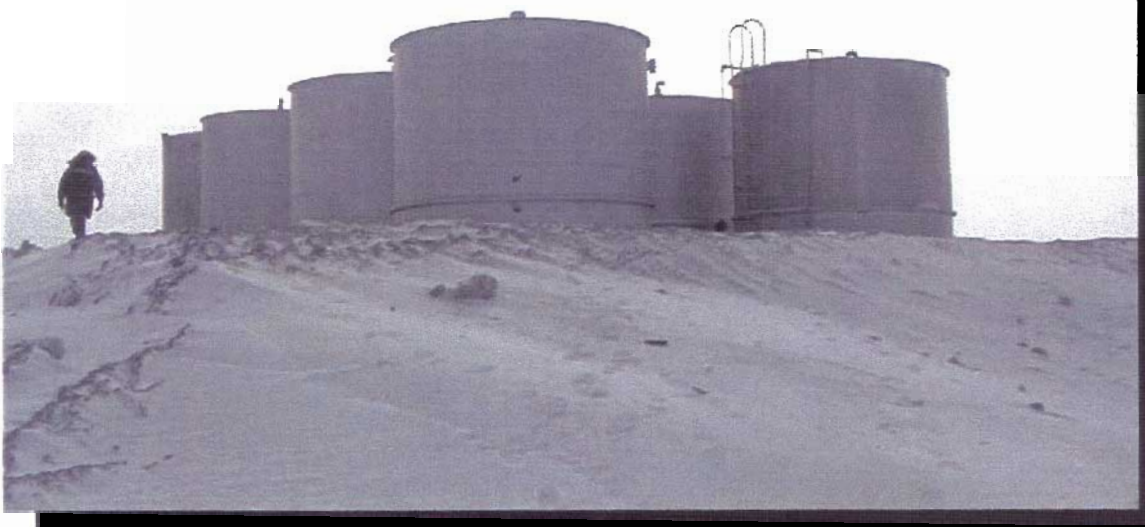
**Photo 22**

All eight fuel tanks placed inside containment berms, as viewed from the northeast. Photo taken by HBJV.

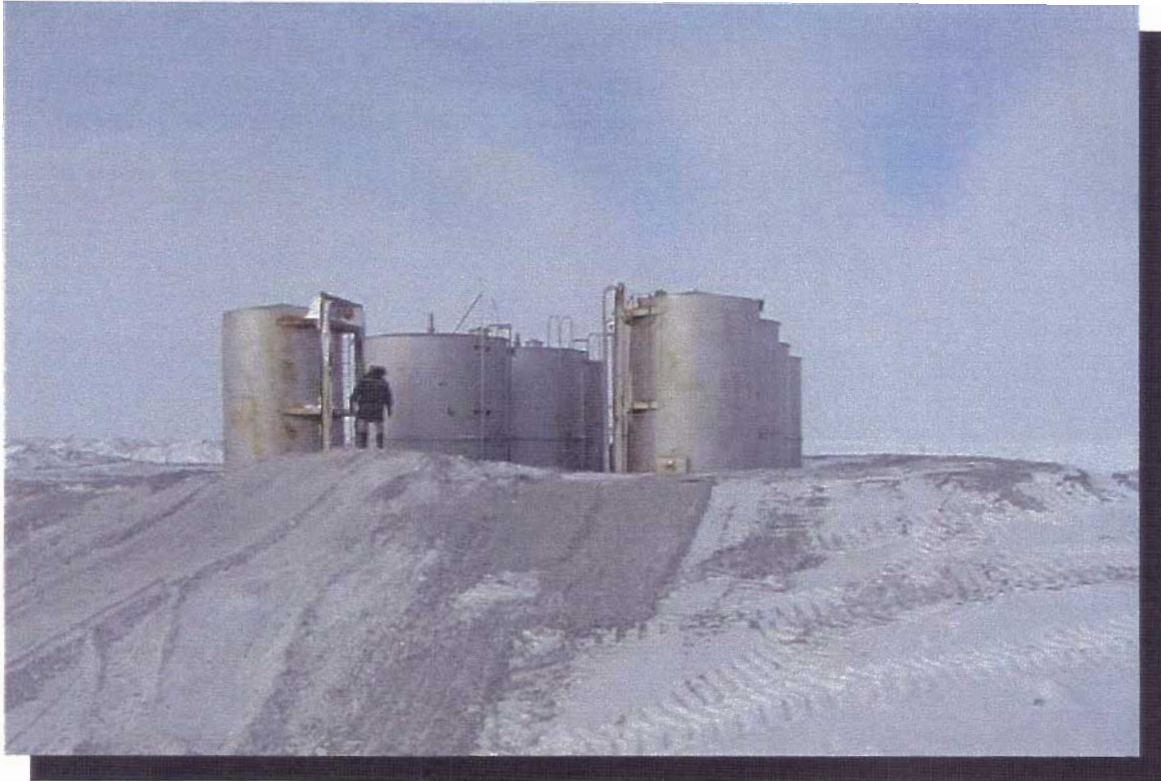
**Photo 23**

All eight fuel tanks placed inside containment berms, as viewed from the south. Note ramp over south berm used to skid tanks into position. Photo taken by HBJV.
