HOPE BAY MINING LIMITED

PHASE III ENVIRONMENTAL SITE ASSESSMENT BOSTON CAMP HOPE BAY PROJECT, NU

REPORT

DECEMBER 2012
ISSUED FOR USE
EBA FILE: E14101223

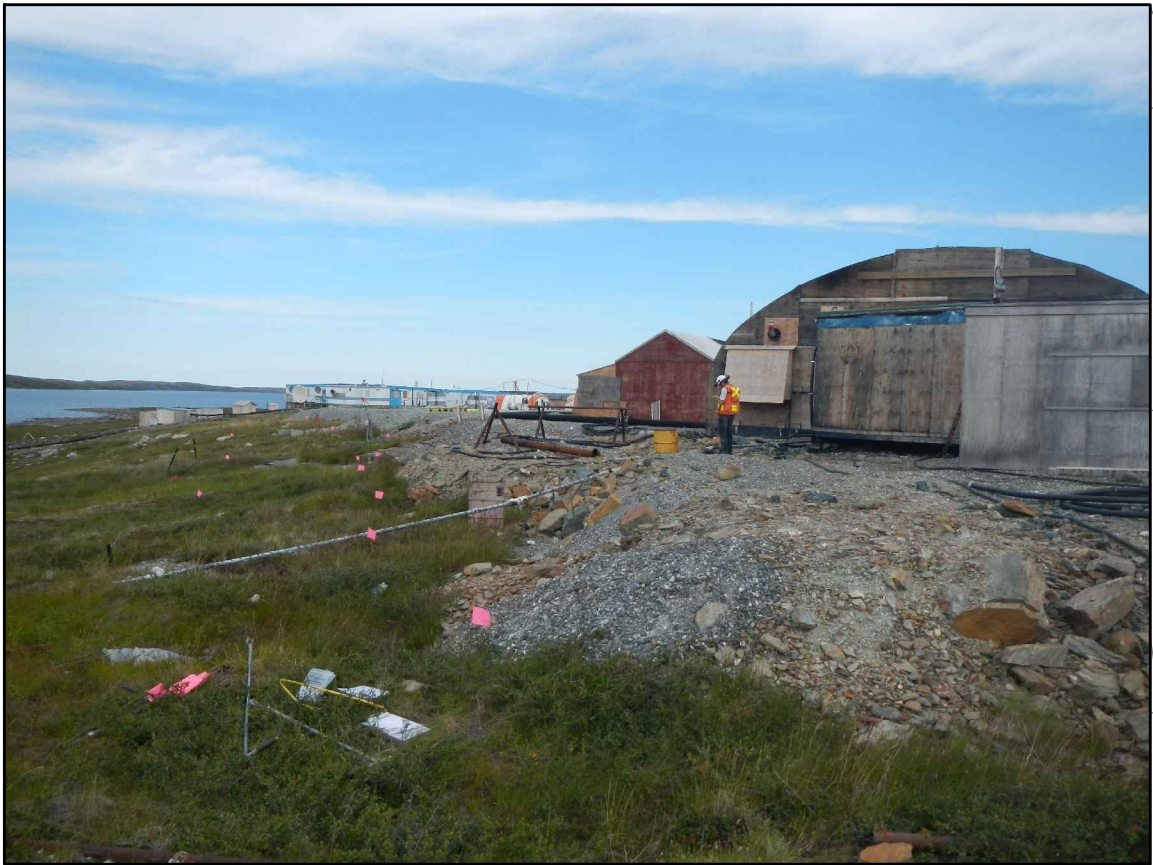
Figure 4Ai

Soil Analytical Results For Hydrocarbons at AEC 1 (Old Spill Area)

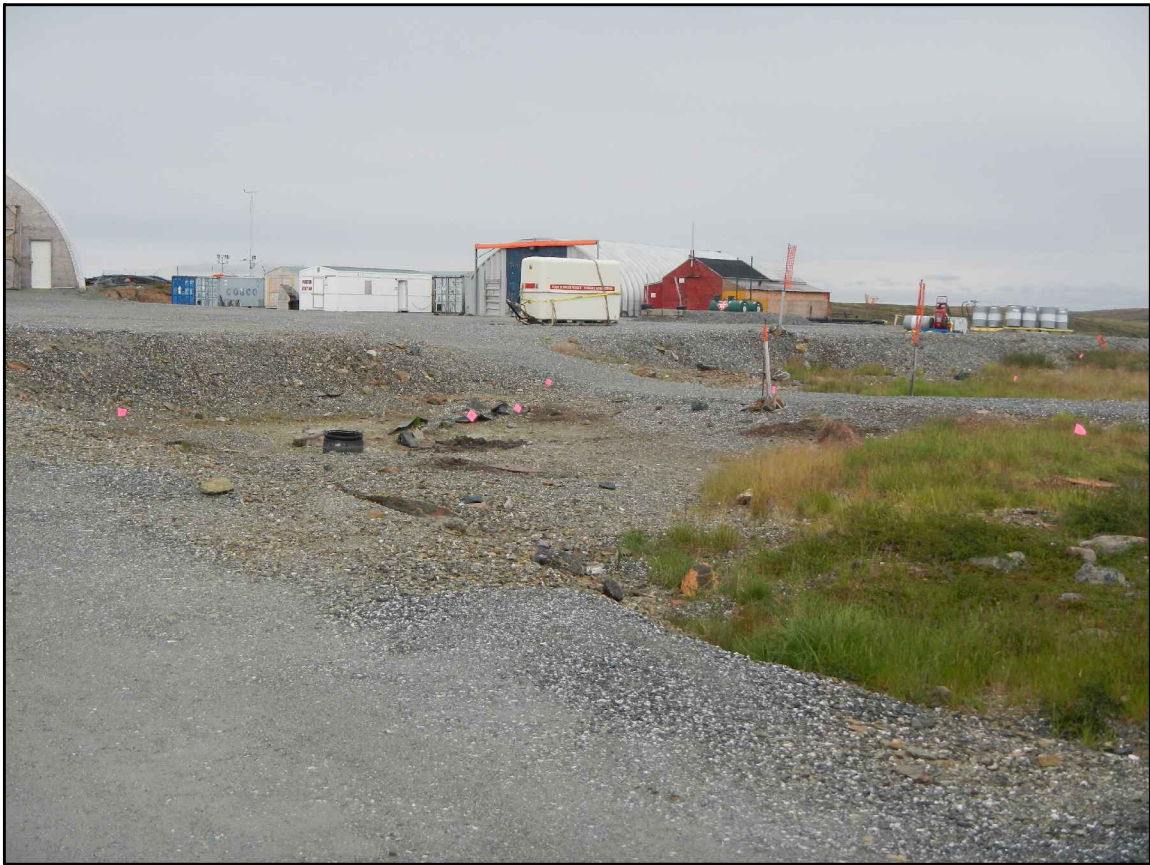
Figure 4Aii

Soil Analytical Results For Hydrocarbons at AEC 1 (Old Spill Area)									
Sample Number	Sample Depth (m)	BTEX and Hydrocarbon Fractions F1 to F4 (mg/kg)							
		Benzene	Toluene	Ethylbenzene	Xylene	F1 (C6-C10)	F2 (>C10-C16)	F3 (>C16-C34)	F4 (>C34-C50)
AEC 1 - 13	0.50 to 0.75	<0.005	<0.02	<0.01	<0.04	<12	<10	48	13
AEC 1 - 14	0.25 to 0.50	<0.005	<0.02	<0.01	<0.04	<12	<10	83	23
AEC 1 - 15	0.50 to 0.75	<0.005	<0.02	<0.01	<0.04	<12	<10	67	46
AEC 1 - 16	0.50 to 0.75	<0.005	<0.02	<0.01	<0.04	<12	16	<10	<10
AEC 1 - 17	0.75 to 1.00	<0.005	<0.02	<0.01	<0.04	<12	<10	<10	<10
AEC 1 - 18	0.75 to 1.00	<0.005	<0.02	<0.01	<0.04	<12	<10	31	<10
AEC 1 - 19	0.25 to 0.50	<0.005	<0.02	<0.01	<0.04	<12	<10	74	11
AEC 1 - 20	0.50 to 0.75	<0.005	<0.02	<0.01	<0.04	<12	<10	22	<10
AEC 1 - 21	0.75 to 1.00	<0.005	0.35	<0.01	<0.04	<12	<10	78	23

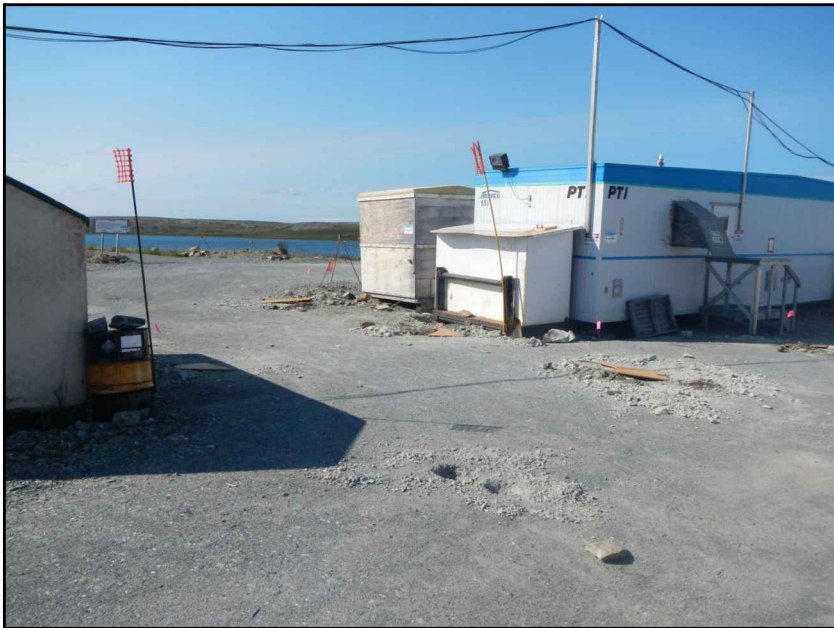
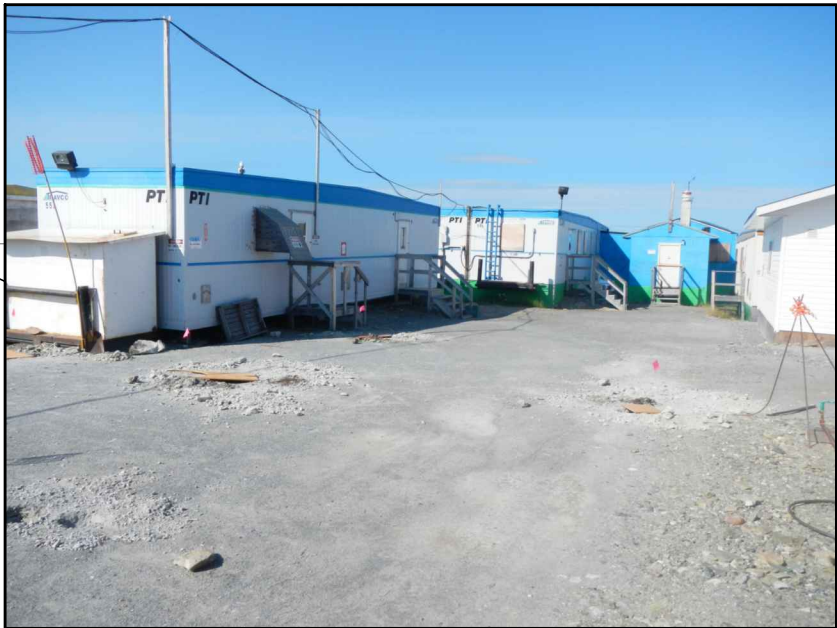
Figure 4B

Areas under the generator shack and the camp buildings were not assessed because the buildings are still present. It is likely that hydrocarbons may be present below these areas. As confirmed by analytical testing in conjunction with PID readings, hydrocarbon impacts exceeding regulatory guidelines were confined to an area of approximately 124 m² with a volume of 248 m³. It is important to note that at AEC 2-1, free water was found in the borehole at a depth of 1 m.

Soil Analytical Results For Hydrocarbons at AEC 2 (Generator Spill)

Based on the evaluation of the impacted areas (AEC 2 and APEC 1), the remediation options above, and the outcome of the soil analysis for PHC, the preferred remedial approach for the Site would be landfarming. The SiREM study of the Patch and Windy Camps suggests that the aerobic bioremediation of fraction F2 impacted soils would be effective. The impacted material would need to be turned periodically for aeration of the soil and have fertilizer amendments, such as urea (46-0-0) and monoammonium phosphate (11-52-0). Both nitrogen and phosphorus have been shown to increase microbial degradation of PHC (Braddock et al. 1997; Thomassin-Lacroix et al. 2002). Landfarming AEC 2 could cause additional issues, since the area would likely need to be excavated to at least 2 m below grade and would expose the free water.

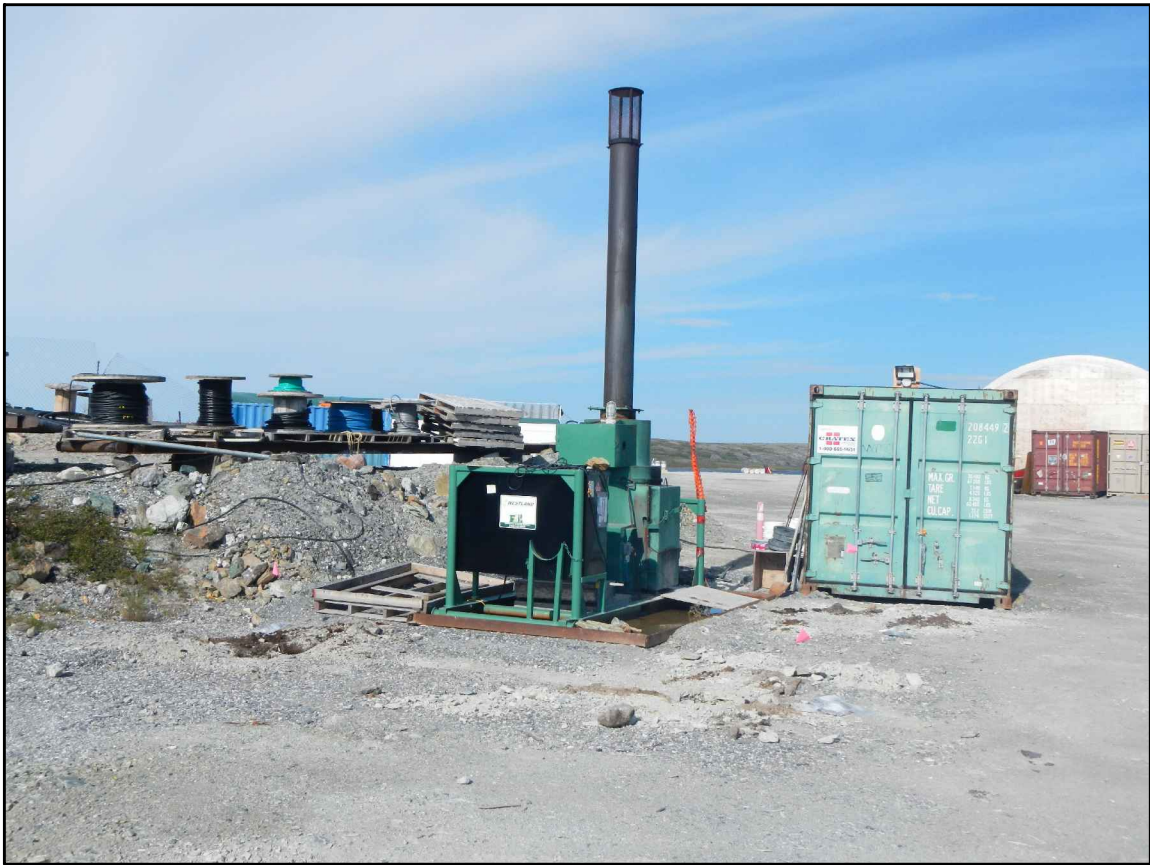
Figure 4D

Soil Analytical Results For Hydrocarbons at AEC 6 (Incinerator)

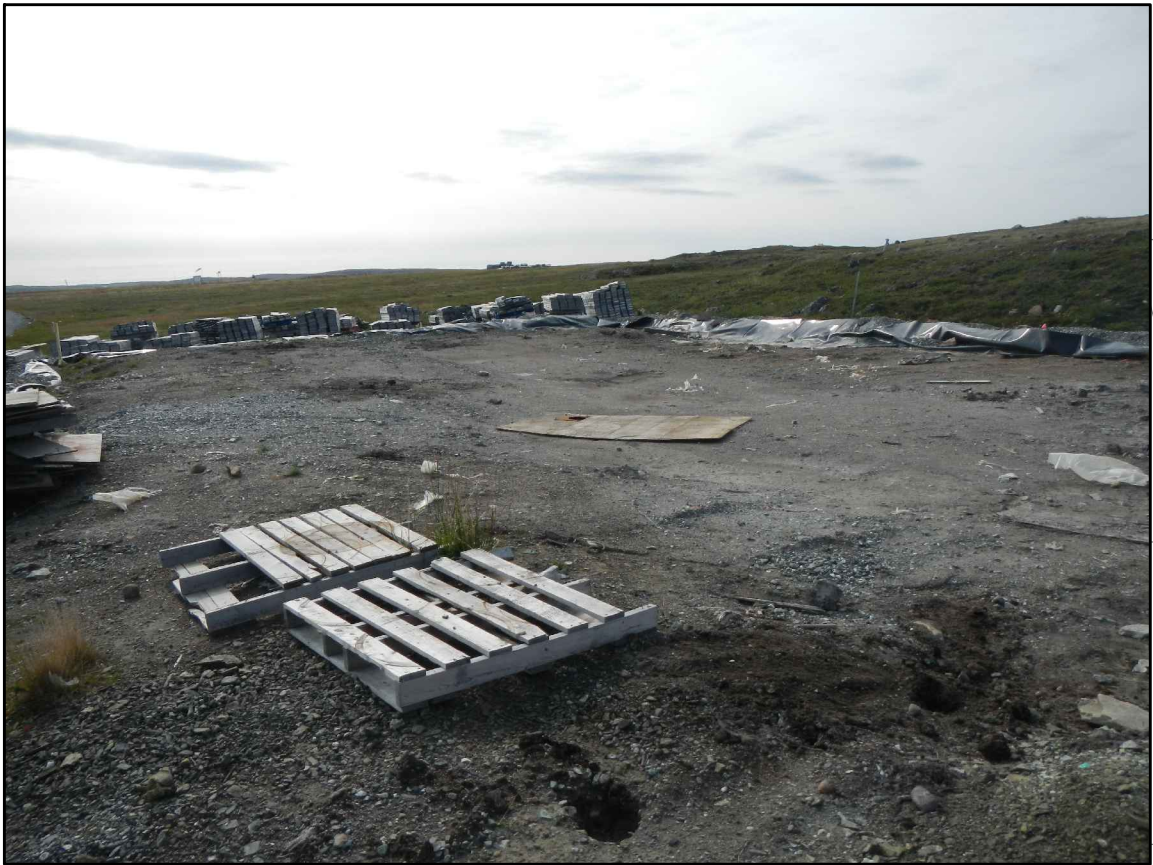
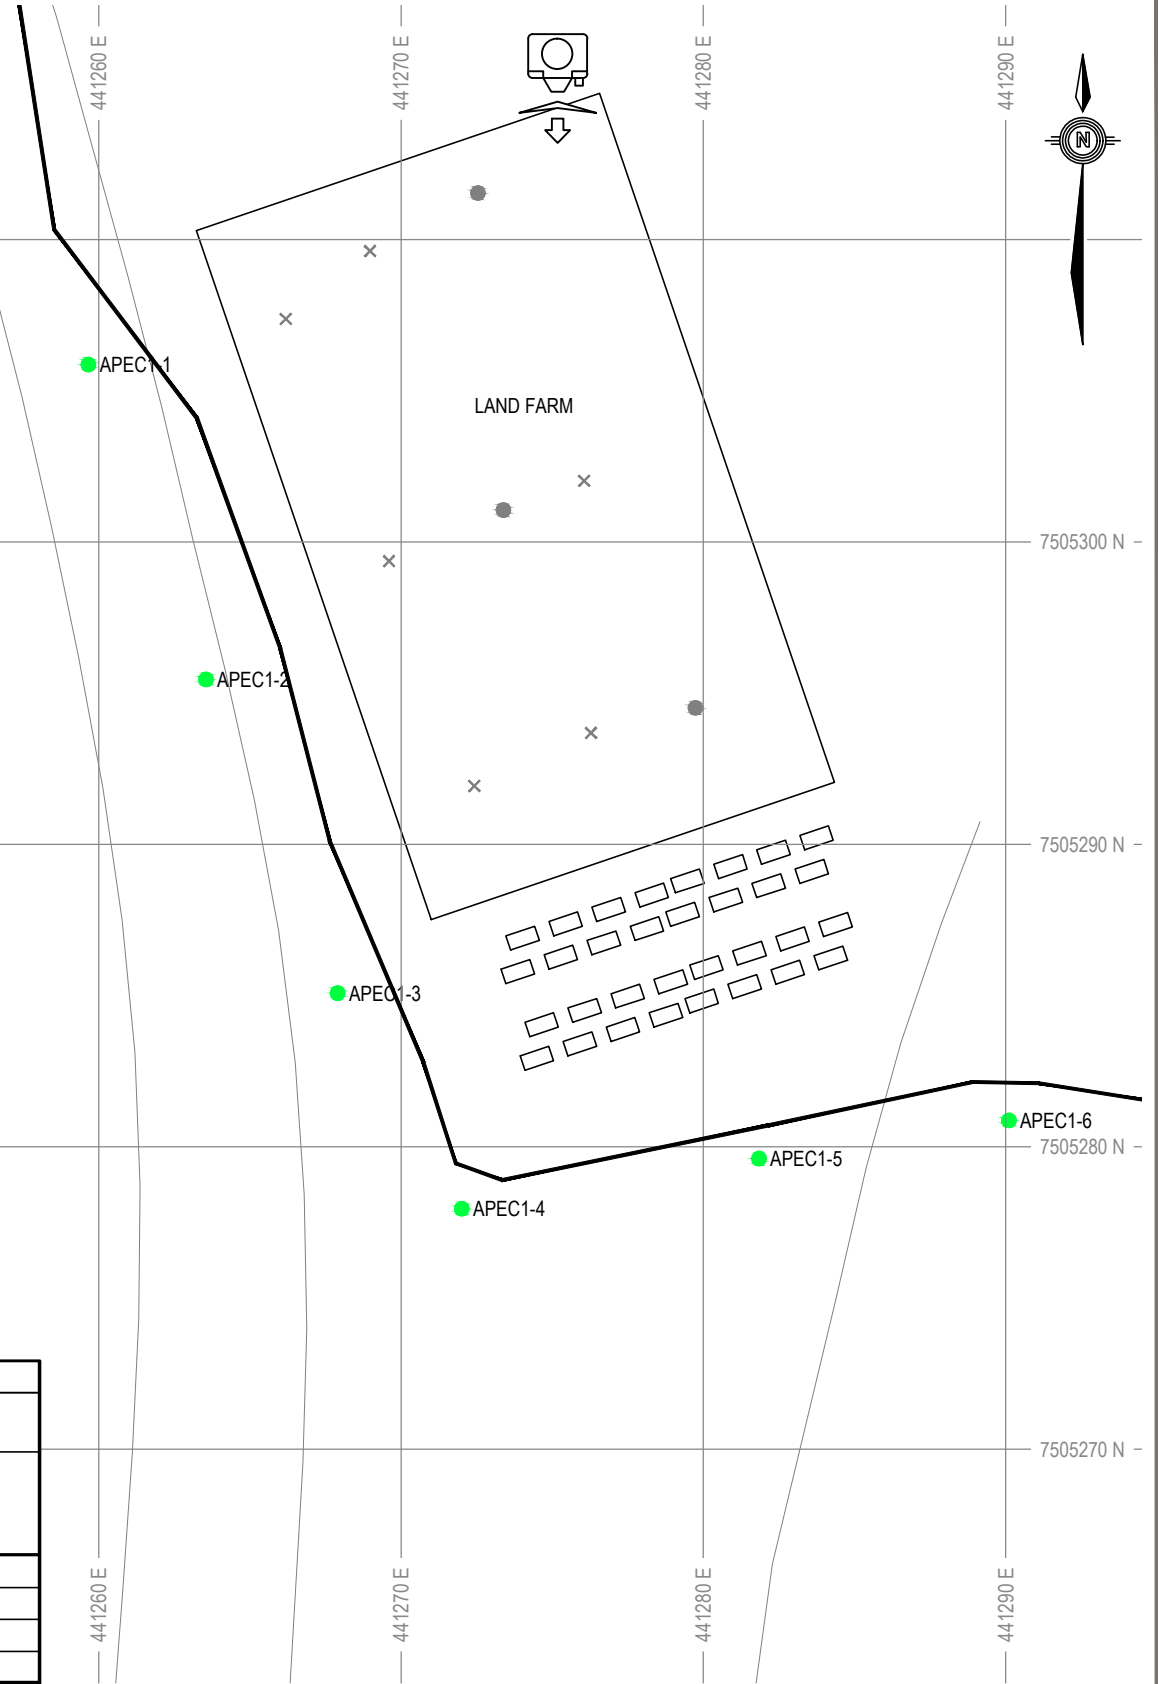
Figure 4E

Soil Analytical Results For Hydrocarbons at APEC 1 (Land Farm Perimeter)

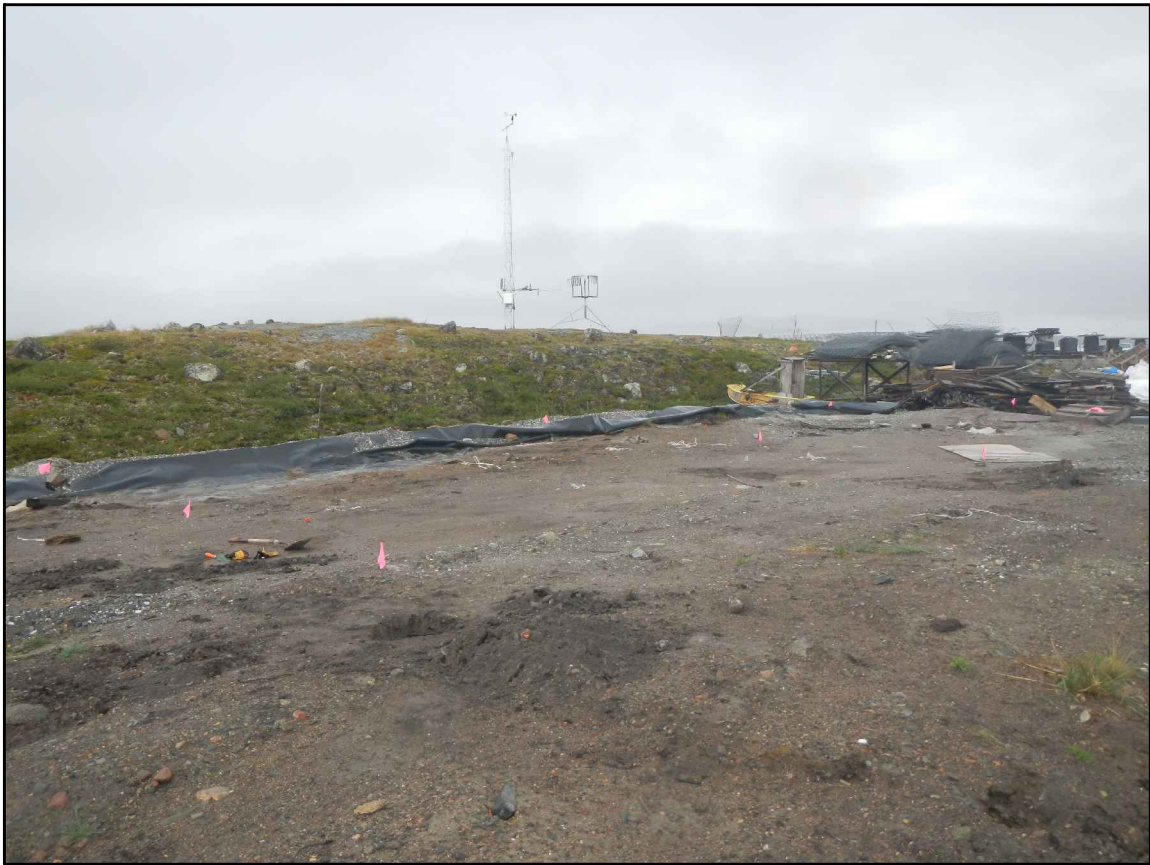
APEC1	
AREA (m²)	358
VOLUME (m³)	100

Soil Analytical Results For Hydrocarbons at APEC 1 (Inside Land Farm)

- APEC 1 (100 m³ of impacted soil) can be remediated in-situ as it is already in a landfarm. This area should be turned periodically with a nutrient amendment to increase biodegradation of PHC.
