# Hope Bay Project Boston Camp Revised Interim Closure Plan

SRK Consulting (Canada) Inc.  
1CT022.001.710  
May 2014

# **PHASE III ENVIRONMENTAL SITE ASSESSMENT BOSTON CAMP HOPE BAY PROJECT, NU**

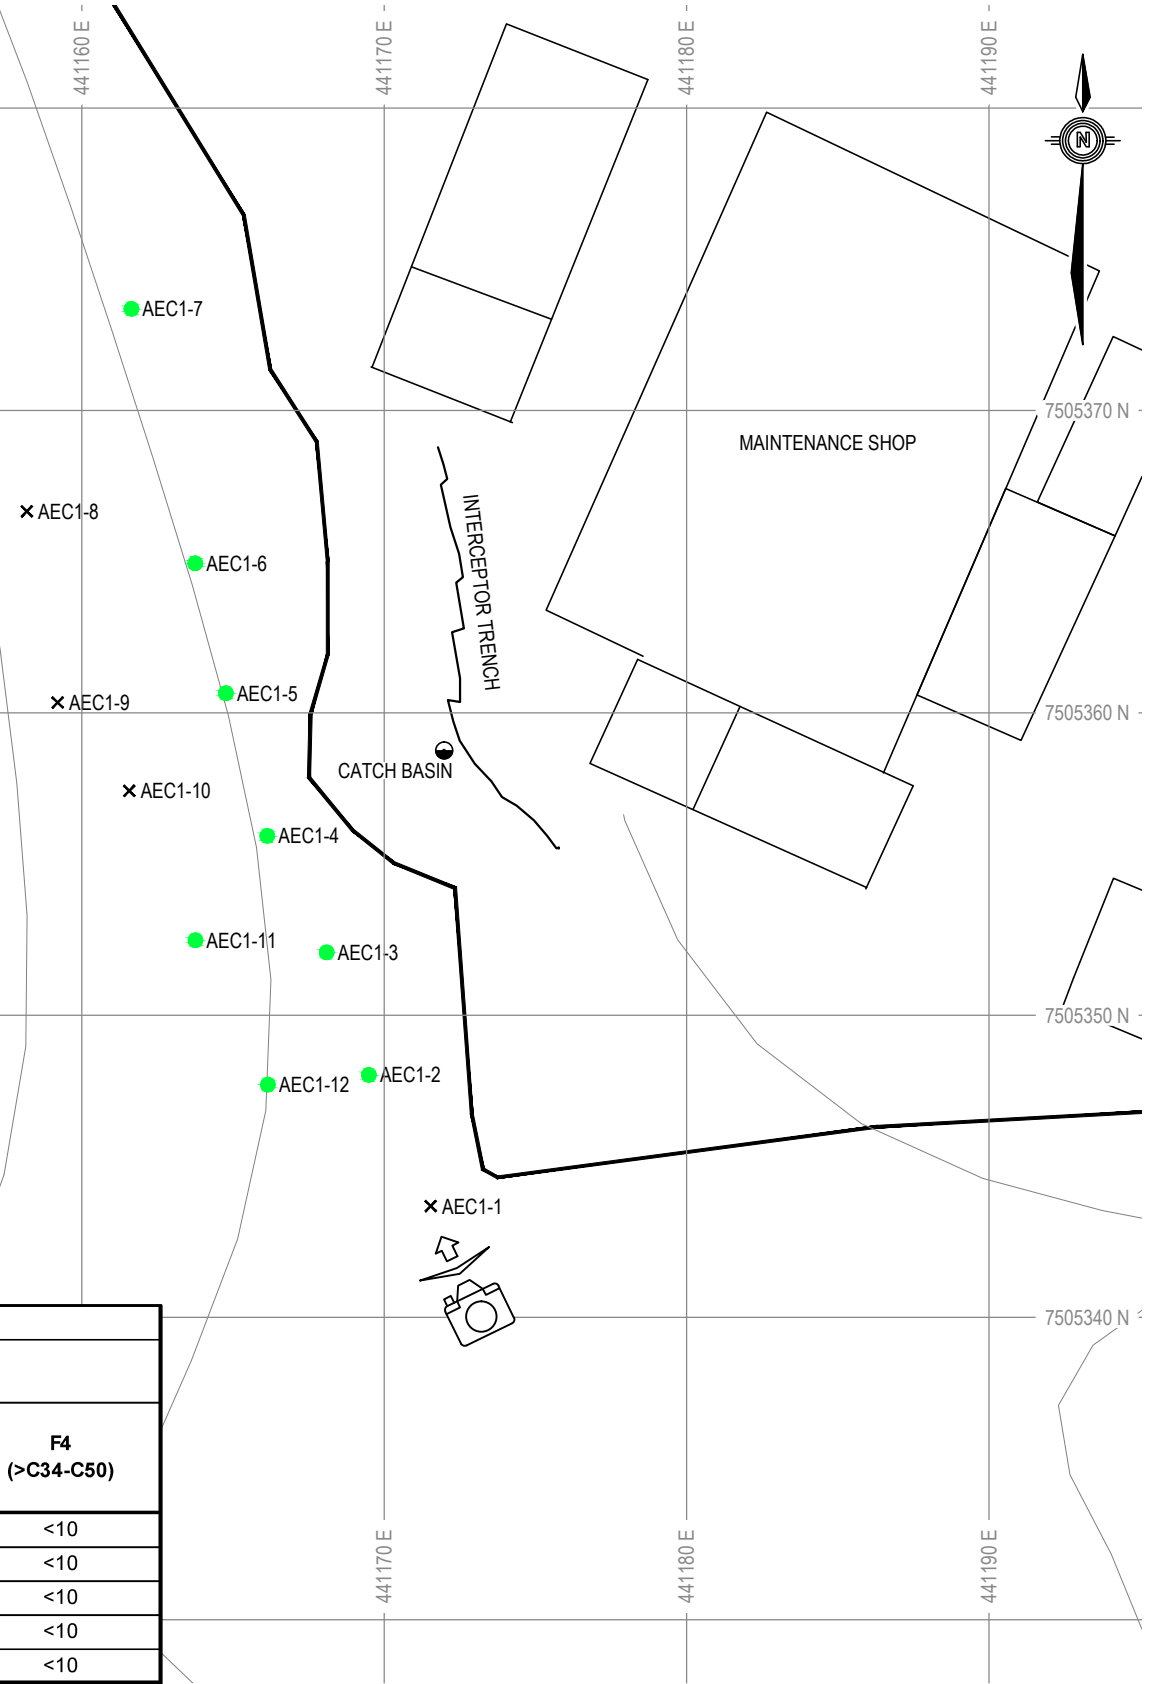
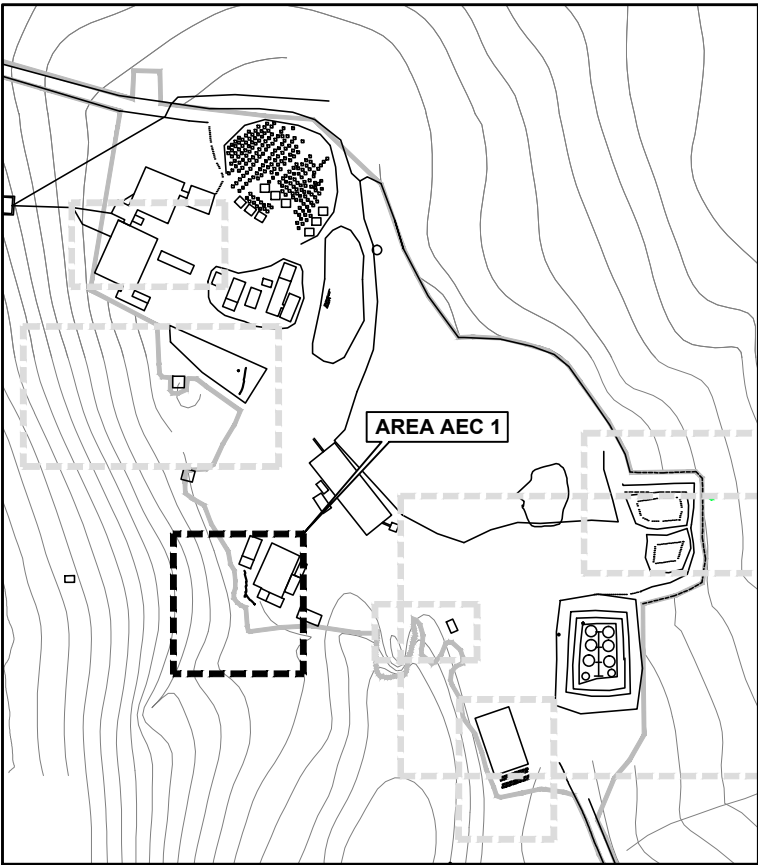
Figure 4Ai

Soil Analytical Results For Hydrocarbons at AEC 1 (Old Spill Area)

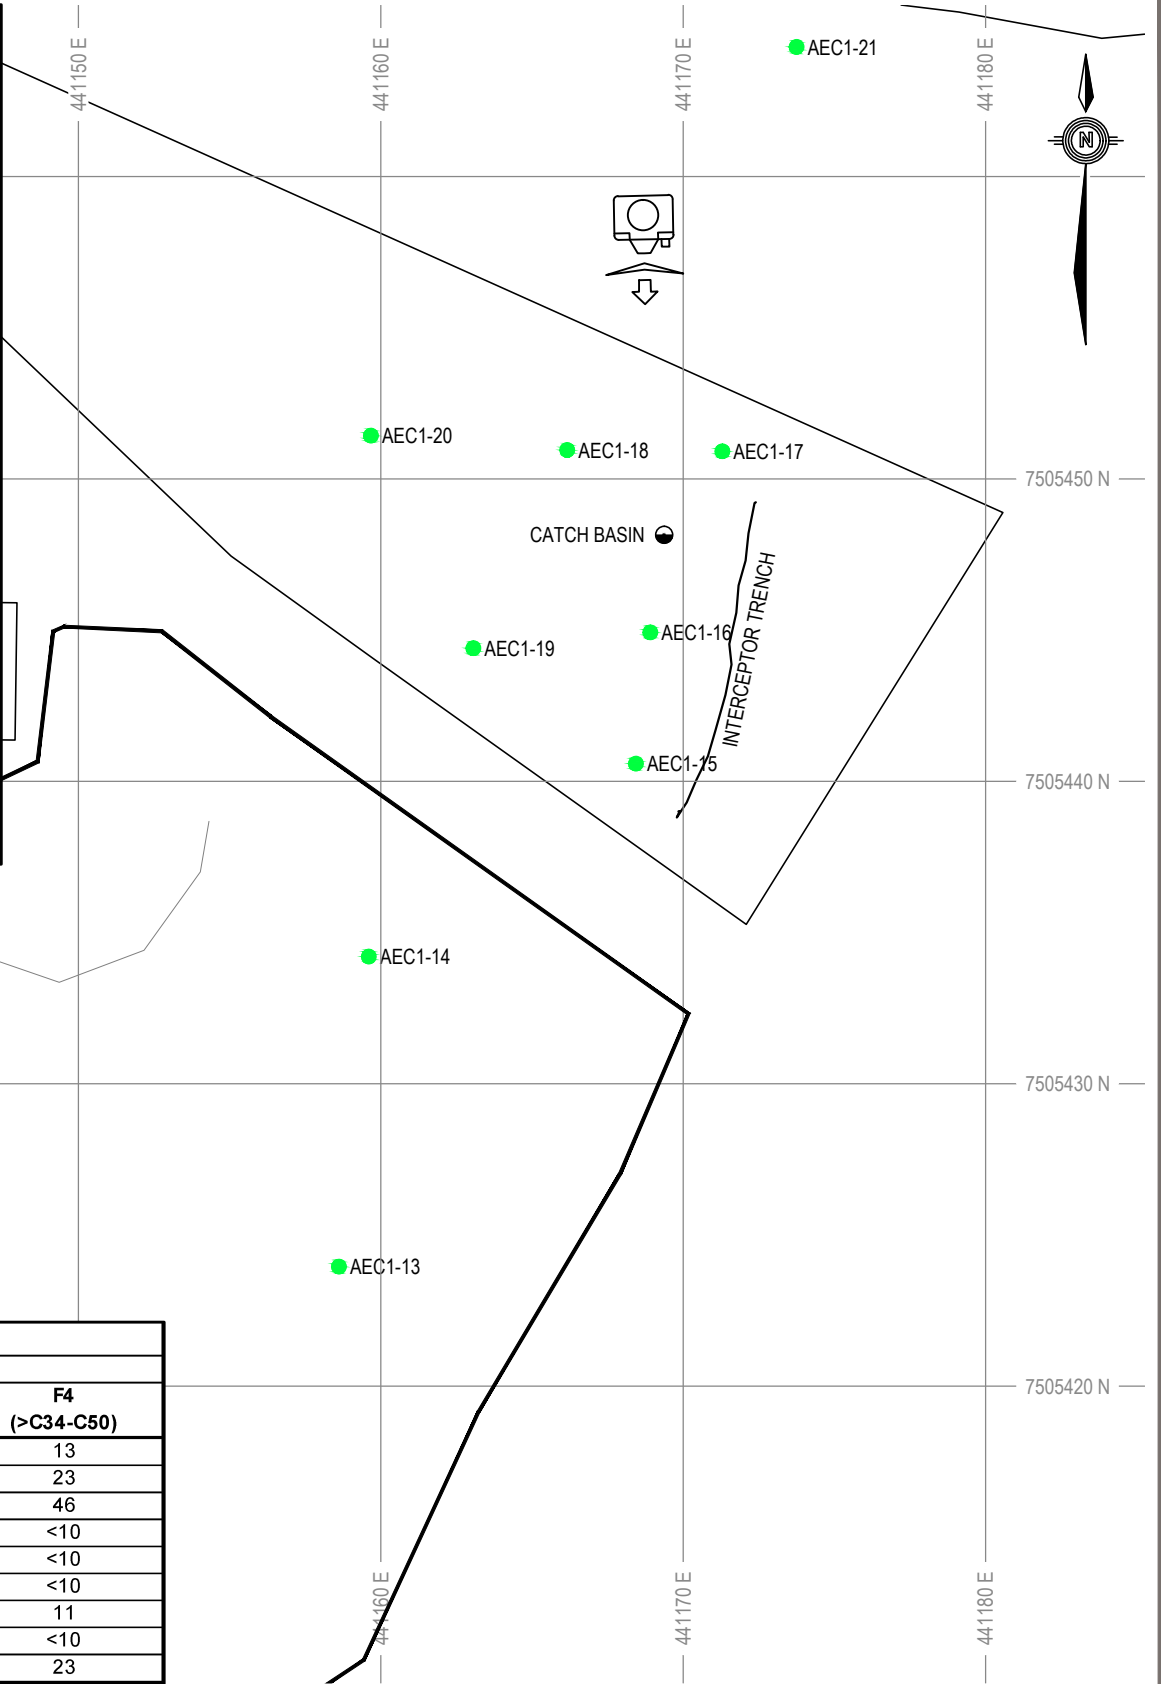
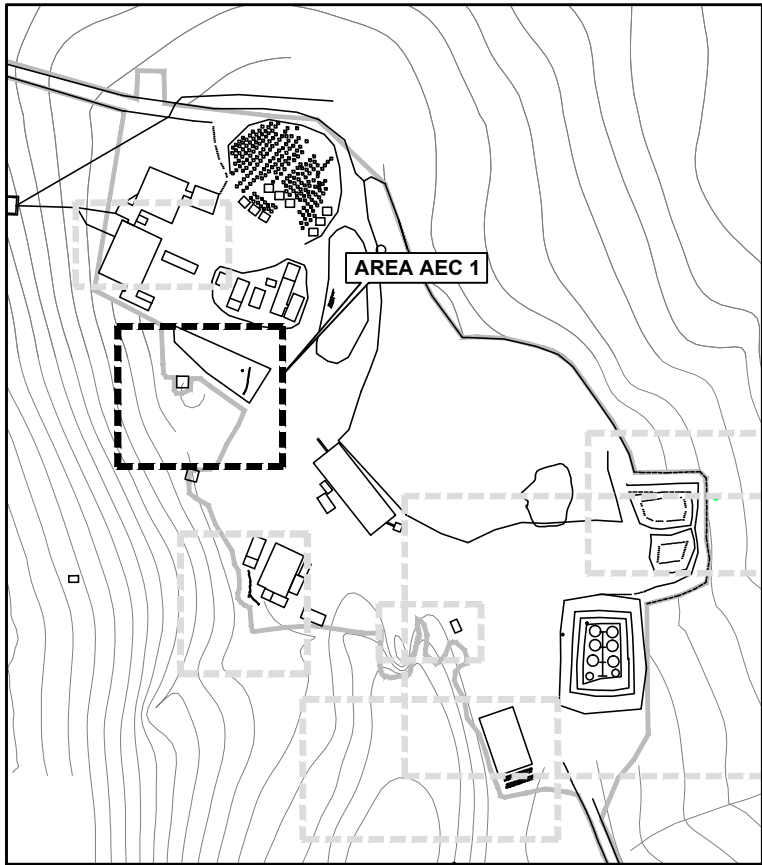
Figure 4Aii

Soil Analytical Results For Hydrocarbons at AEC 1 (Old Spill Area)									
Sample Number	Sample Depth (m)	BTEX and Hydrocarbon Fractions F1 to F4 (mg/kg)							
		Benzene	Toluene	Ethylbenzene	Xylene	F1 (C6-C10)	F2 (>C10-C16)	F3 (>C16-C34)	F4 (>C34-C50)
AEC 1 - 13	0.50 to 0.75	<0.005	<0.02	<0.01	<0.04	<12	<10	48	13
AEC 1 - 14	0.25 to 0.50	<0.005	<0.02	<0.01	<0.04	<12	<10	83	23
AEC 1 - 15	0.50 to 0.75	<0.005	<0.02	<0.01	<0.04	<12	<10	67	46
AEC 1 - 16	0.50 to 0.75	<0.005	<0.02	<0.01	<0.04	<12	16	<10	<10
AEC 1 - 17	0.75 to 1.00	<0.005	<0.02	<0.01	<0.04	<12	<10	<10	<10
AEC 1 - 18	0.75 to 1.00	<0.005	<0.02	<0.01	<0.04	<12	<10	31	<10
AEC 1 - 19	0.25 to 0.50	<0.005	<0.02	<0.01	<0.04	<12	<10	74	11
AEC 1 - 20	0.50 to 0.75	<0.005	<0.02	<0.01	<0.04	<12	<10	22	<10
AEC 1 - 21	0.75 to 1.00	<0.005	0.35	<0.01	<0.04	<12	<10	78	23

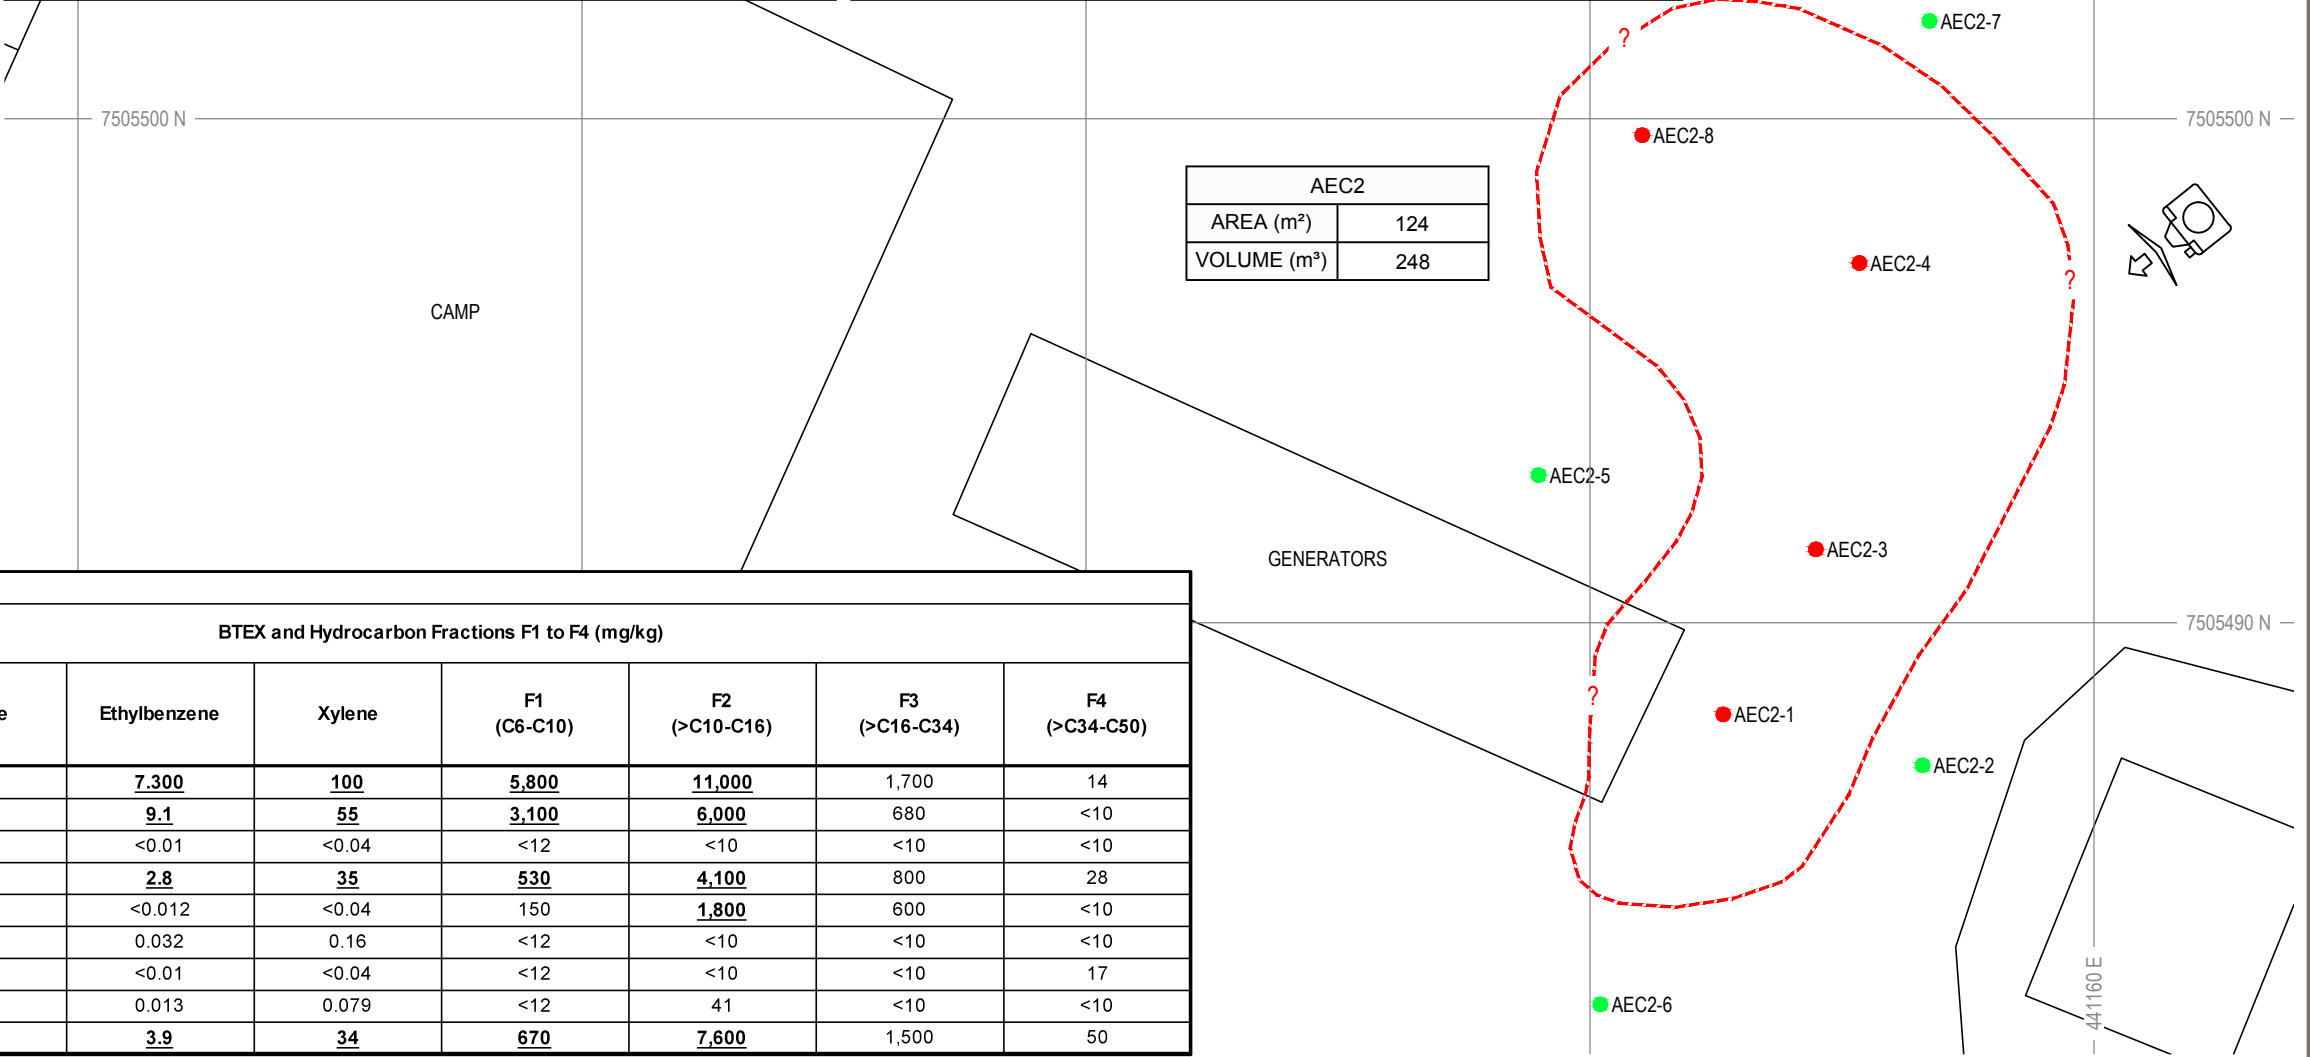
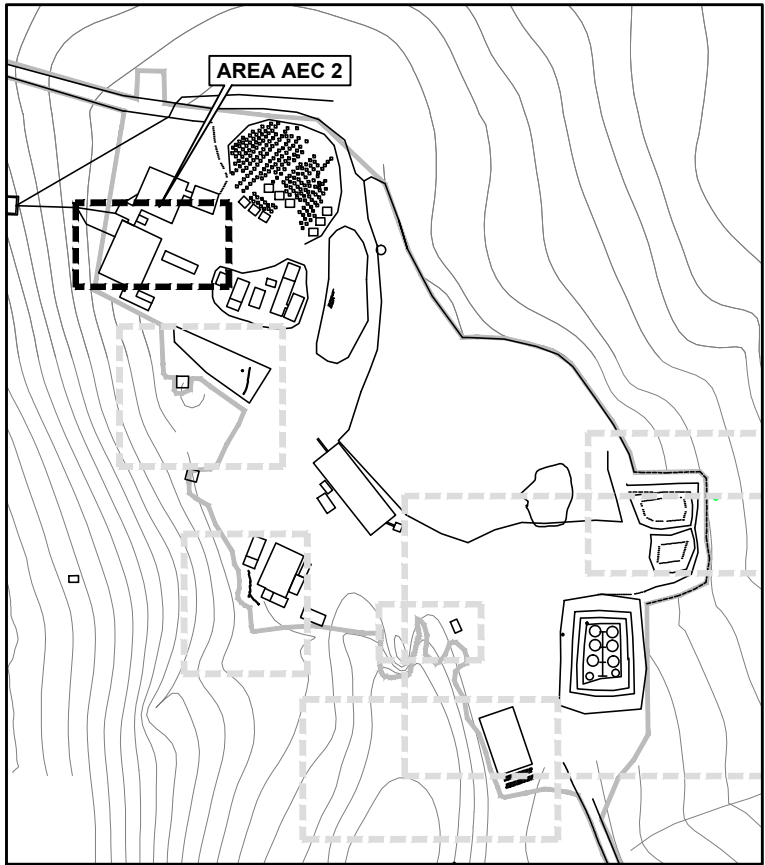
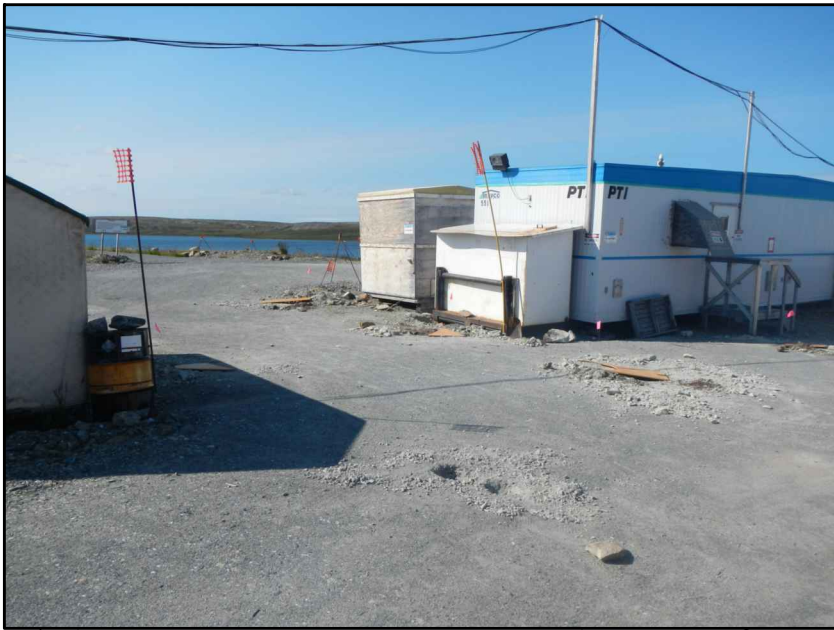
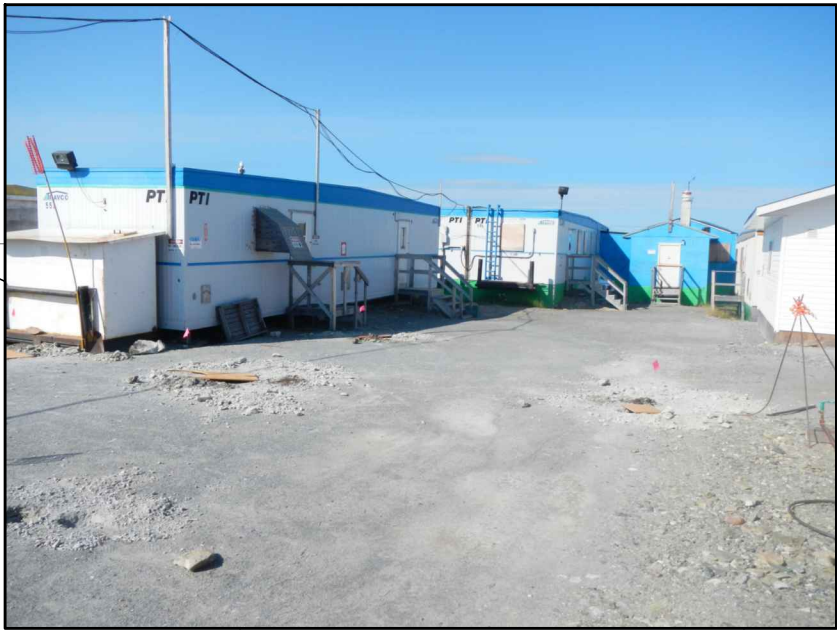
Figure 4B

Soil Analytical Results For Hydrocarbons at AEC 2 (Generator Spill)

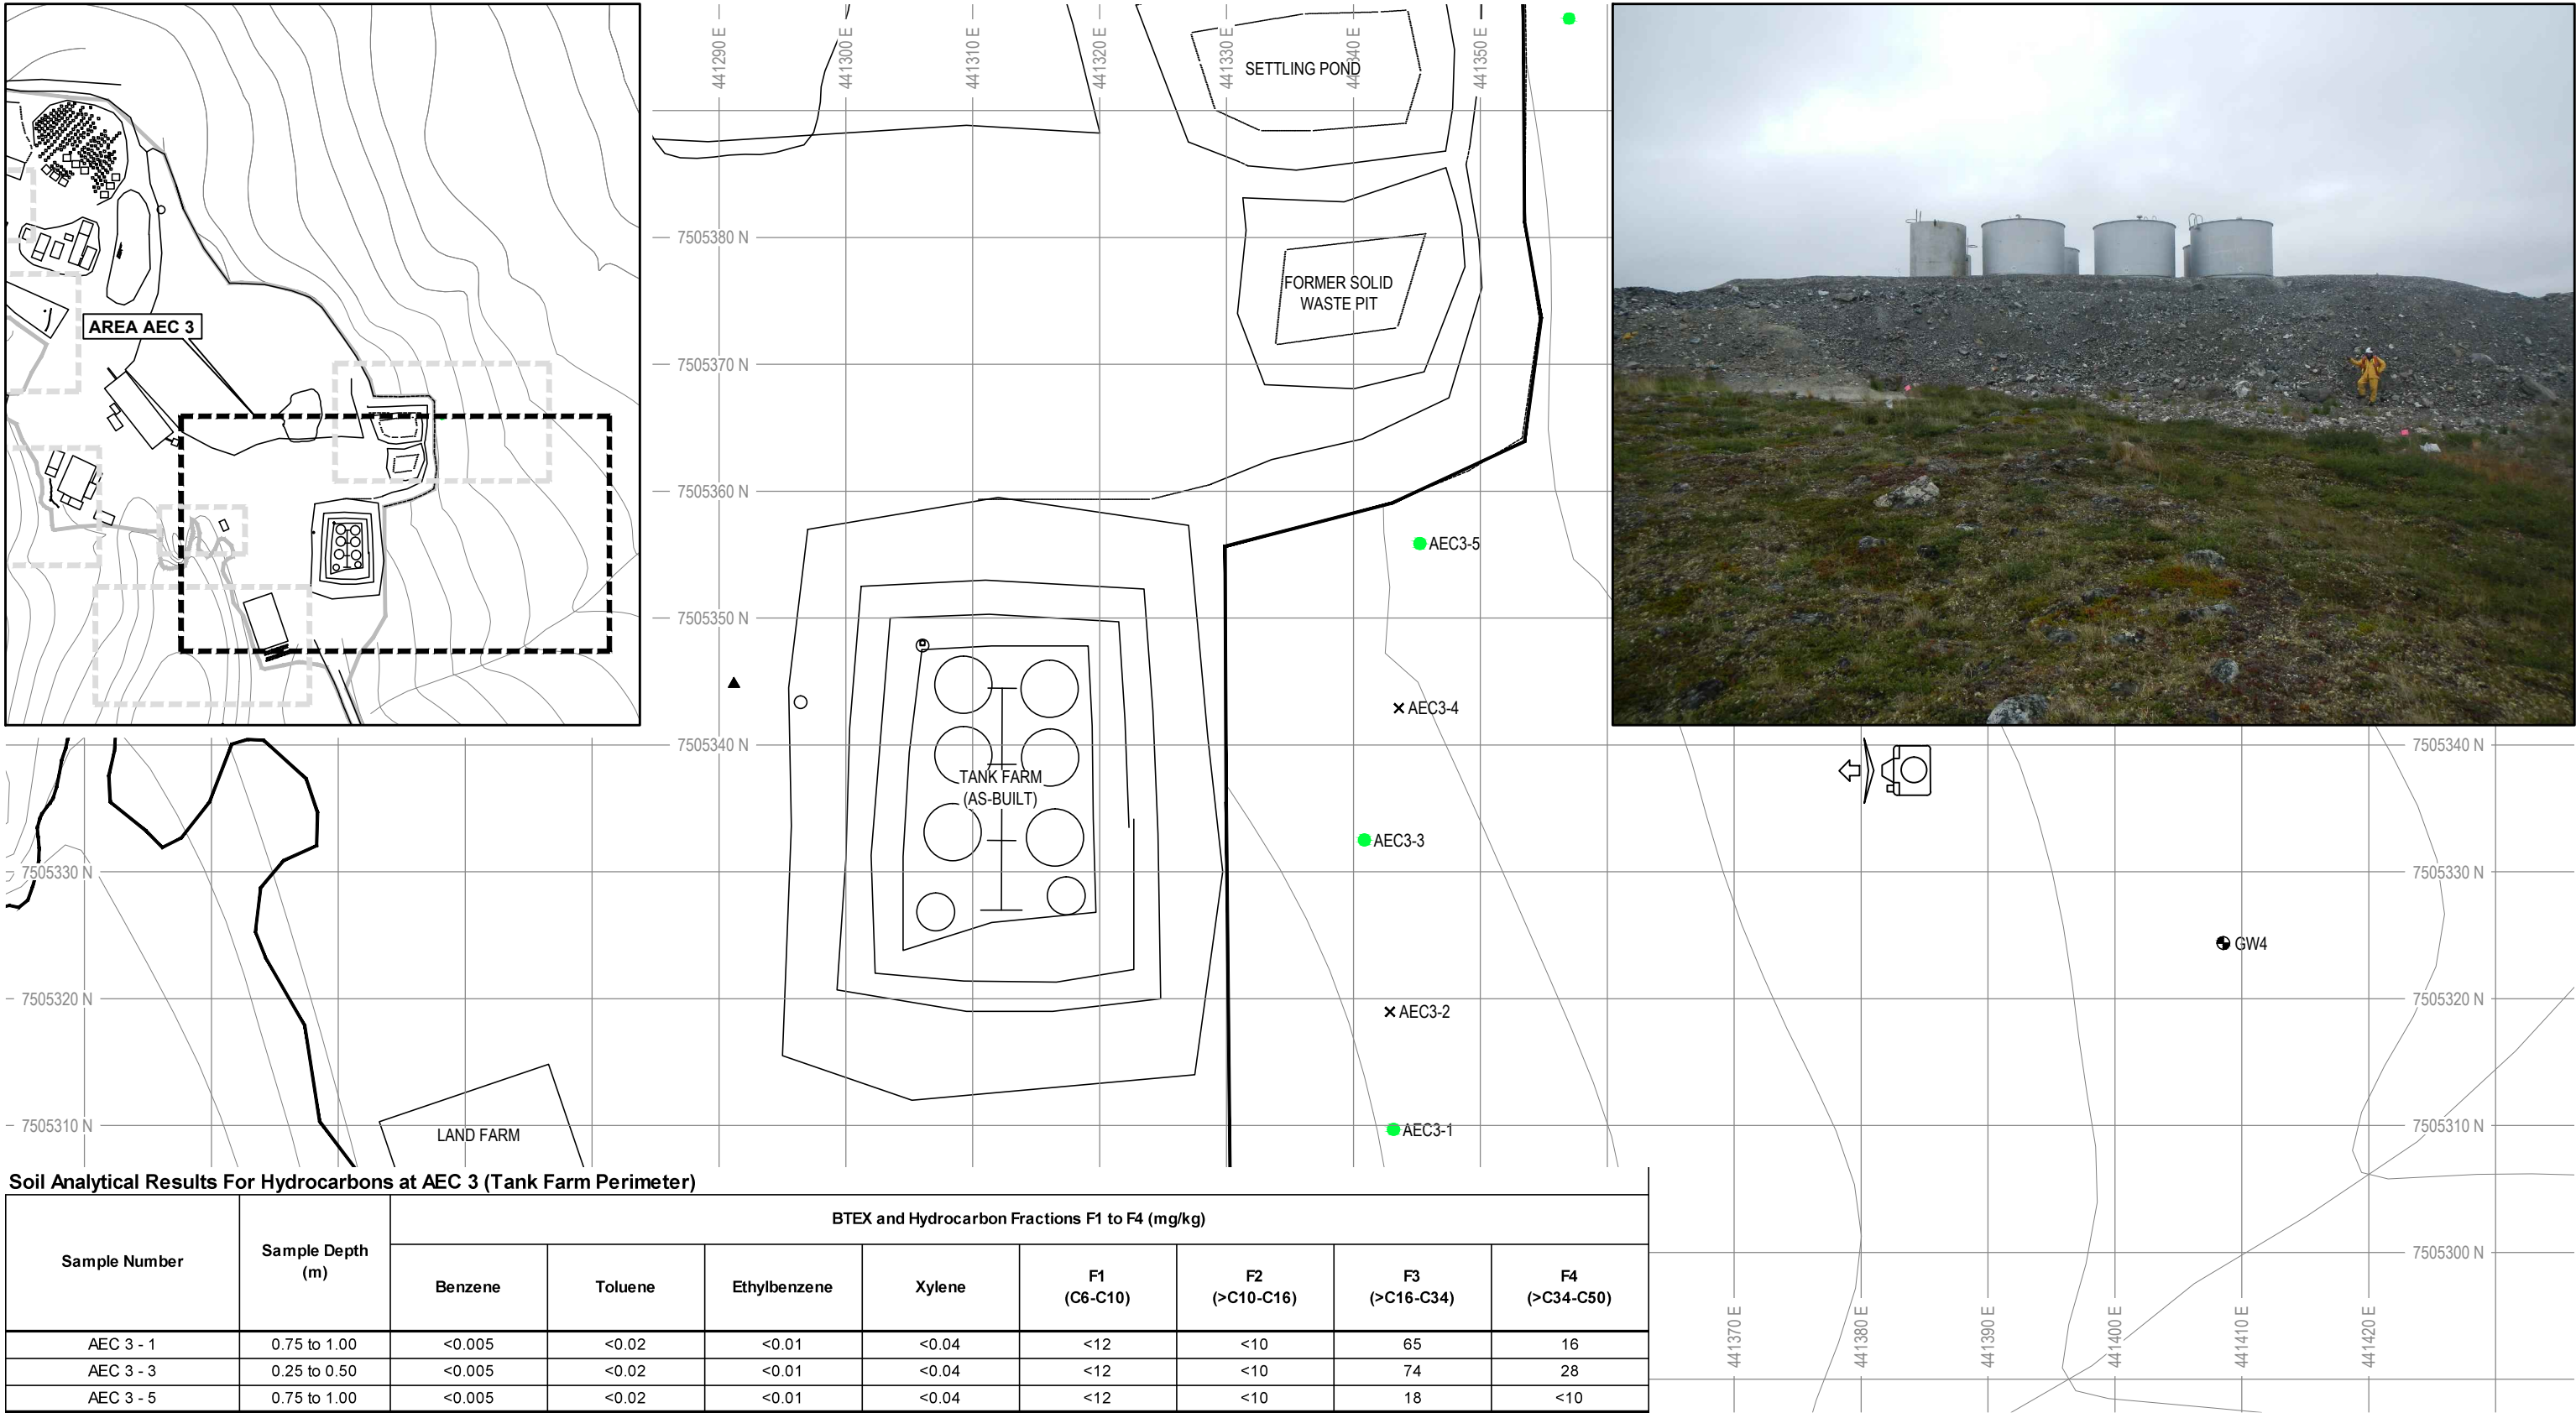
Figure 4C

Soil Analytical Results For Hydrocarbons at AEC 3 (Tank Farm Perimeter)

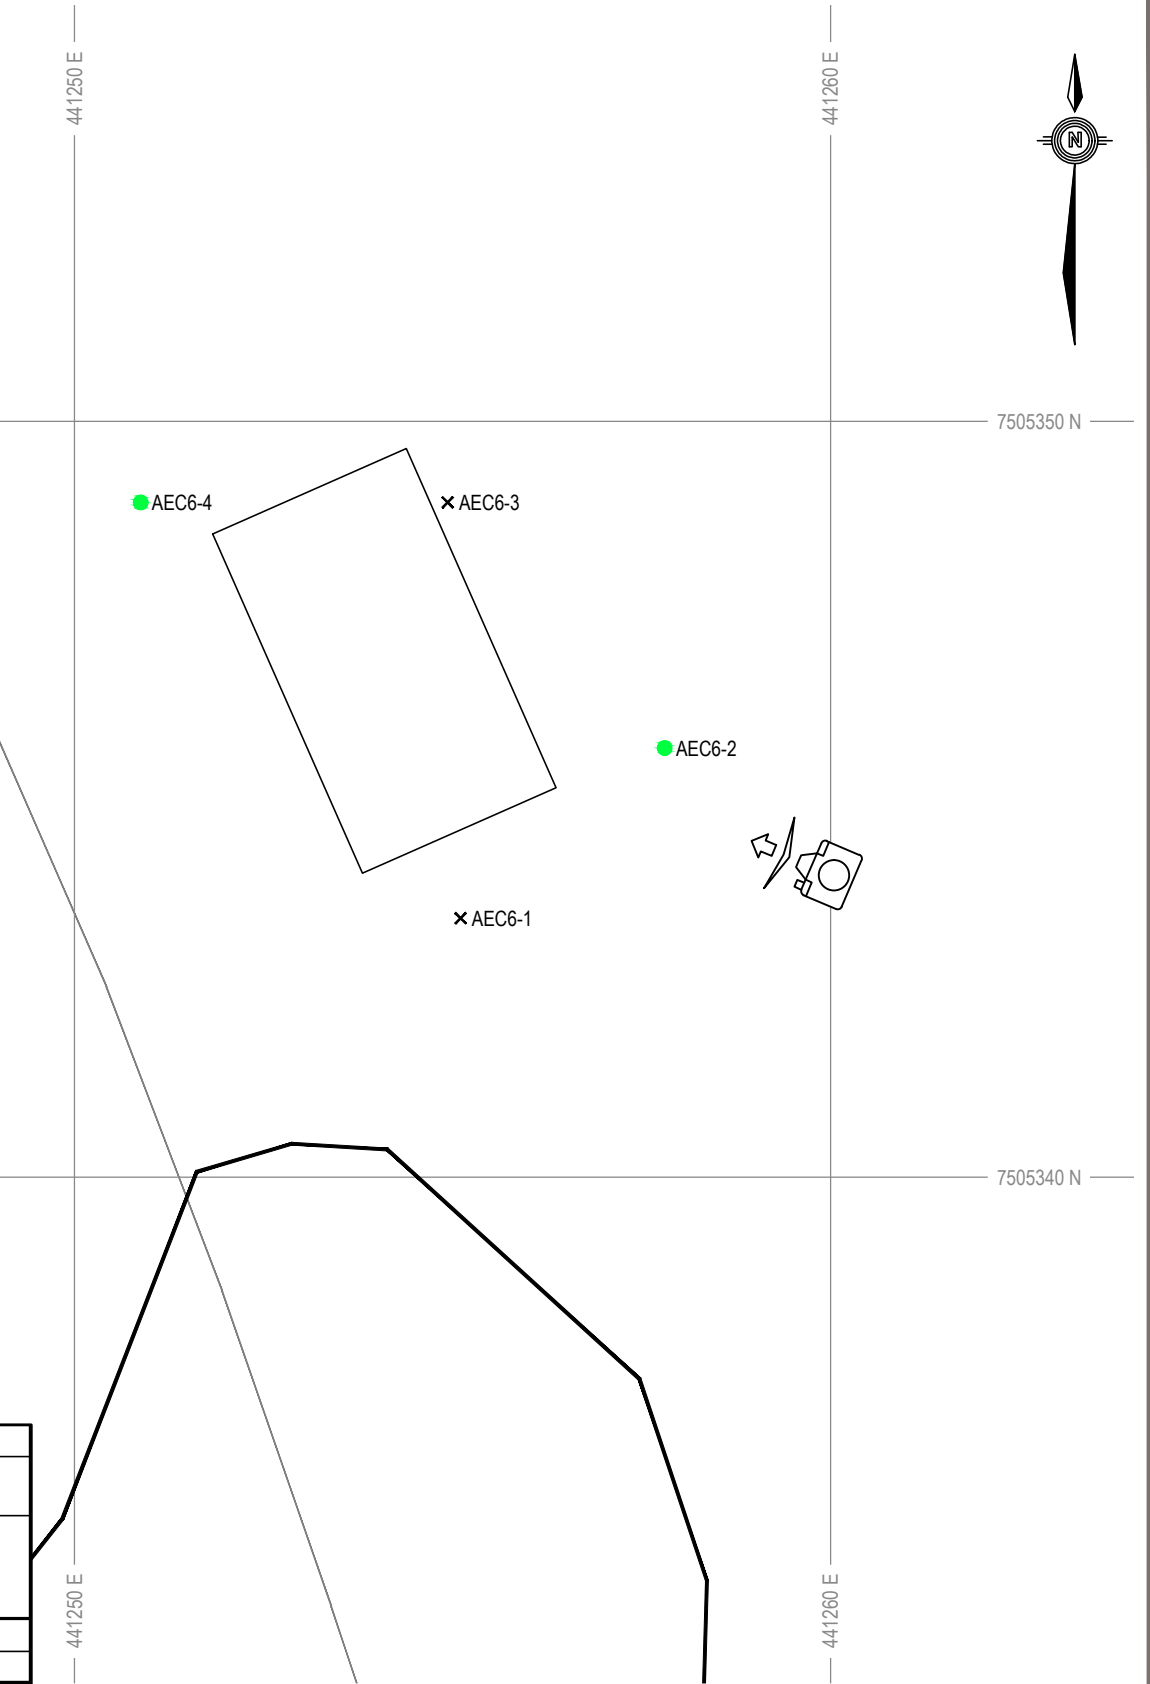
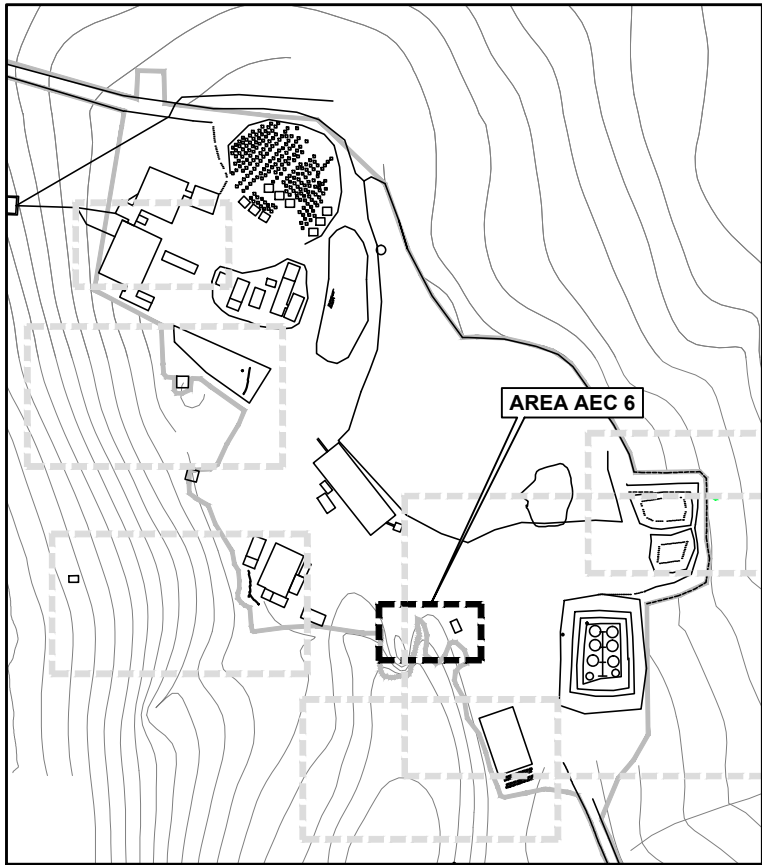
Figure 4D

Soil Analytical Results For Hydrocarbons at AEC 6 (Incinerator)

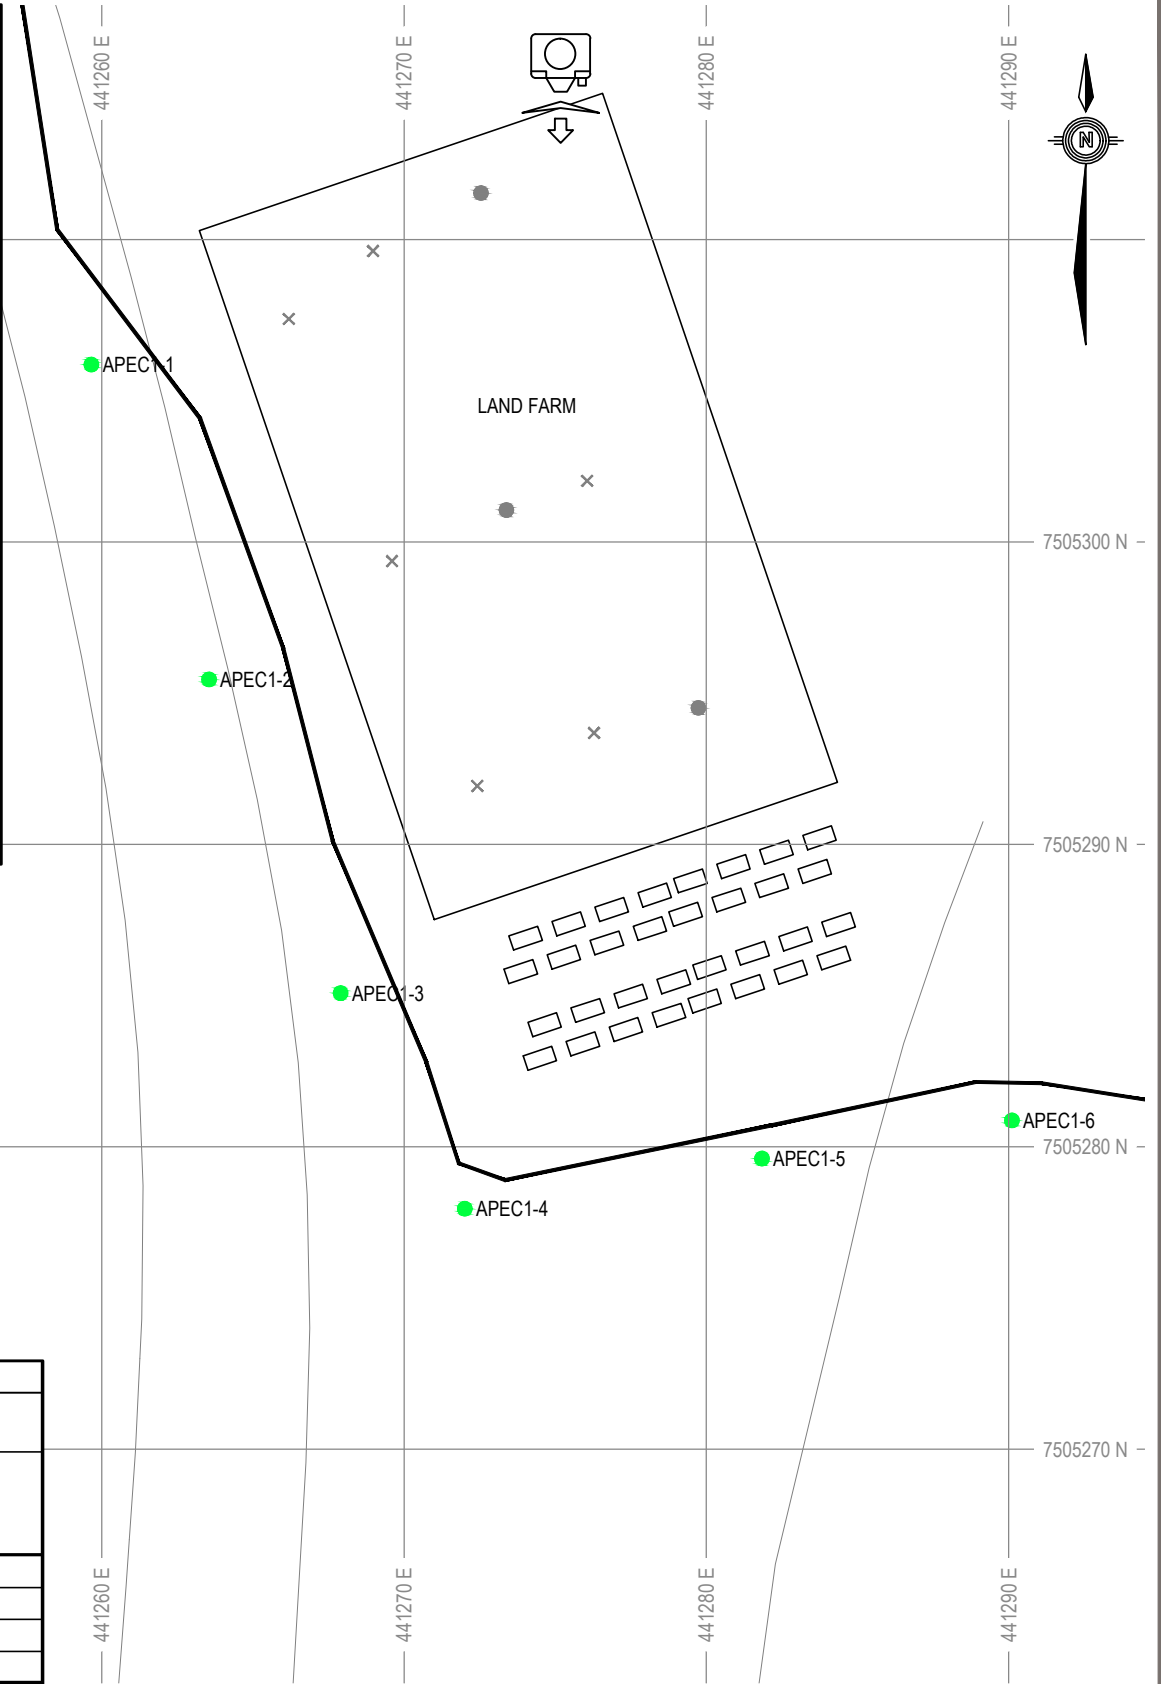
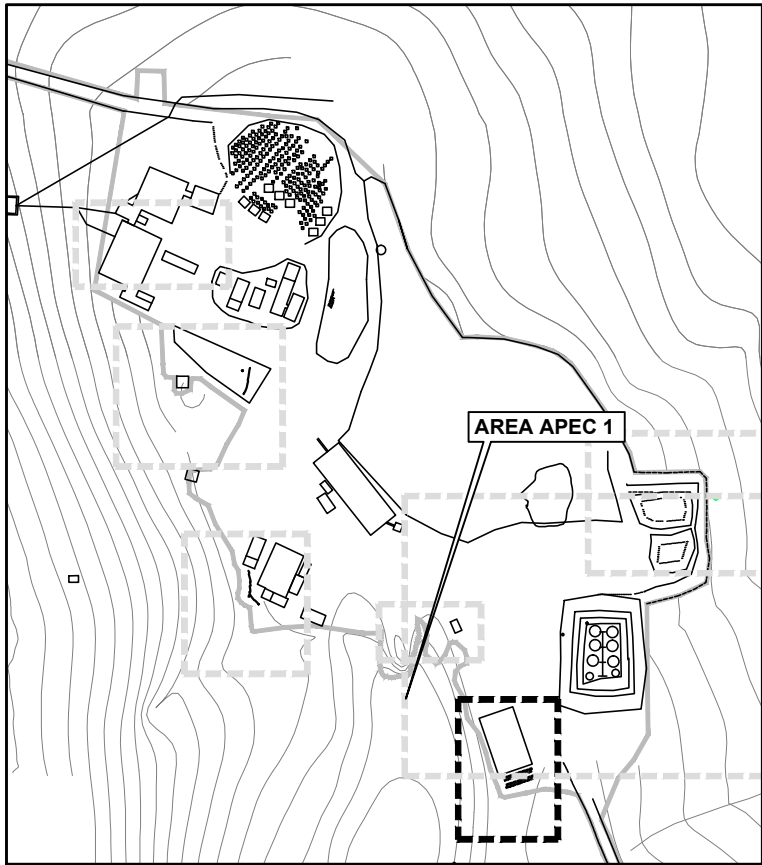
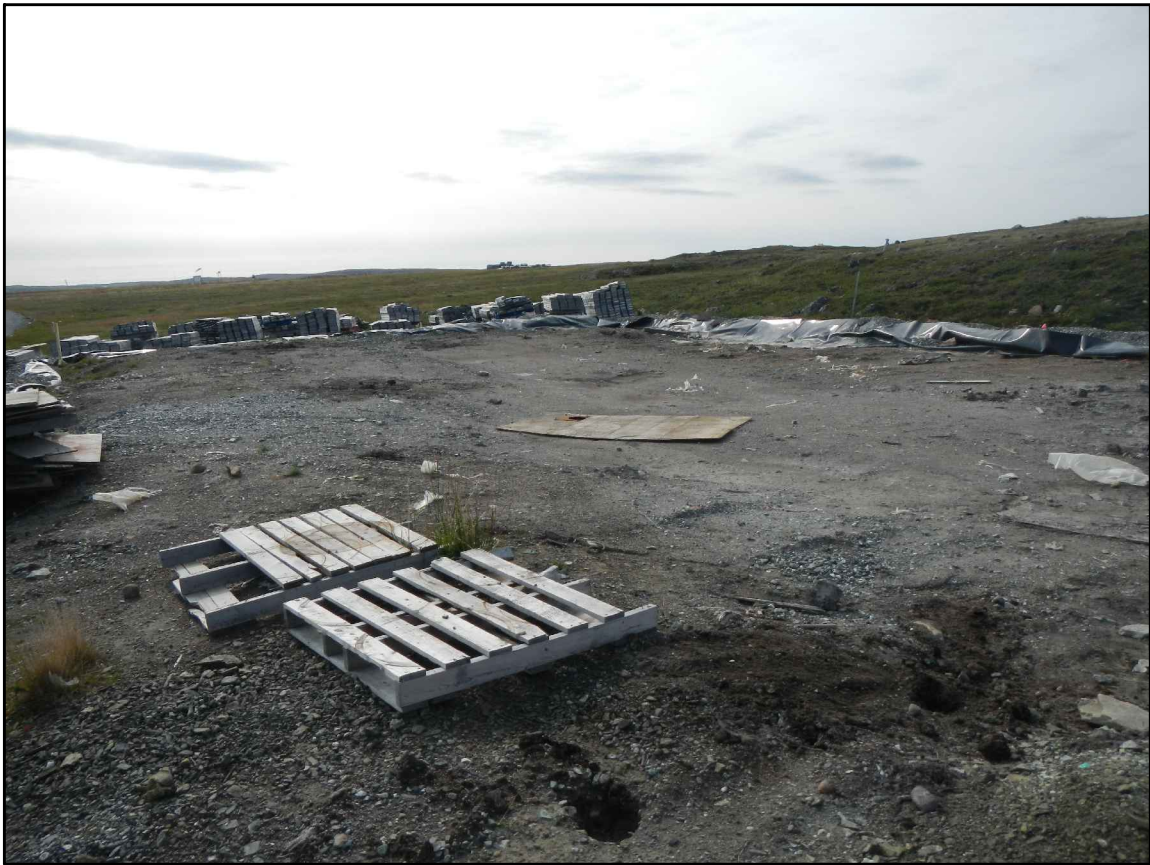
Figure 4E

Soil Analytical Results For Hydrocarbons at APEC 1 (Land Farm Perimeter)

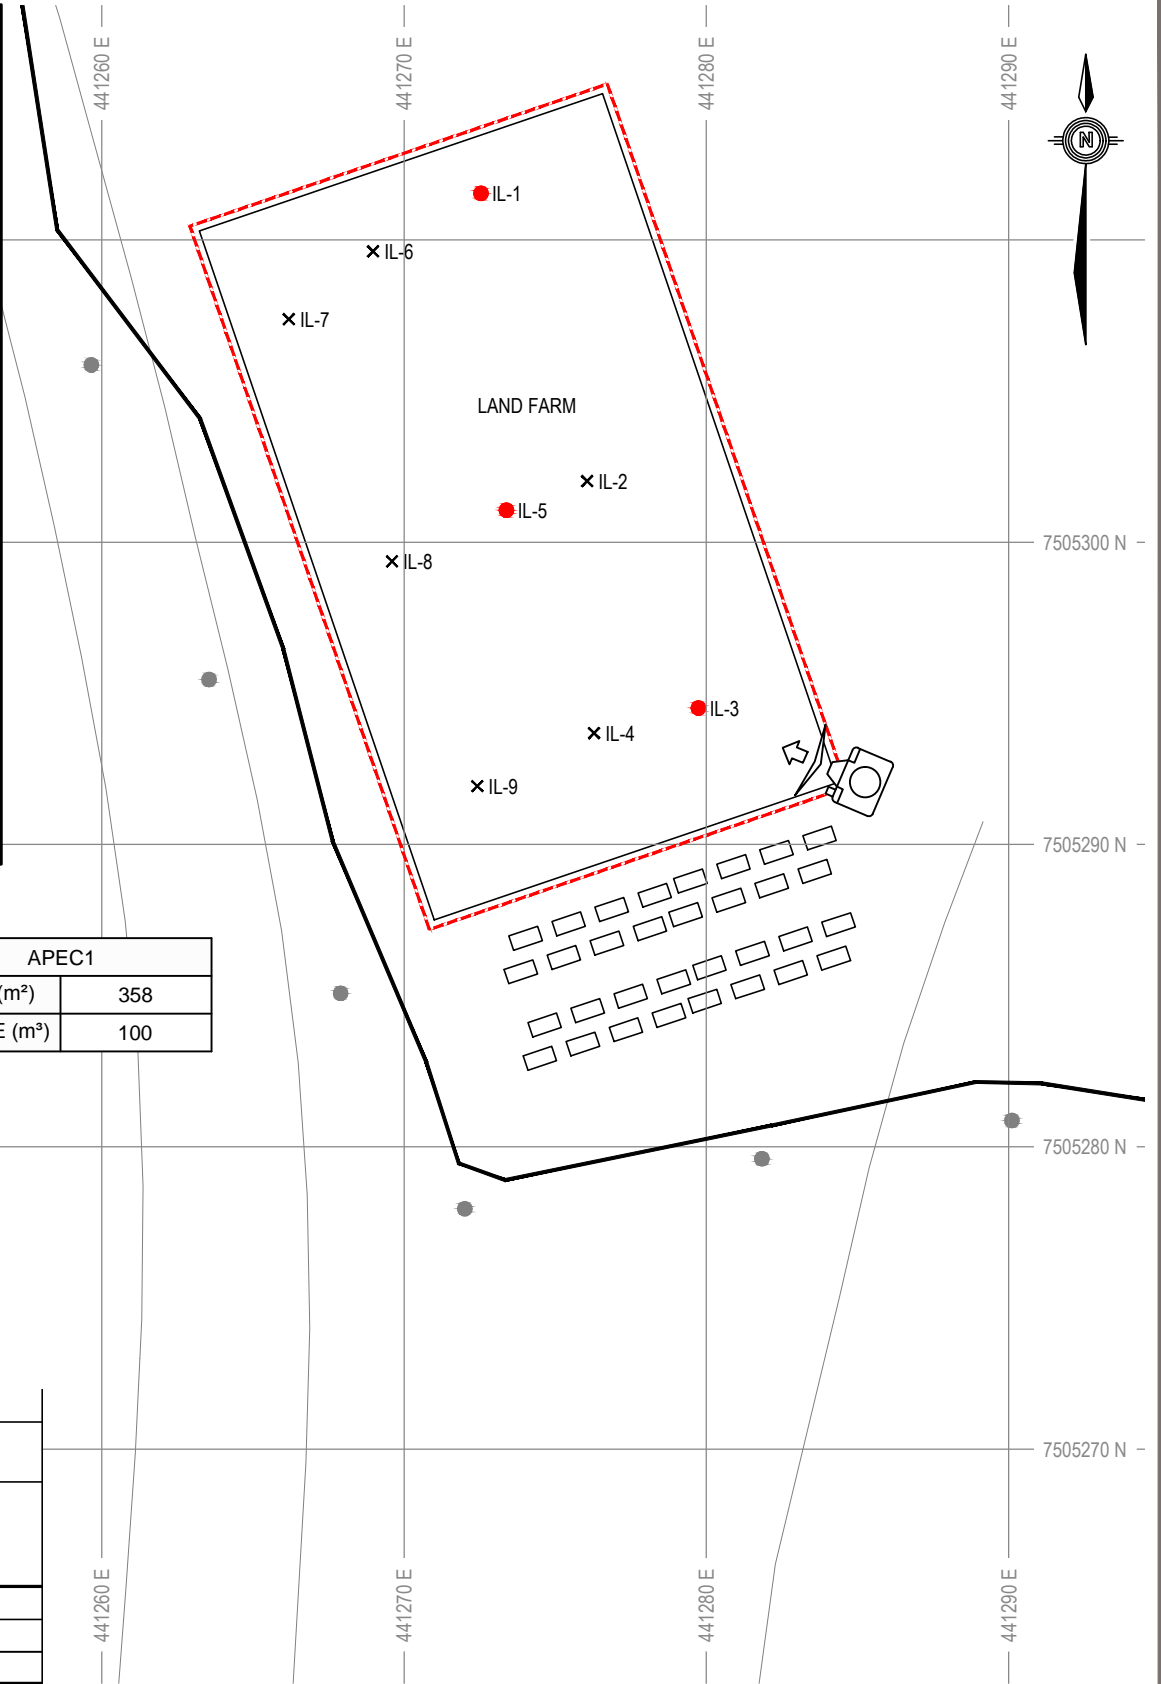
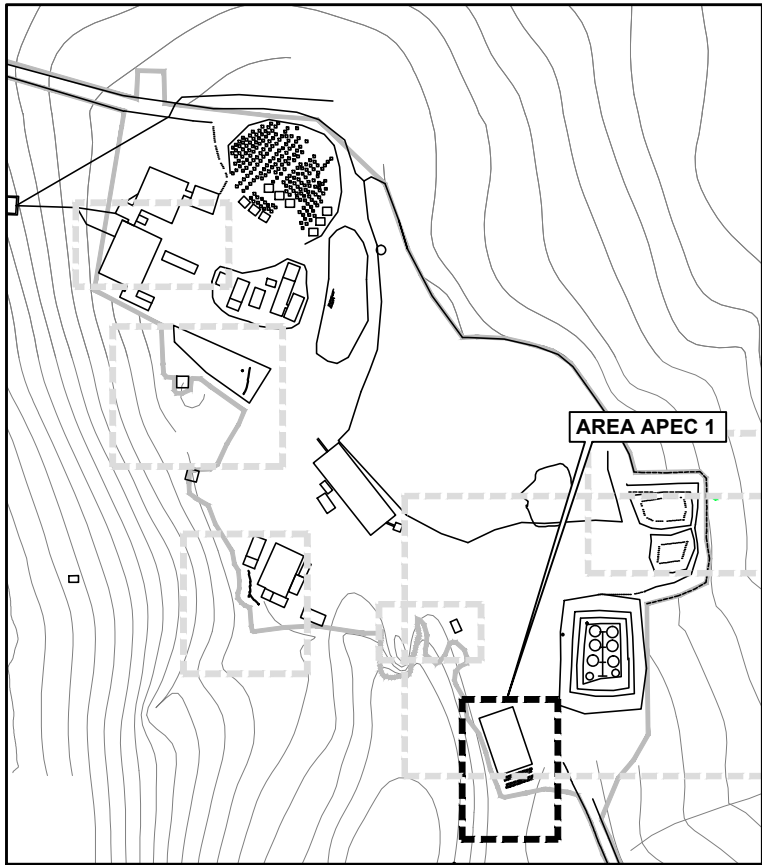
Figure 4F

APEC1	
AREA (m²)	358
VOLUME (m³)	100

Soil Analytical Results For Hydrocarbons at APEC 1 (Inside Land Farm)

- APEC 1 (100 m<sup>3</sup> of impacted soil) can be remediated in-situ, as it is already in a land farm. This area should be turned periodically with a nutrient amendment to increase biodegradation of PHC.
