# Hope Bay Project Boston Camp Revised Interim Closure Plan

SRK Consulting (Canada) Inc.  
1CT022.001.710  
May 2014

# **PHASE III ENVIRONMENTAL SITE ASSESSMENT BOSTON CAMP HOPE BAY PROJECT, NU**

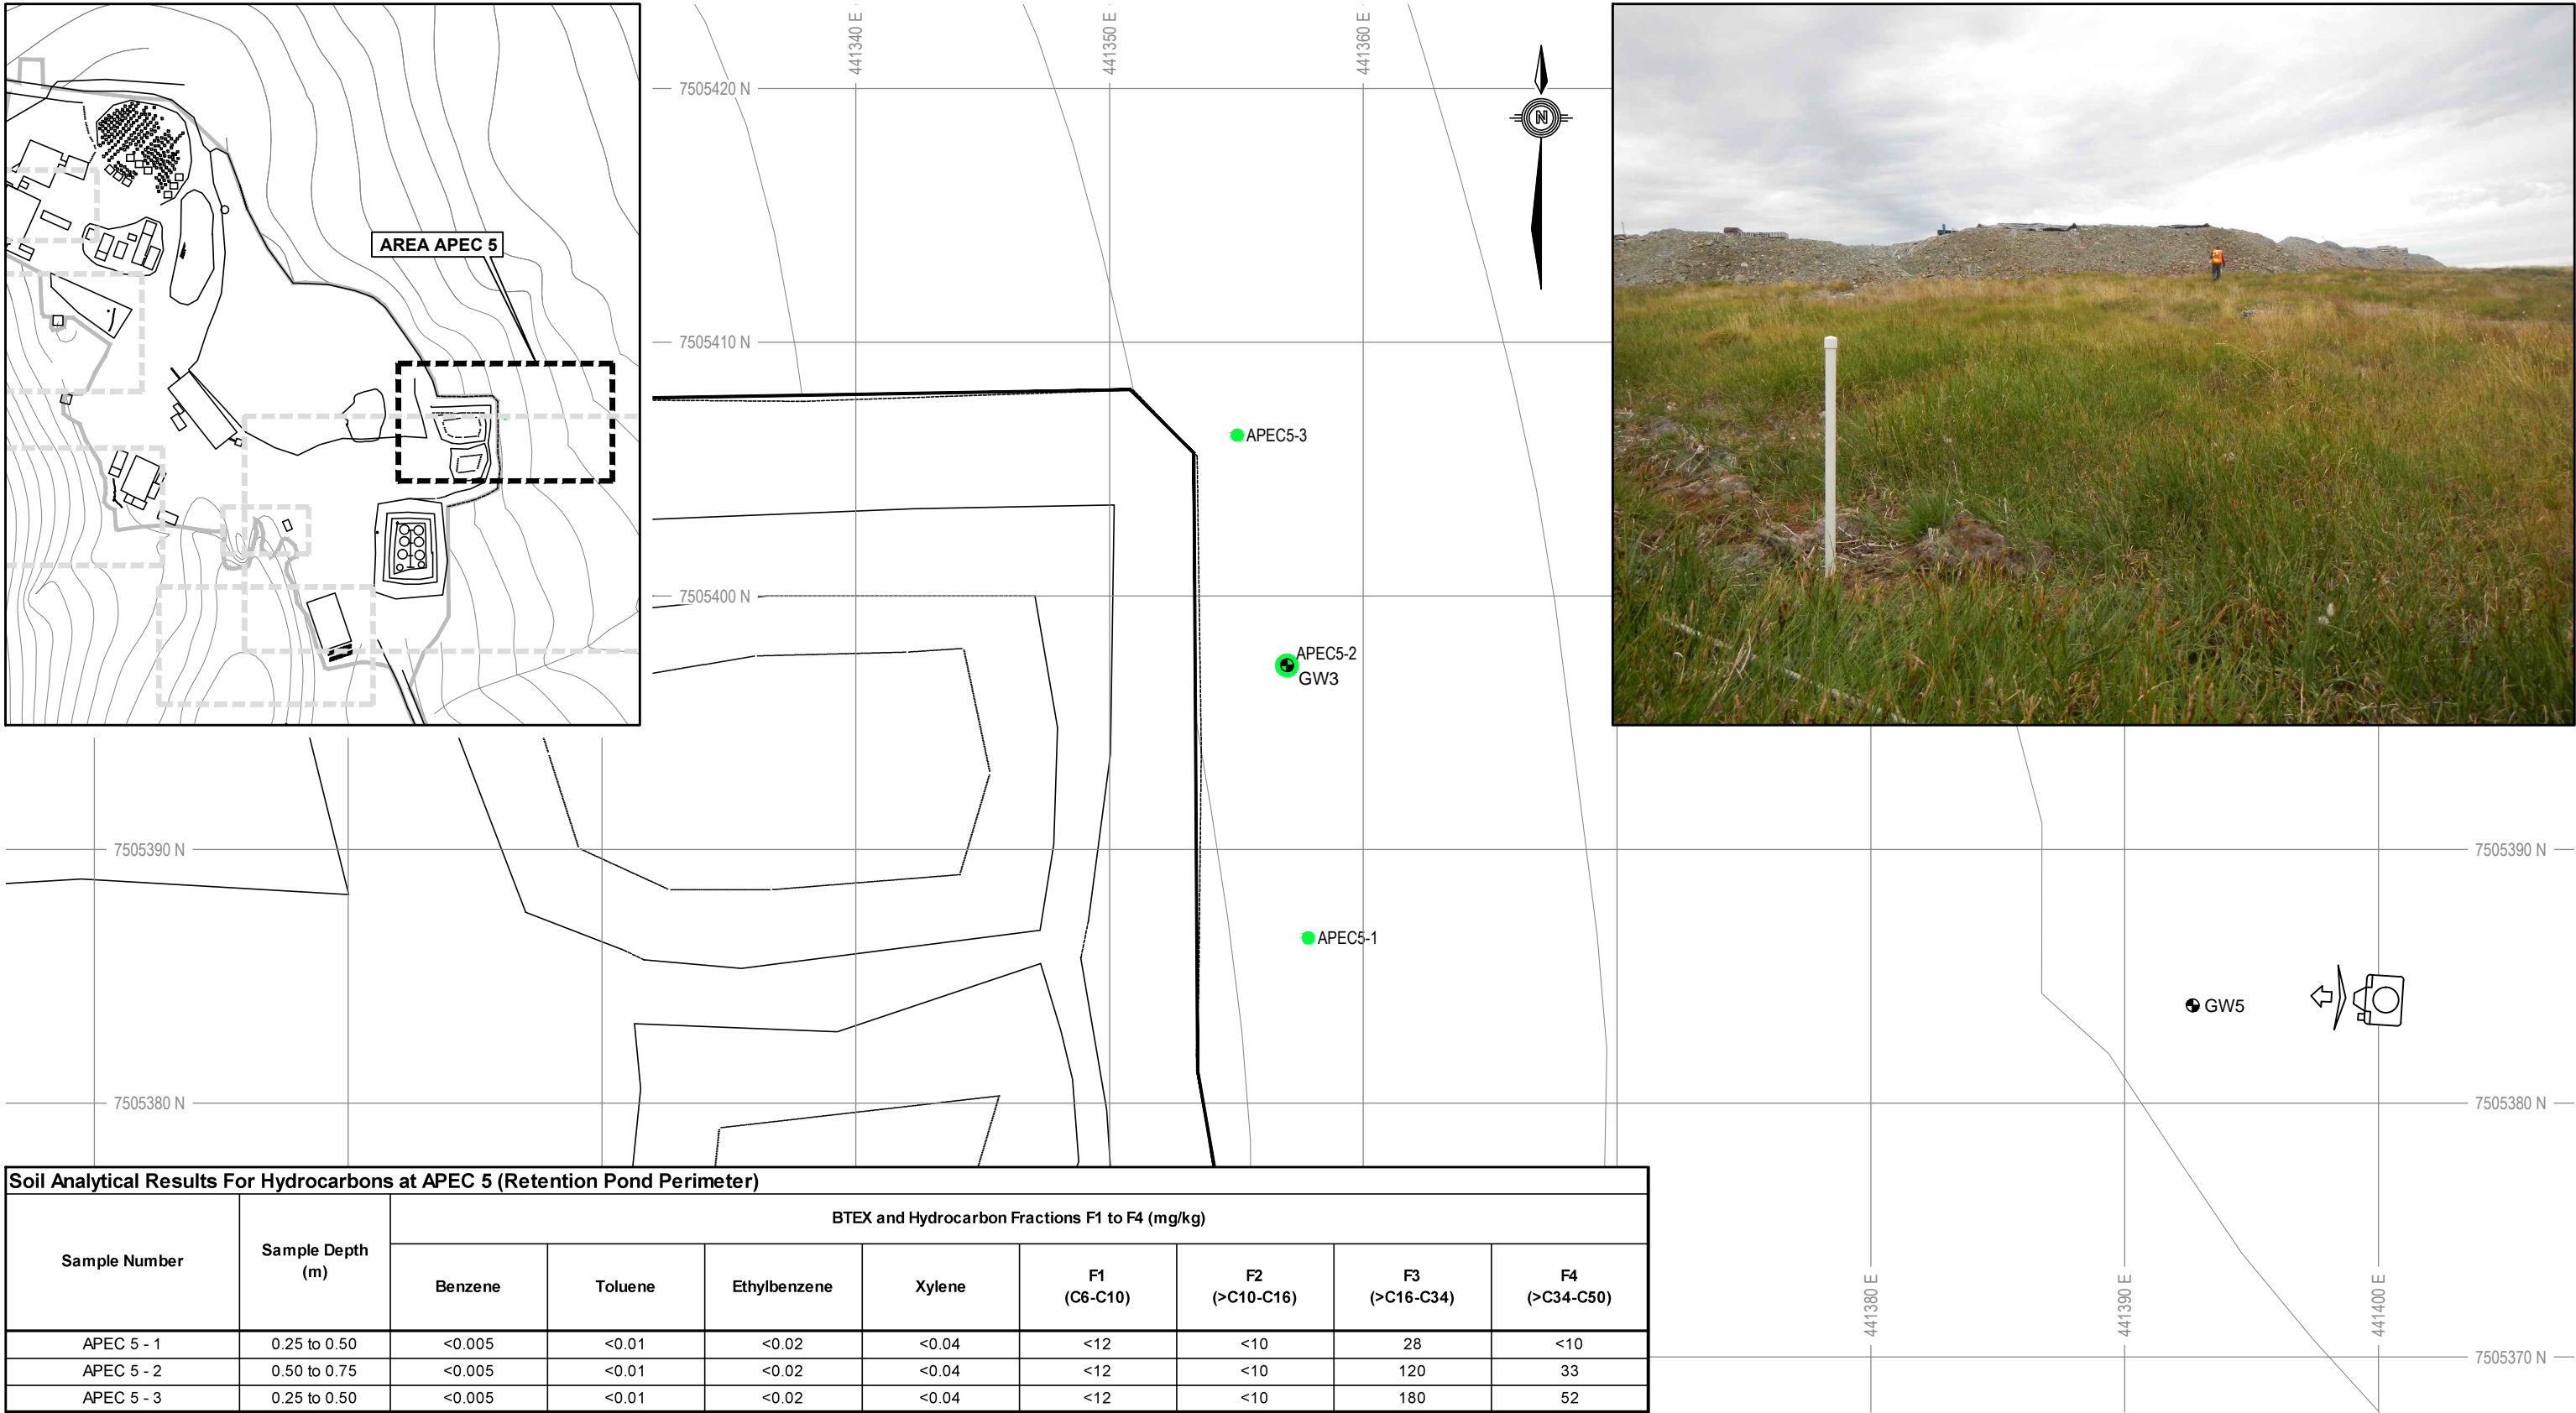
Soil Analytical Results For Hydrocarbons at APEC 5 (Retention Pond Perimeter)
