**Re: August 2018 – Monthly Monitoring Report for Water Licence 2BB-BOS1727**

This report is comprised of monitoring requirements as set out in Part J of water licence 2BB-BOS1727. Boston Camp is used to support seasonal surface exploration programs. Boston Camp was shutdown for the winter season on September 12, 2017 and remains inactive at this time. Sampling locations monitored under this licence (seasonally or when facilities are operational) are provided in Figure 2 at the end of this report.

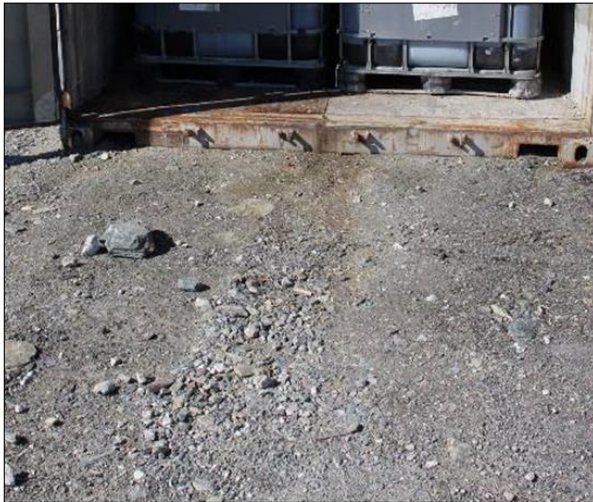
**Figure 1. Spill #18-315 Completed spill cleanup**

Spill #18-315 – On August 5, a spill of wastewater was discovered while conducting a routine inspection of the unoccupied Boston advanced exploration site. A small stain was observed outside of a seacan being utilized for storage of treated sewage sludge that was generated during the 2017 seasonal exploration program based at the Boston

camp. A single tote was found to have released 0.5m<sup>3</sup> of the liquid contents (wastewater) of the sludge stored within its containment.

- Tote potentially compromised due to freeze/thaw over the winter.
- Insufficient secondary containment used. The seacan did not have a liner installed to act as a form of secondary containment unlike others at the site used to store this material.

Spill location.

Upon discovery of the spill a plan was actioned to expedite transport of all remaining totes containing treated sewage sludge back to Doris Camp for disposal in the Tailings Impoundment Area (TIA) to eliminate the risk of future spills from these totes. Once the seacan was empty, it was moved in order to access the contaminated material beneath. Contaminated material was excavated from the spill area and placed into a mega bag for backhaul to the Doris Project for disposal. See Figure 1 below with photos of pre- and post-cleanup of the spill.

- Treated sewage sludge will be transported back to Doris Camp for disposal as soon as possible to reduce the risk of stored totes undergoing damage during freeze/thaw (complete);
- Seacan liners will be used in the event that totes are to be stored in seacans; and
- If seacans are utilized for storage of liquids they will be sloped to encourage drainage towards the back of the seacan rather than the front in order to contain any spilled material.

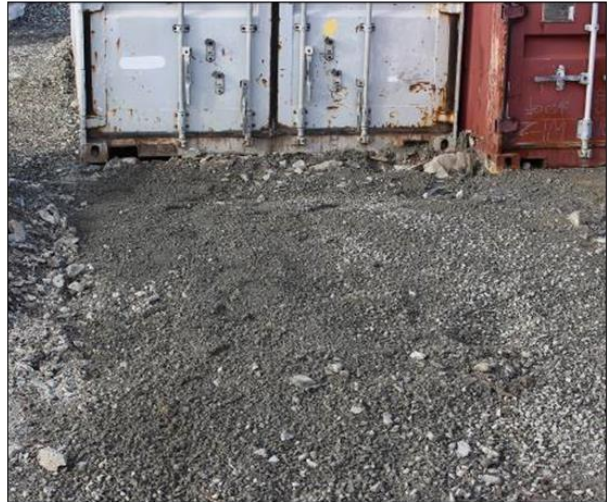
Spill reclamation.
