Re: June 2019 – Monthly Monitoring Report for Water Licence 2BB-BOS1727

This report is comprised of monitoring requirements as set out in Part J of water licence 2BB-BOS1727. Boston Camp is used to support seasonal surface exploration programs. During the subject focus of this report, the Boston Camp was recommissioned to prepare support for a surface exploration program beginning in July 2019. Sampling locations monitored under this licence (seasonally or when facilities are operational) are provided in Figure 2 at the end of this report.

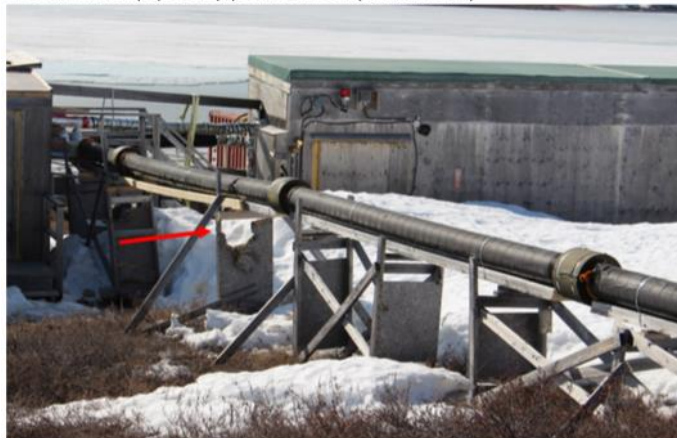
Figure 1. Pipeline and pipe connection of main kitchen grey water line

Spill #19-240 – On June 23, 2019, while conducting an inspection of the camp lift station and pipeline facilities at the Boston Camp, an employee identified that the pipe support of the main kitchen grey water line to the camp lift station had failed resulting in the pipe dropping approximately 1ft. While the grey water line was being repaired, two sections of the pipeline separated resulting in approximately 100L of grey water being released to the tundra below. Upon investigation, it was found that a 2" HDPE pipeline had been glued to an ABS pipeline. The additional strain resulting from the pipeline dropping caused the glue to separate at this location. The pipe support was also found to be weathered and no longer adequate to support the weight of the pipe.

Location of pipe support failure (red arrow)

The pipe sections were reconnected and insulated; a Victaulic clamp appropriate for the pipeline materials (HDPE to ABS connection) has been ordered and will be installed at this location to reduce the risk of a reoccurrence.

- Use Victaulic fittings for pipe connections that are appropriate for the pipe material;
- Conduct assessment of pipe connections along entire length of the grey water pipeline at Boston Camp and replace if necessary;
- Replace current pipe support with robust materials that are less susceptible to weathering and failure.

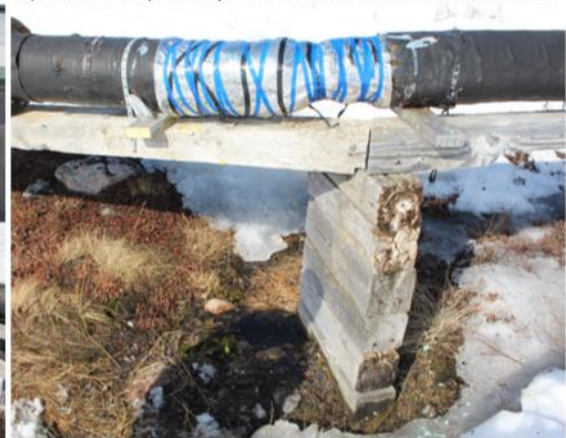
Pipeline temporarily reconnected and reinsulated
