Re: July 2019 – Monthly Monitoring Report for Water Licence 2BB-BOS1727

This report is comprised of monitoring requirements as set out in Part J of water licence 2BB-BOS1727. Boston Camp is used to support seasonal surface exploration programs.

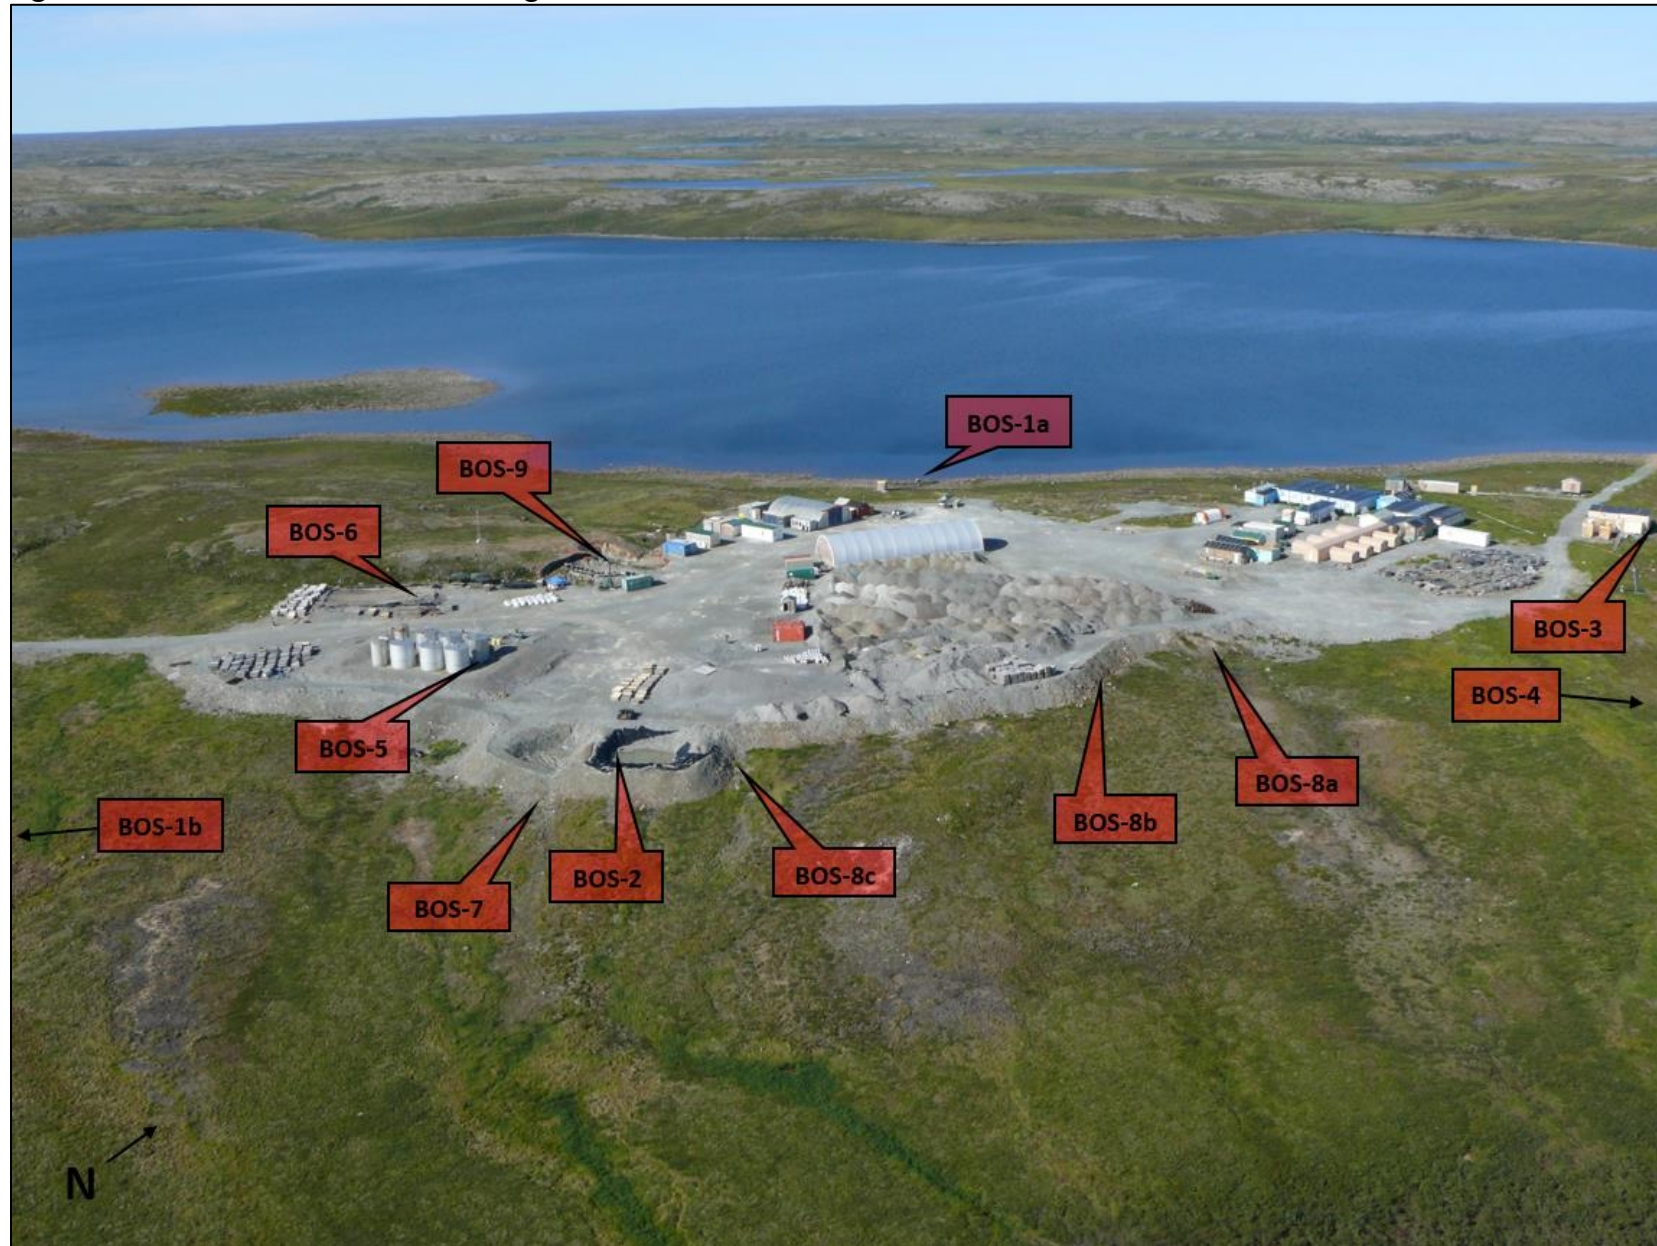
Figure 1. 2BB-BOS1727 SNP Monitoring Locations

Sampling locations monitored under this licence (seasonally or when facilities are operational) are provided in Figure 1 at the end of this report.
