Re: September 2019 – Monthly Monitoring Report for Water Licence 2BB-BOS1727

This report is comprised of monitoring requirements as set out in Part J of water licence 2BB-BOS1727. Boston Camp is used to support surface exploration programs.

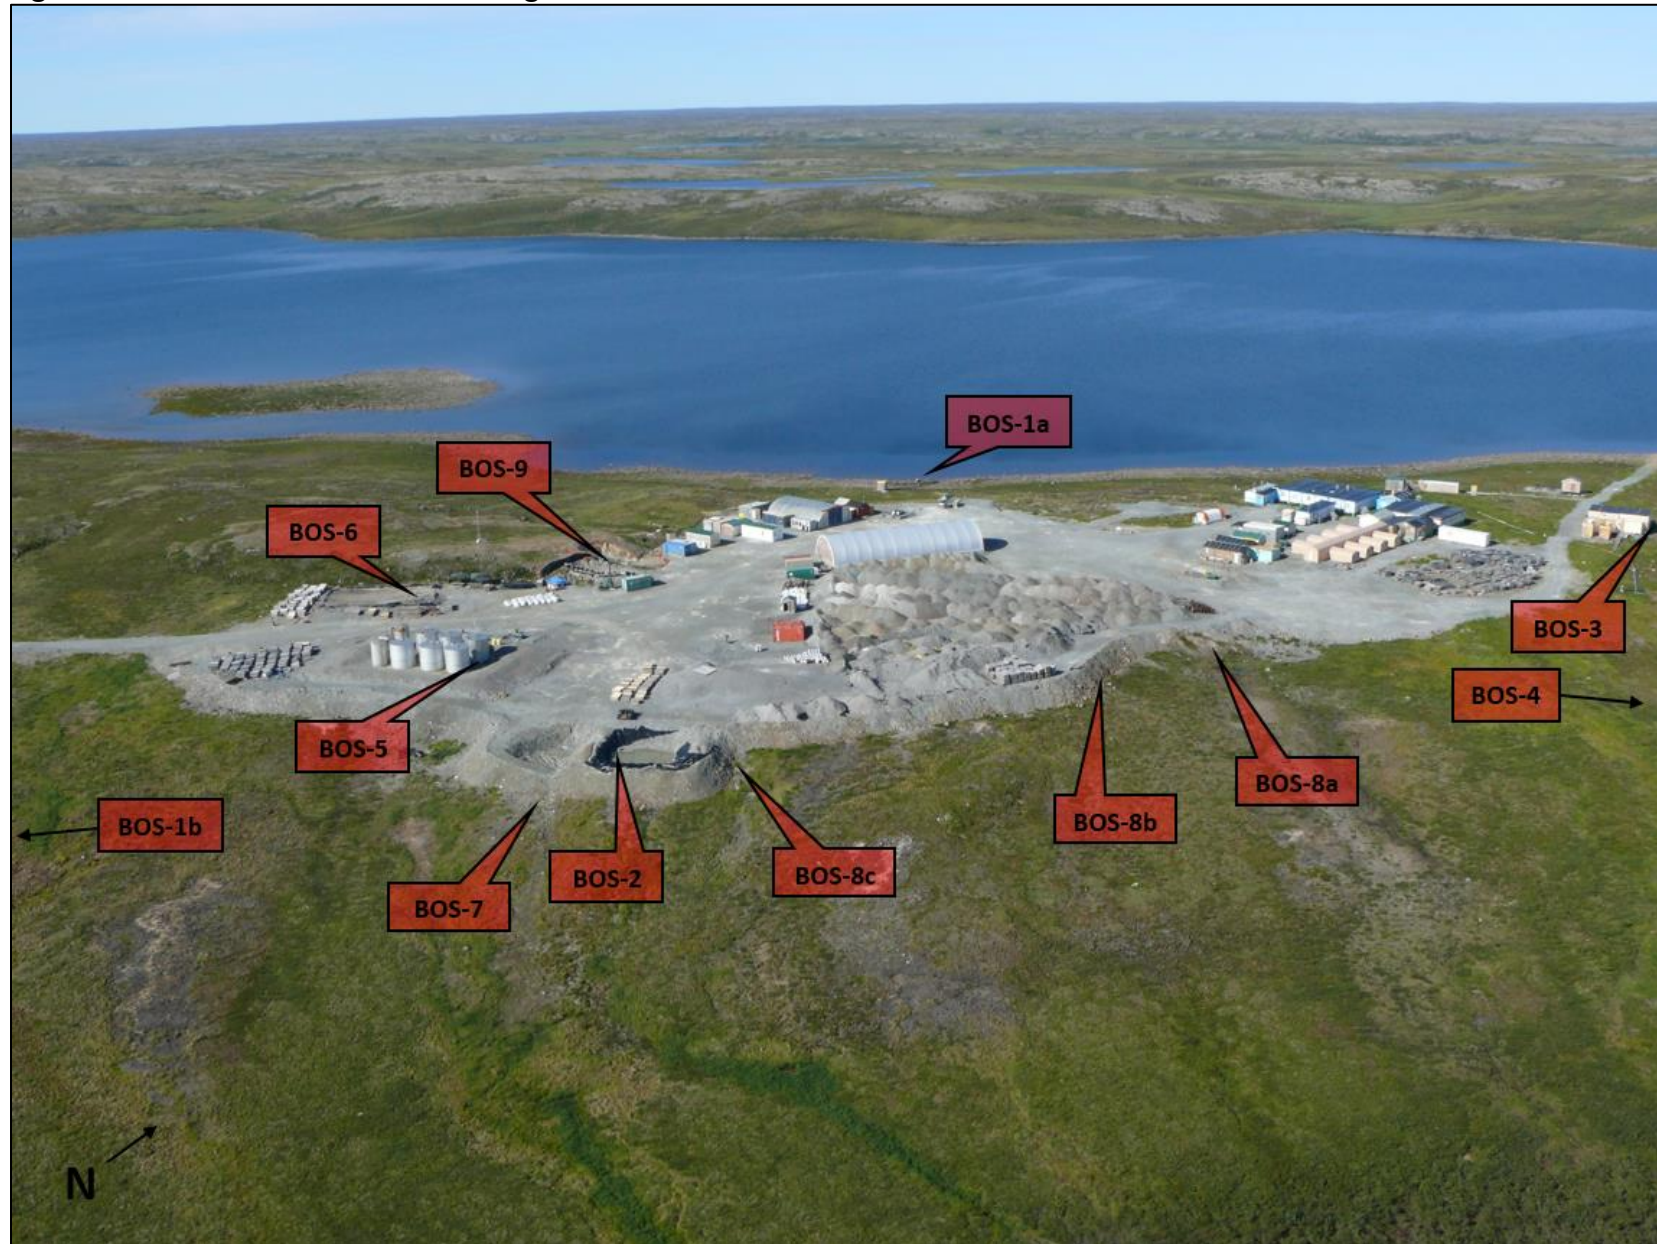
Figure 1. 2BB-BOS1727 SNP Monitoring Locations

Sampling locations monitored under this licence (seasonally or when facilities are operational) are provided in Figure 1 at the end of this report.
