HOPE BAY BELT PROJECT 2018 Nunavut Water Board Annual Report

2018 Nunavut Water Board Annual Report

Prepared by
TMAC Resources Inc.
Toronto, ON

March 2019

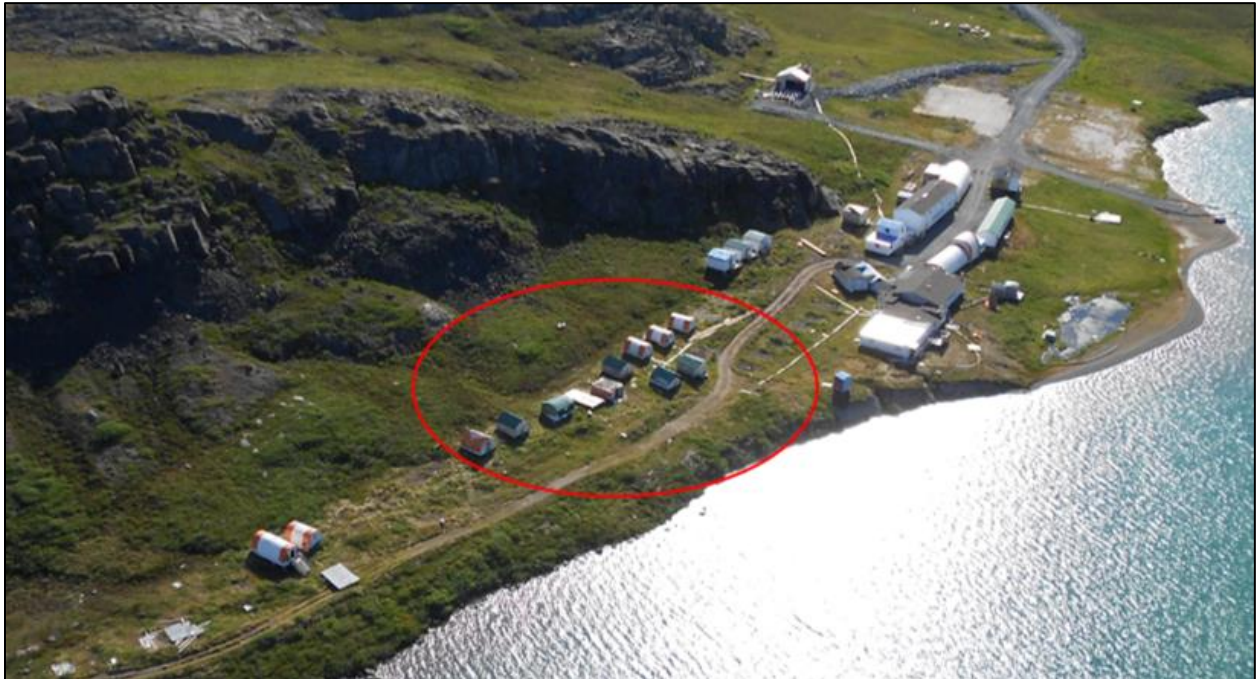
Photo 13.1-1. Windy Camp pictured in 2013. Area of 2018 reclamation activities denoted by red circle.

In 2018, progressive reclamation work was focused on Windy Camp. Environmental Affairs personnel completed reclamation activities with focus was to dismantle the Weather Haven tents and wood framed cabins at the north end of the camp (Photo 13.1-1).

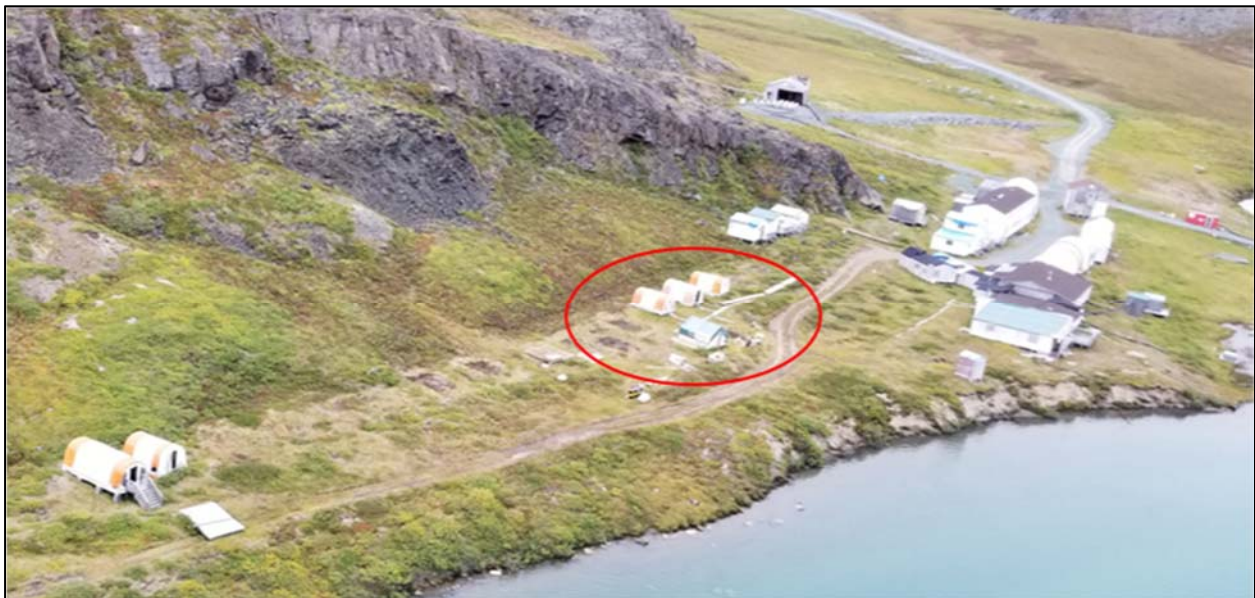
Photo 13.1-3. Progressive reclamation completed as of August 26, 2018. Additional reclamation work conducted in September 2018 (indicated by red circle).

Photo 13.1-3 provides an aerial view of the progressive reclamation completed as of August 26, 2018. Additional reclamation work was completed in early September and additional cabins (indicated by red circle) were dismantled.

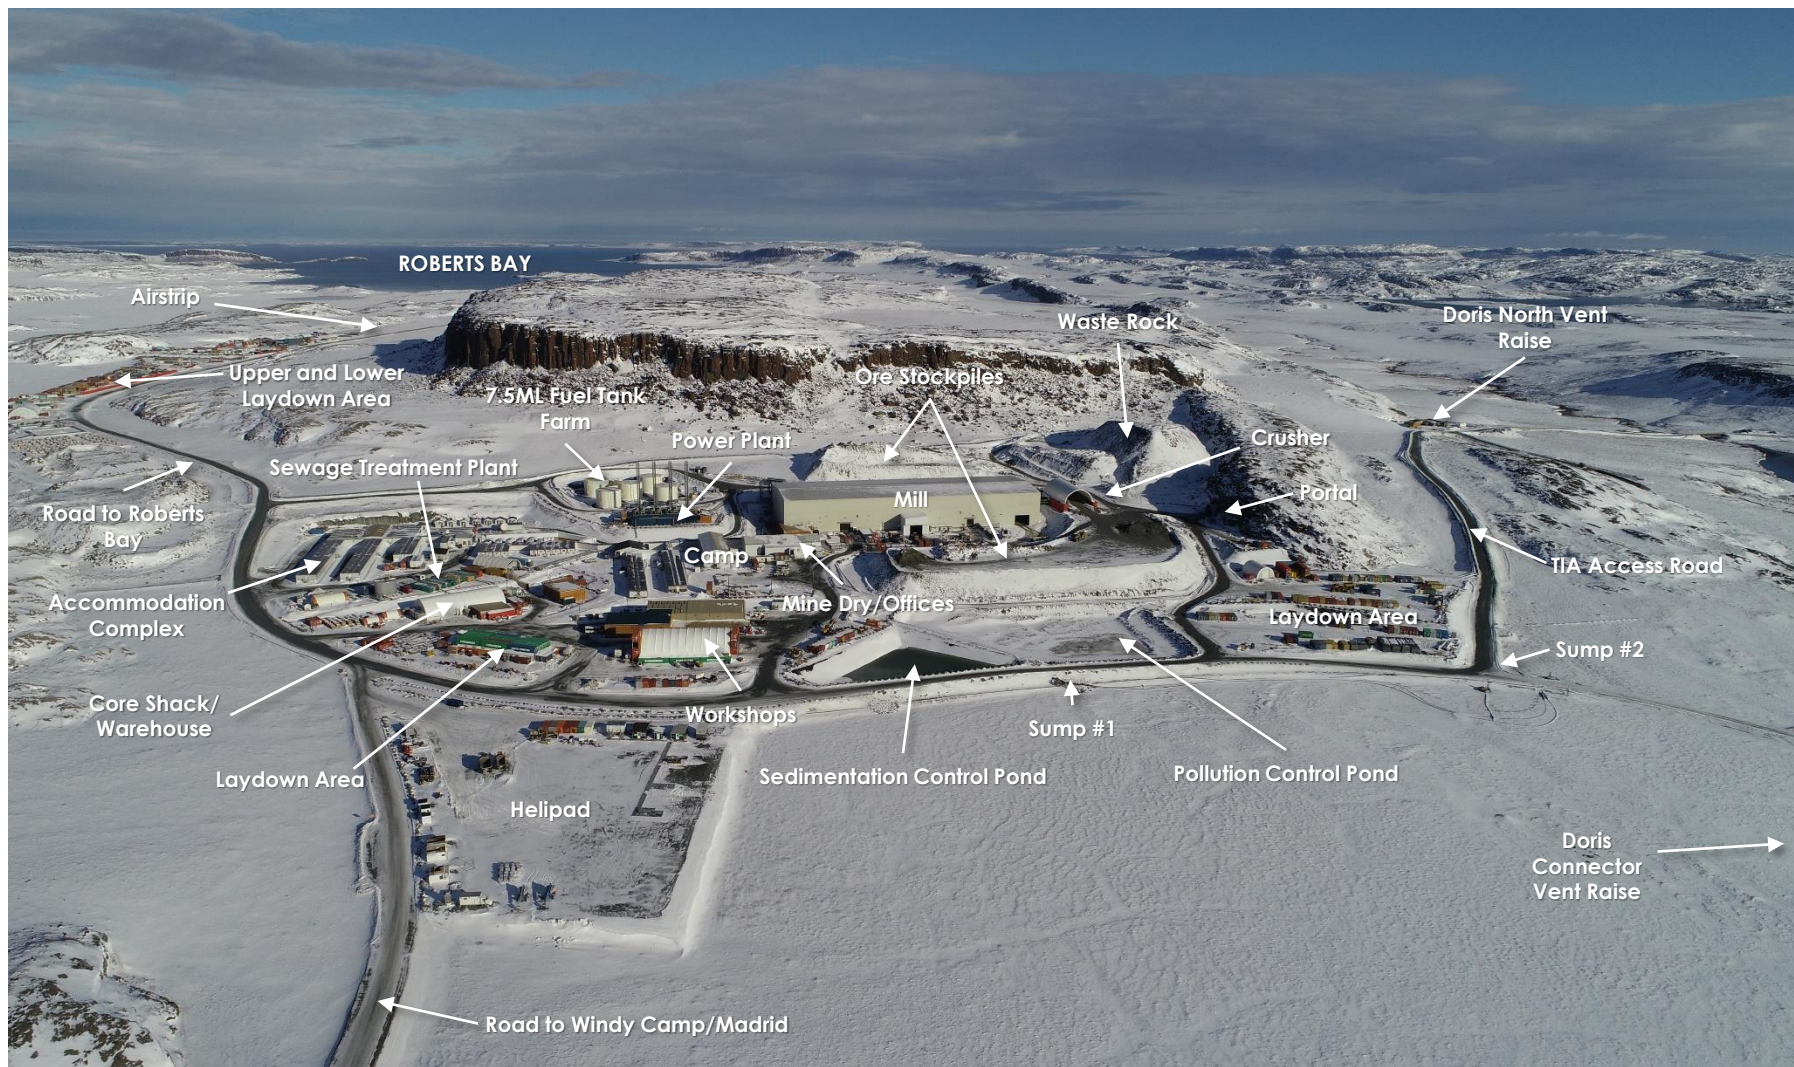
Doris Site Layout (looking North)

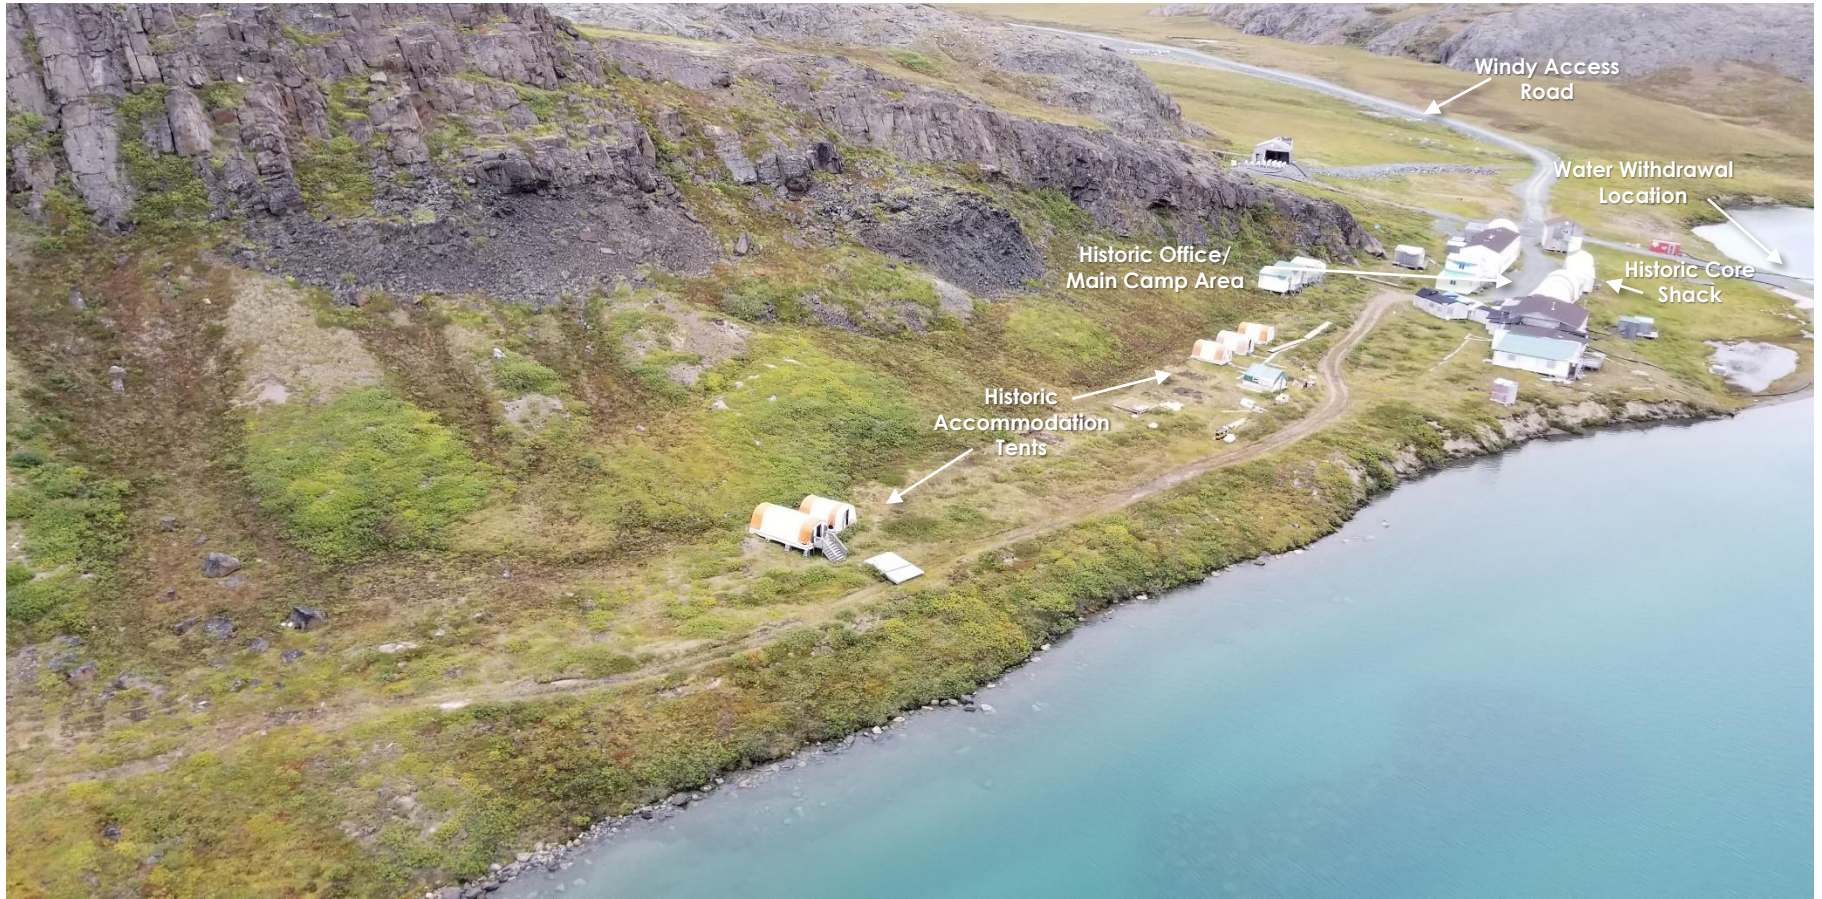
Windy Camp Layout (looking East)

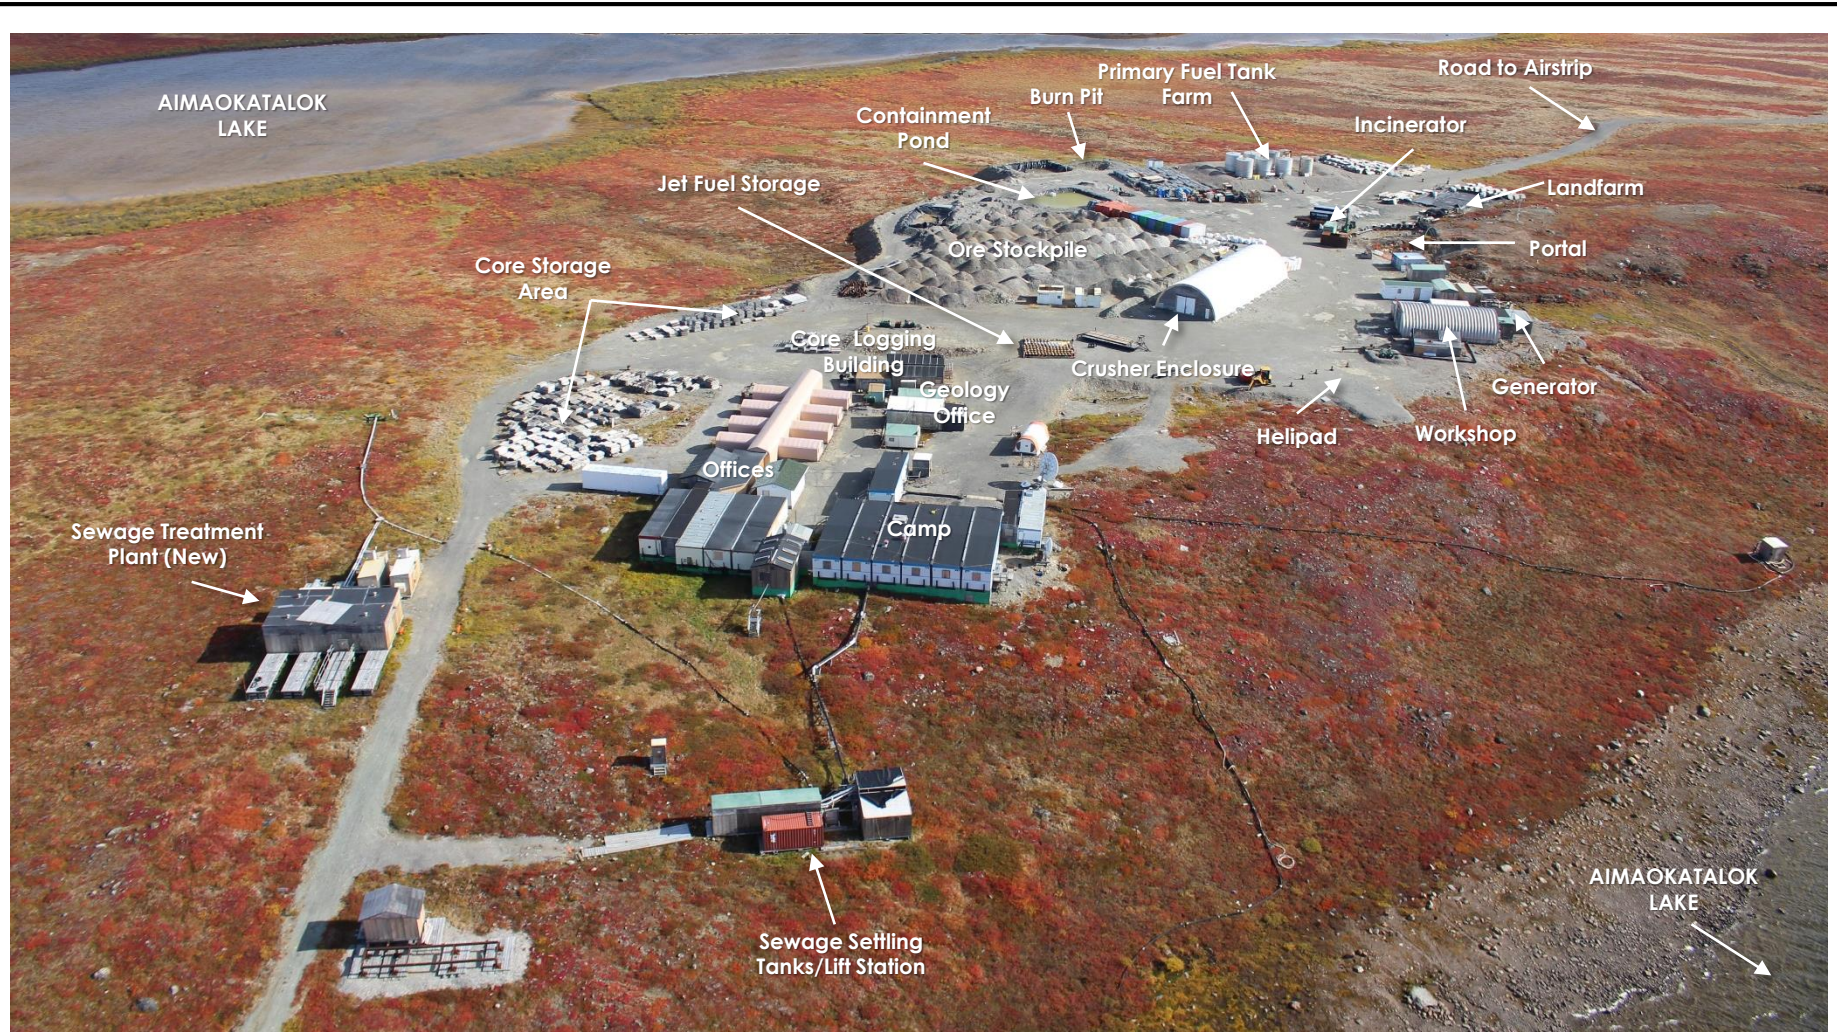
Boston Site Layout (looking South)

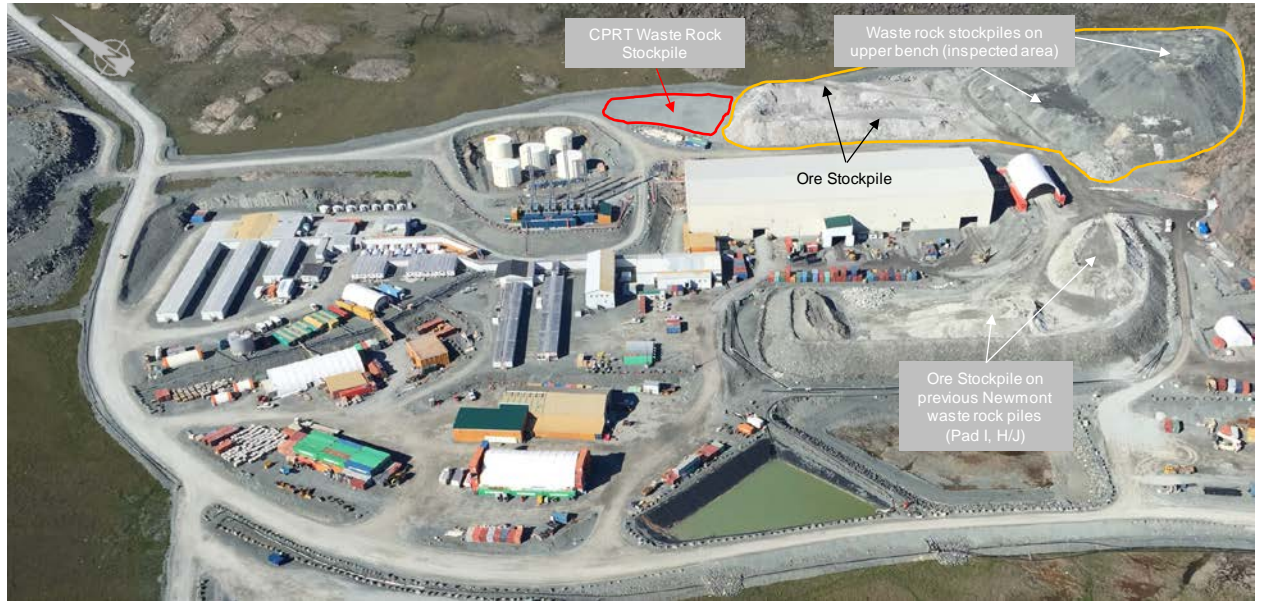
Figure 1-1: Waste Rock and Ore Stockpile Locations, Doris Mine (Photo taken August 5, 2018)

and that could be safely accessed would be found on the upper bench (Figure 1-1). This upper bench contained over two dozen small waste rock piles.

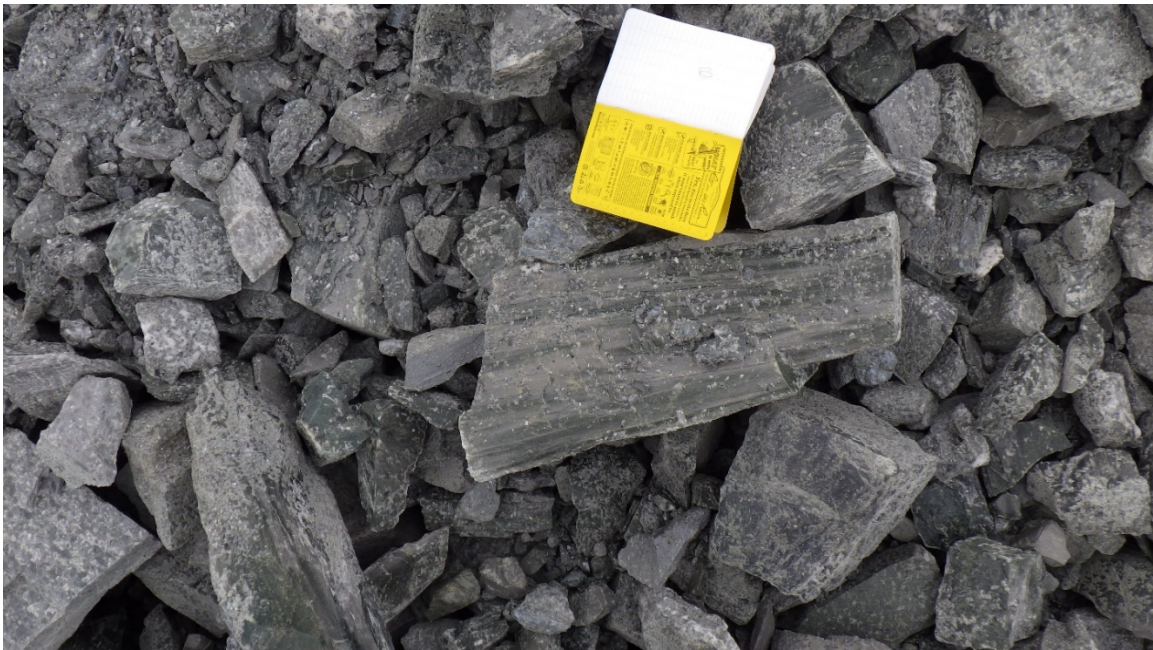
Figure 3-1: Light green metavolcanics with quartz veining

The majority (about 80 to 90%) of the waste rock inspected was green mafic metavolcanics (basalt or lithology code 1) with varying degrees of sericitic alteration, quartz veinlets (up to several cm thick) and trace pyrite ($\leq 1\%$) occurring as disseminations or stringers (Figure 3-1). Mafic metavolcanics without or with lesser sericitic alteration were darker green and contained trace amounts of pyrite ($< 1\%$). Mafic metavolcanics with sericitic alteration tended to be lighter colored, more foliated and commonly associated with quartz veining and with slightly more pyrite ($\sim 1\%$) than mafic metavolcanics with lesser sericite alteration.

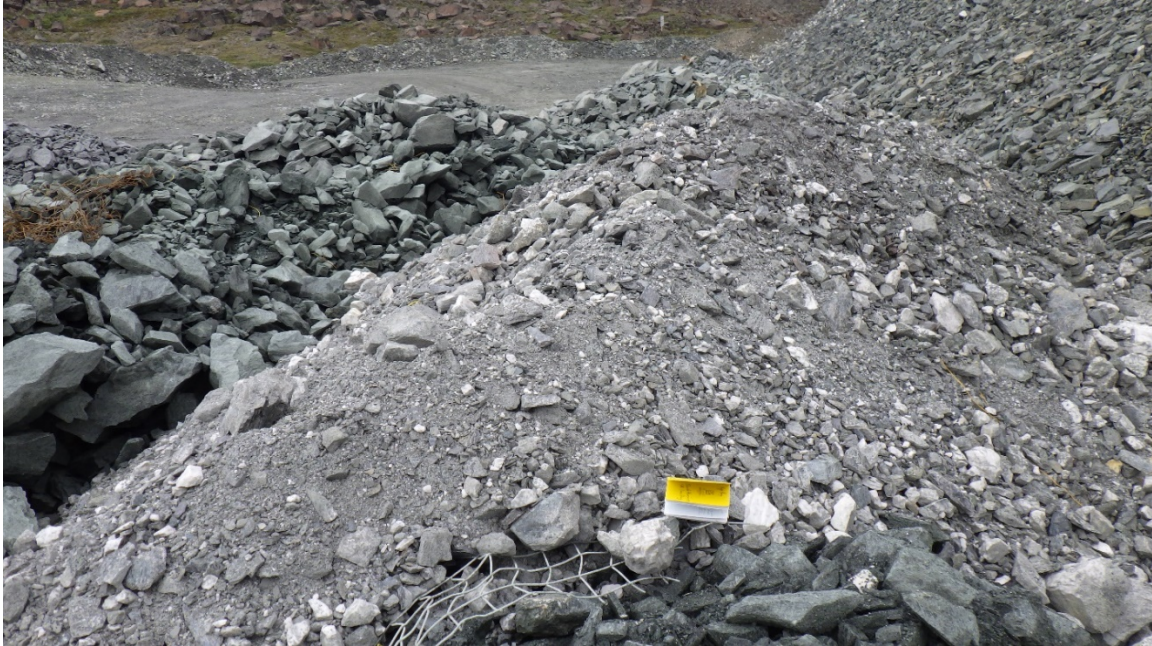
Figure 3-2: Quartz vein on the upper bench of Pad T (waste rock)

About 5 to 10% of the waste rock observed was massive blocky quartz with trace ($< 1\%$) pyrite occurring as stringers and cubes (Figure 3-2). Few ($< 5\%$) occurrences of diabase were observed among the mafic metavolcanics, as well as traces of a pale cream-colored rock which has been described in the past as altered metavolcanics rock proximal to the contact with the diabase (i.e., low NP basalt).

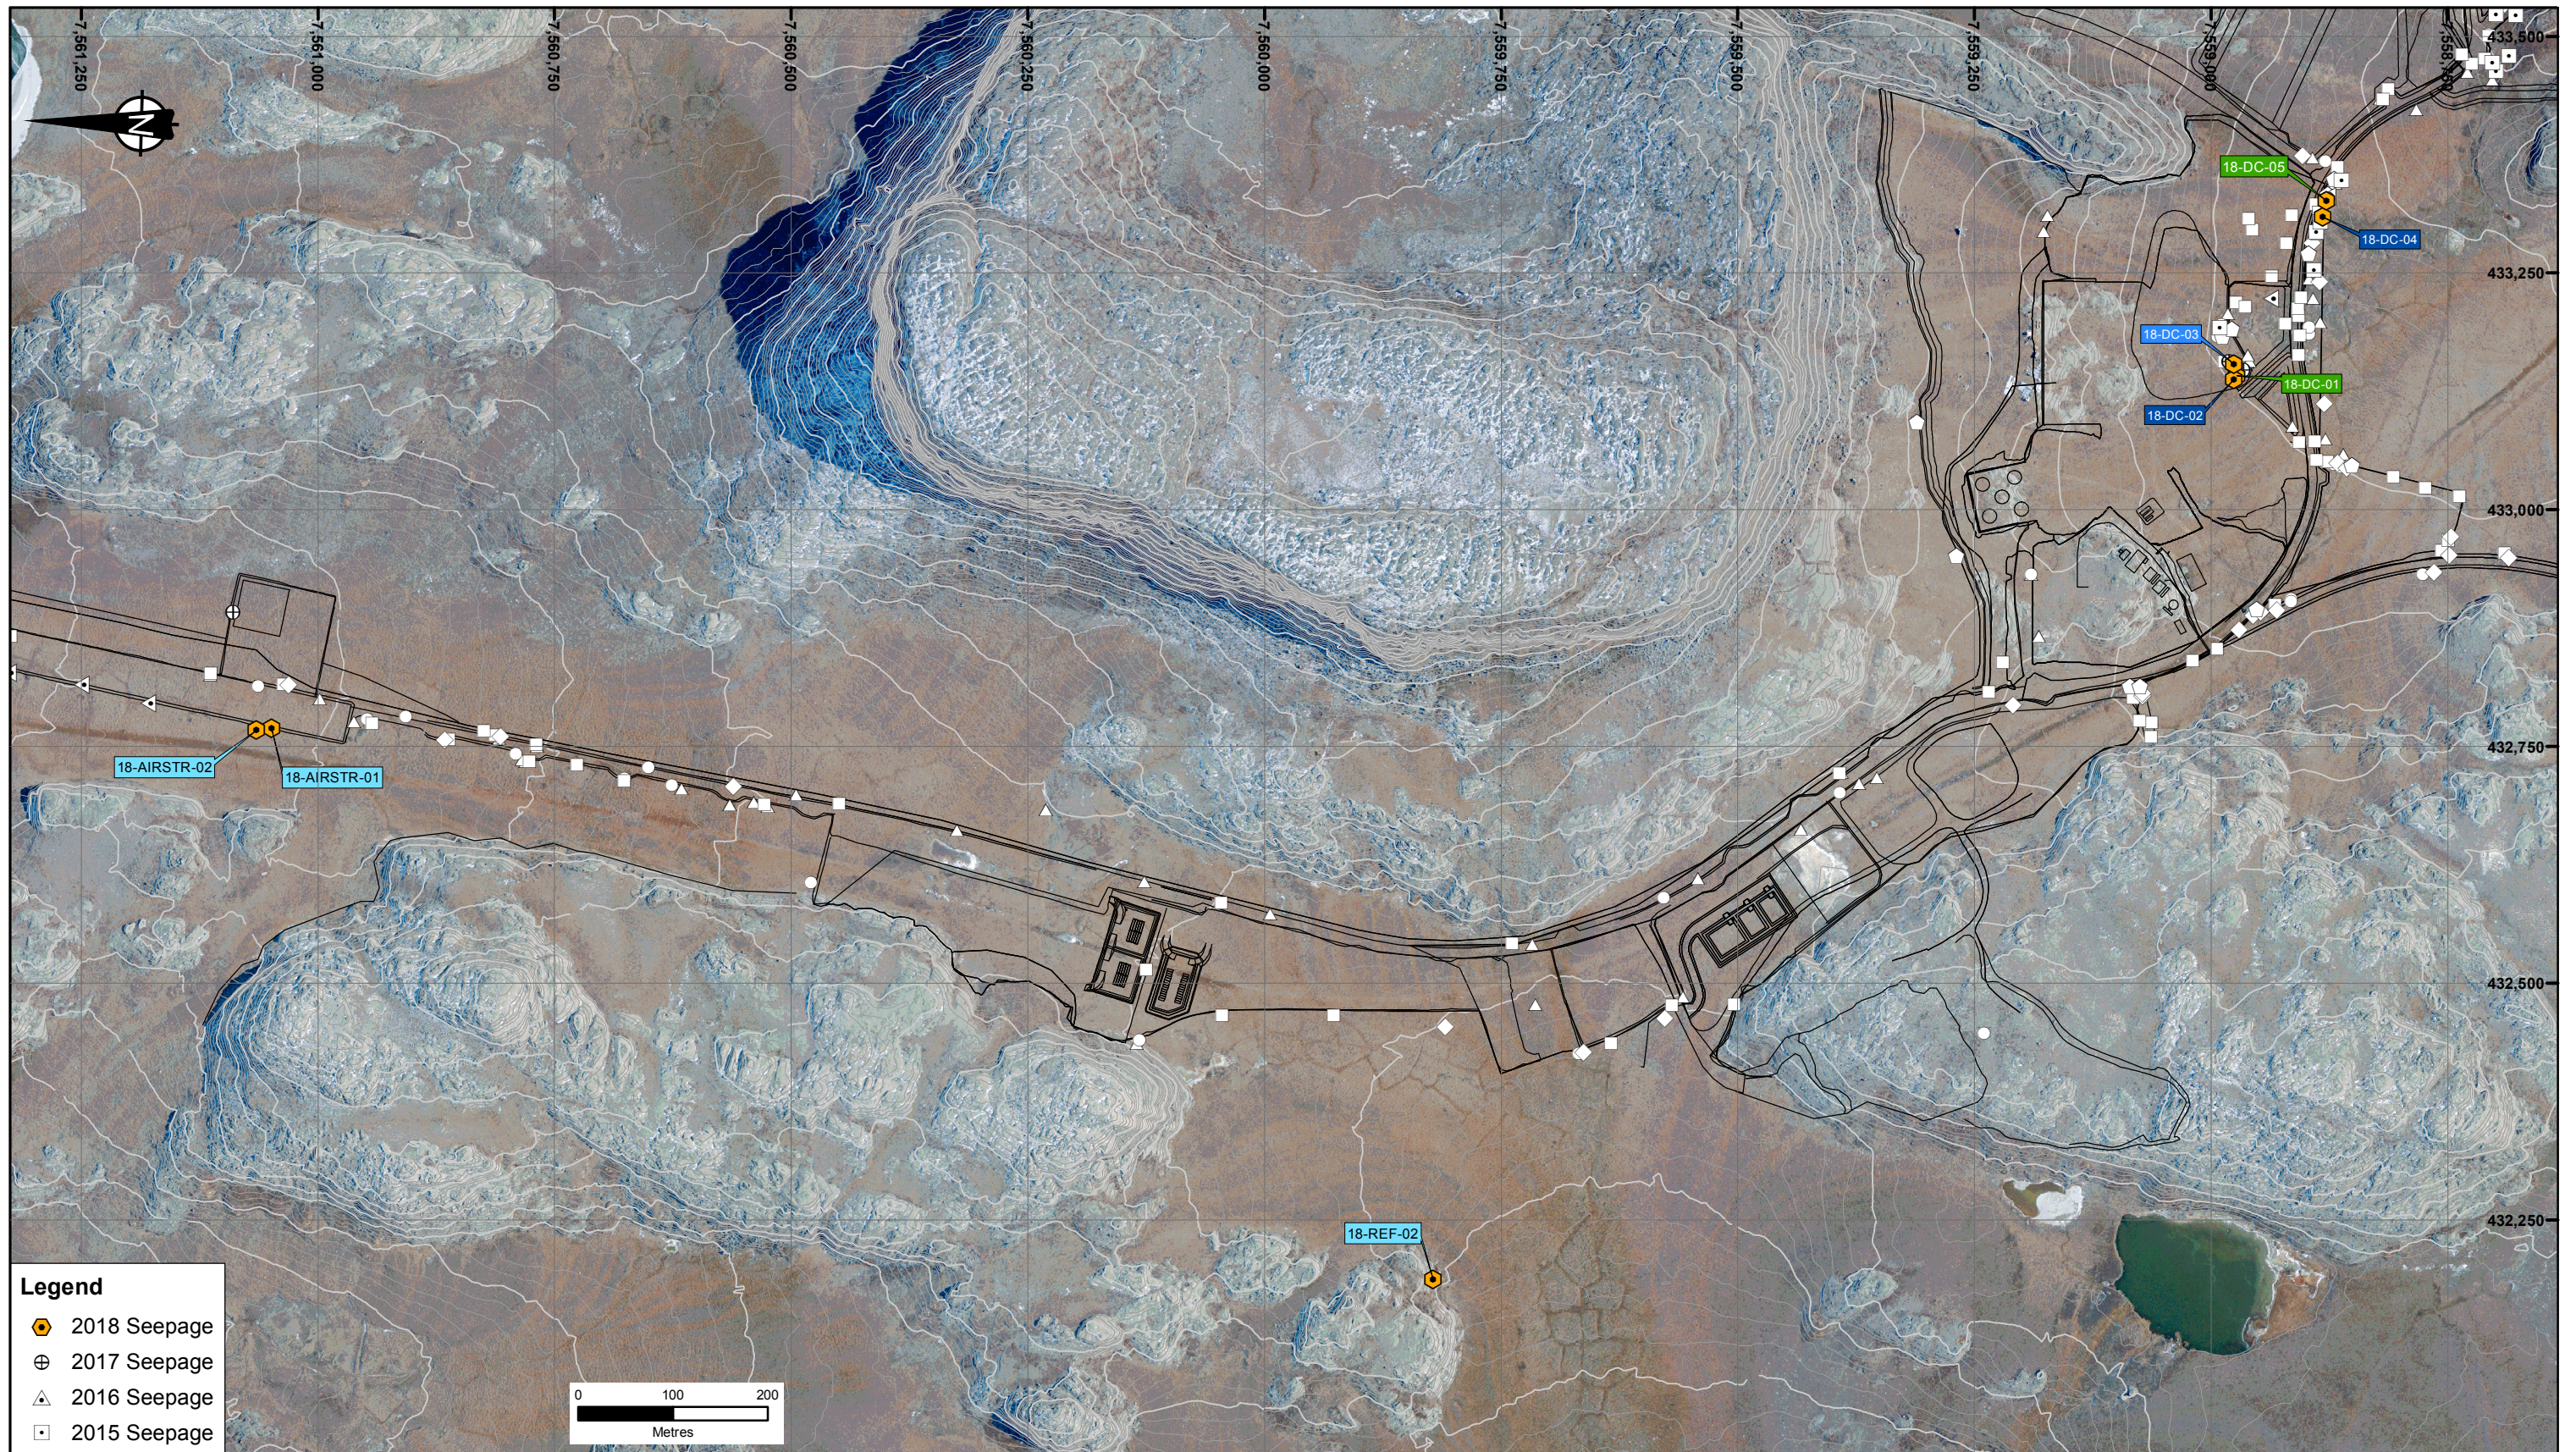
Hope Bay Gold Project		
Seep Survey Locations North Area		
Date: Feb 2019	Approved: MCN	Figure: 3

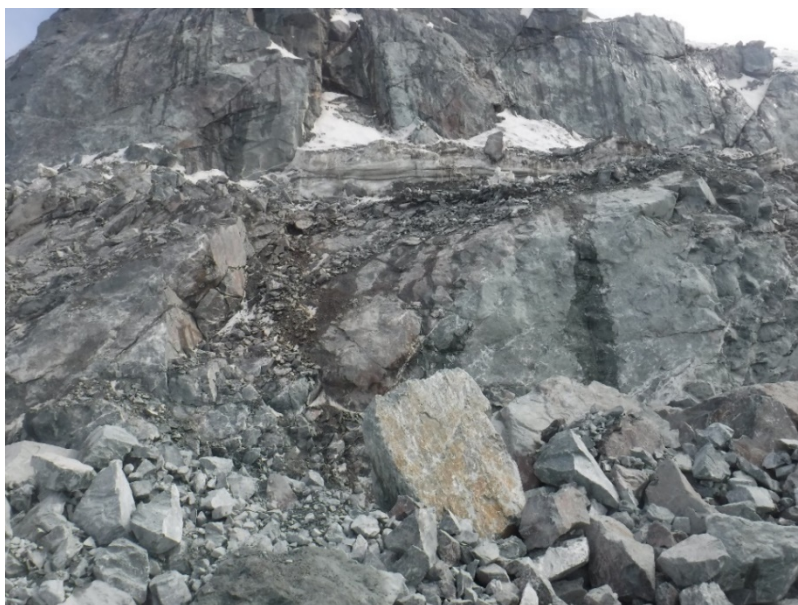
Figure 3-1: Quarry 2 Active Face (Photo taken May 26, 2018)

In 2018, TMAC conducted 28 active face inspections in Quarry 2 between February and October. Figure 3-1 presents an example of a typical quarry face.

The key observations recorded by TMAC geologists were that all of the materials inspected were light to medium grey mafic metavolcanics (basalt) containing trace amounts of disseminated pyrite (<1%). Quartz-carbonate veins were typically present (approximately 1 to 3%) and up to 5 mm wide. One of the visual inspections in May reported up to 15% quartz-carbonate veins up to 15 cm wide. Small amounts of hematite staining were frequently observed on the surface. Moderate epidote alteration was recorded in August 2018 and weak chlorite alteration was reported during the September and October inspections. All inspections noted the absence of fibrous actinolite with the exception of the April 28 inspection which reported that drilling was taking place adjacent to a fibrous actinolite stake. TMAC clarified that a surface surveyor observed the suspected actinolite outside of the quarry boundary. The TMAC geologist recorded the anecdotal evidence of actinolite but was not able to confirm the occurrence of actinolite. .

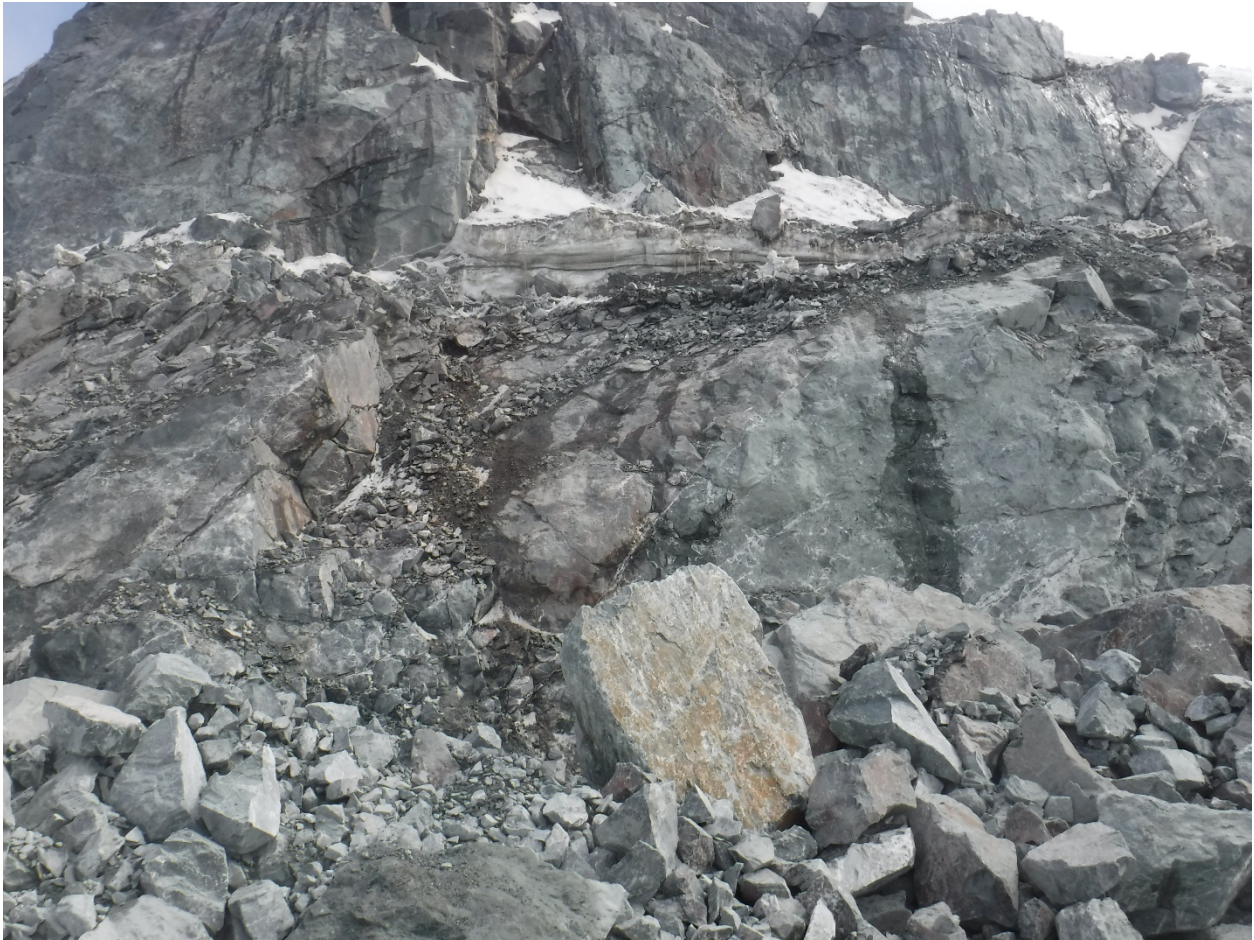
Photo: Quarry Monitoring Inspection 26th May 2018

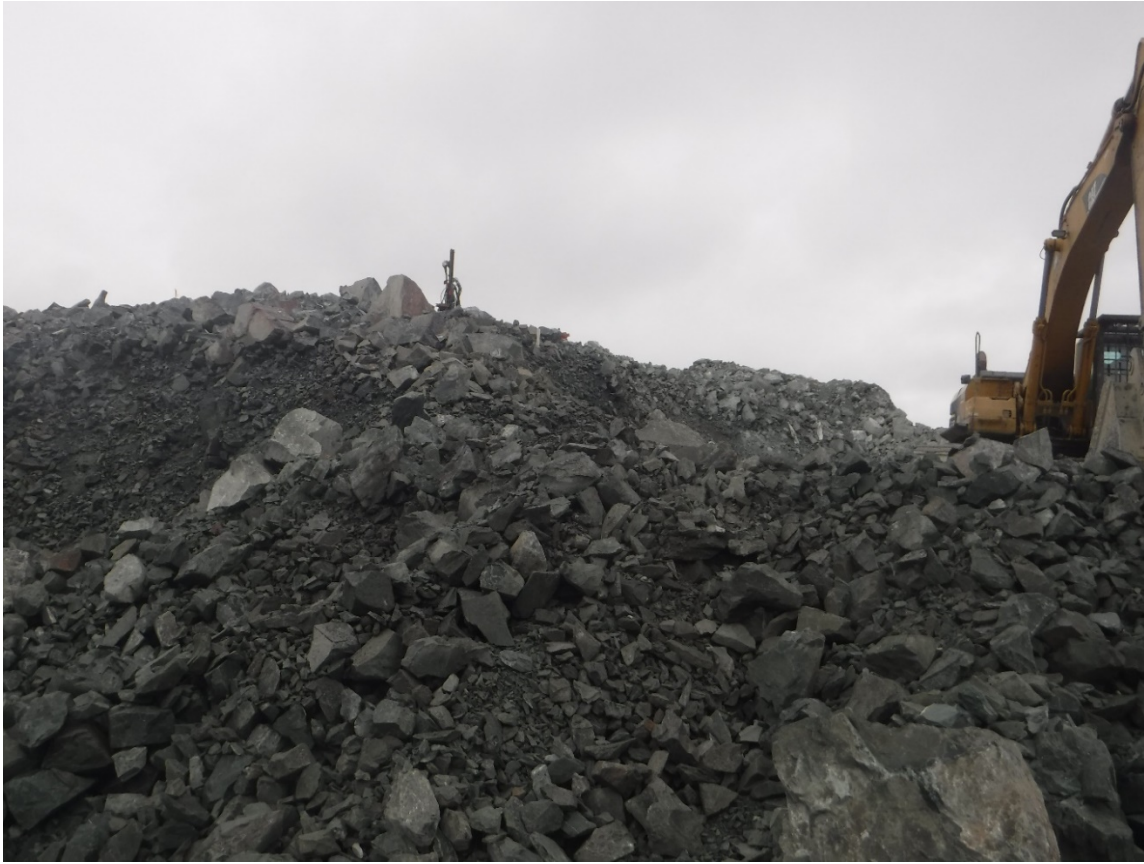
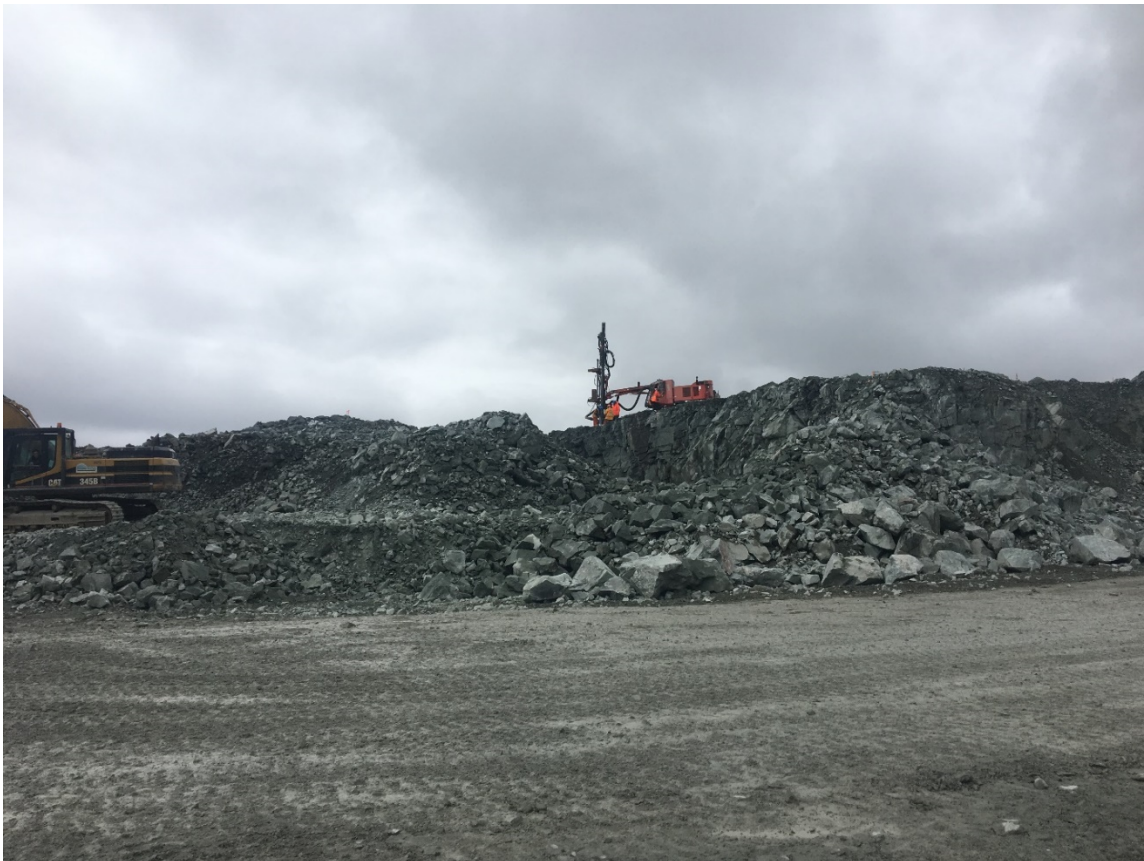
Photo: Quarry Monitoring Inspection 11th August 2018

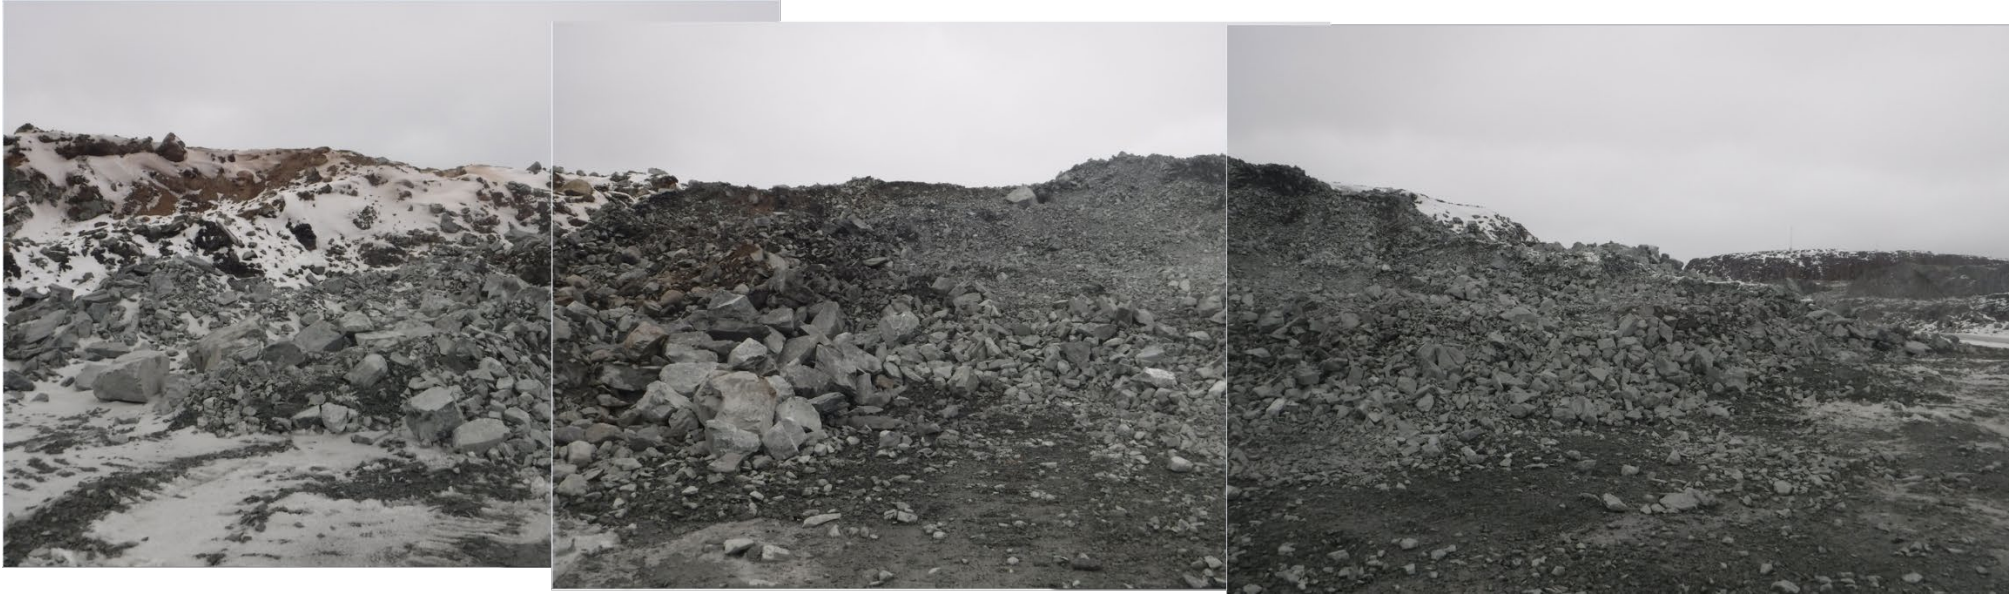
Photo: Quarry Monitoring Inspection 16th September 2018

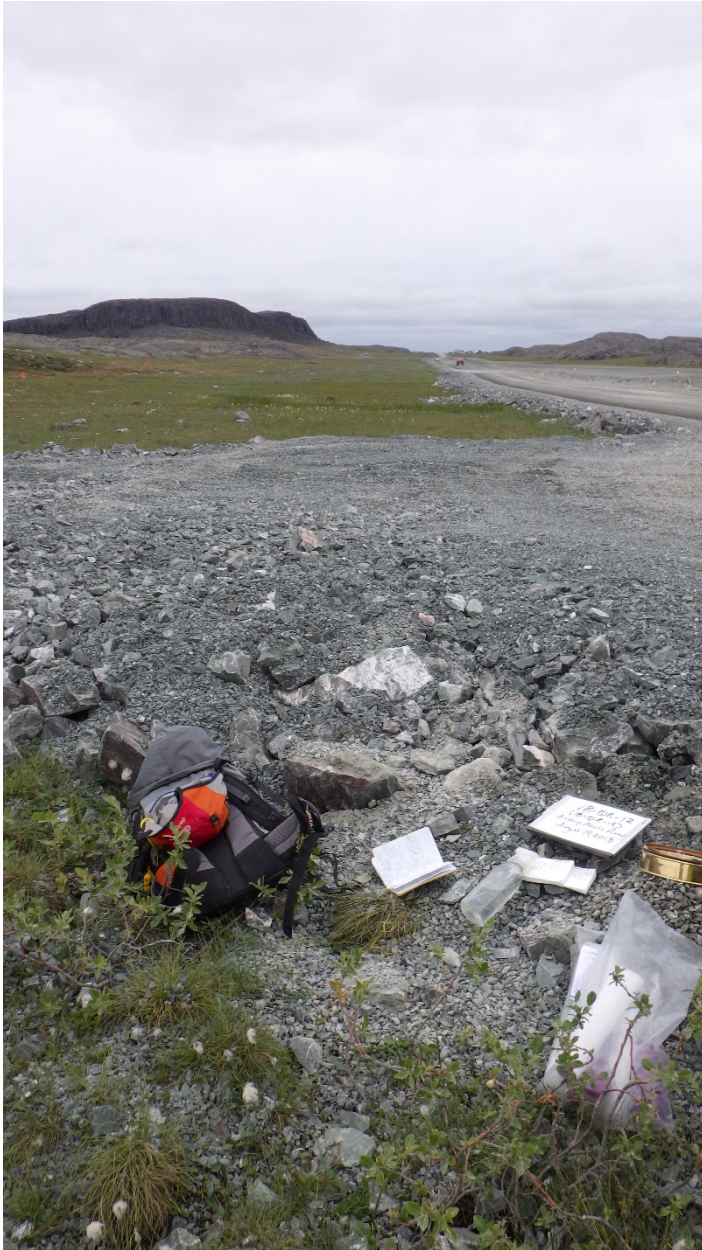
Photo: Sampling location for 18-QR-12

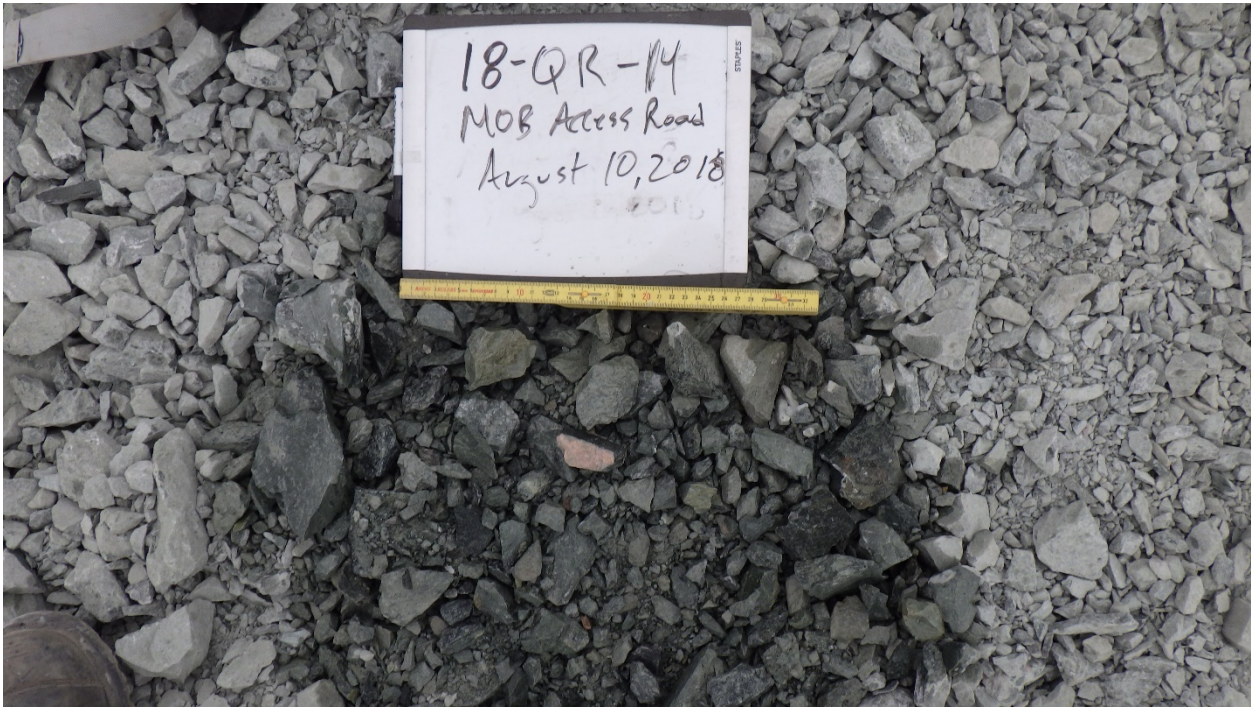
Photo: Sampling location for 18-QR-12

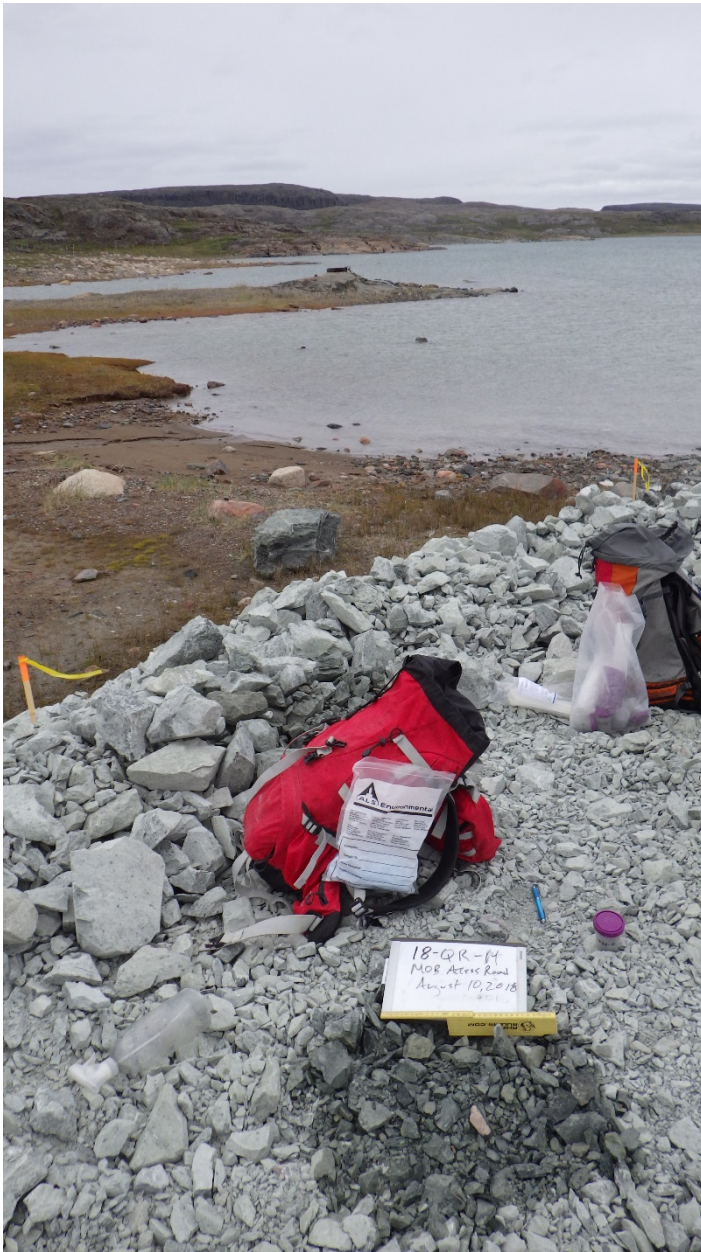
Photo: Sampling location for 18-QR-14

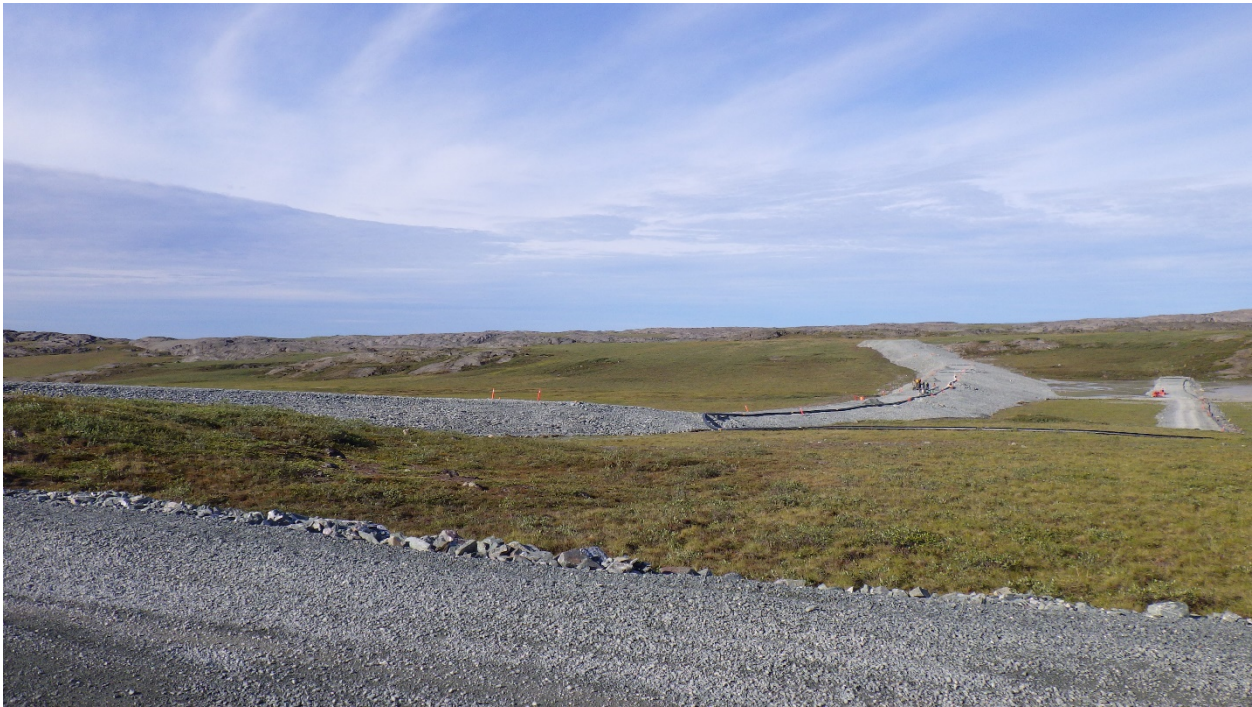
Photo: Sampling location for 18-QR-14
