HOPE BAY BELT PROJECT 2018 Nunavut Water Board Annual Report

2018 Nunavut Water Board Annual Report

Prepared by
TMAC Resources Inc.
Toronto, ON

March 2019

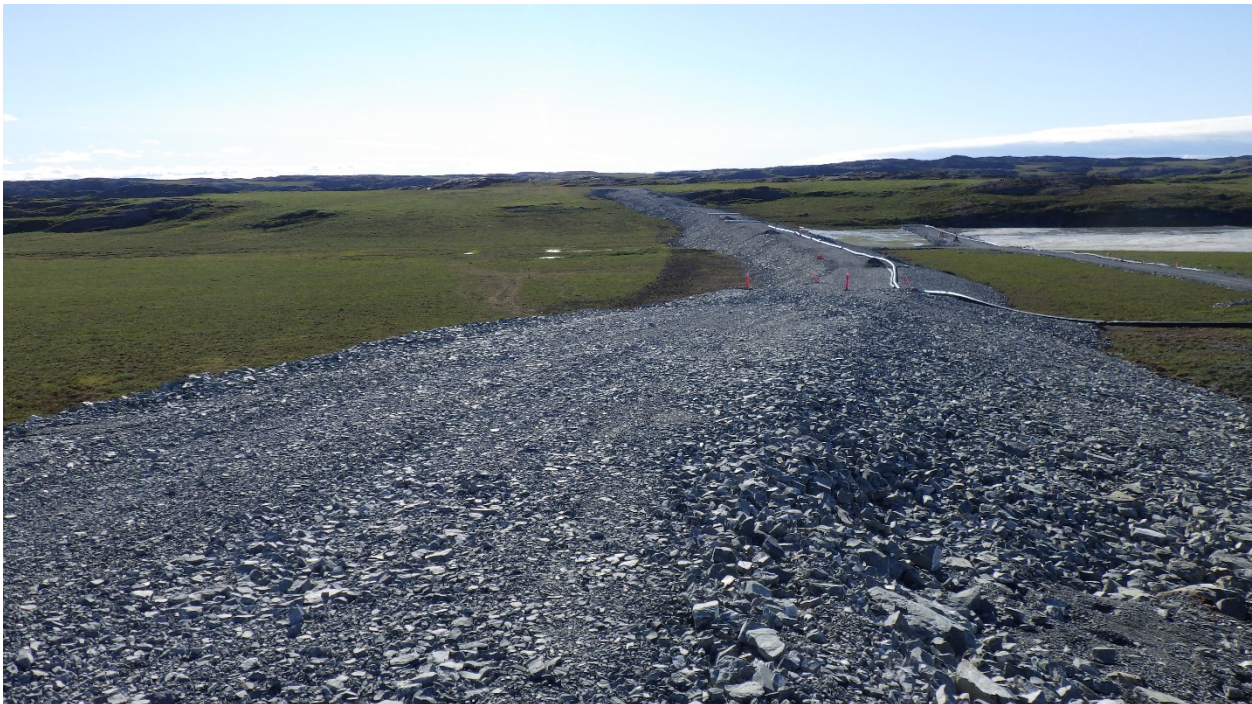
Photo: South Dam

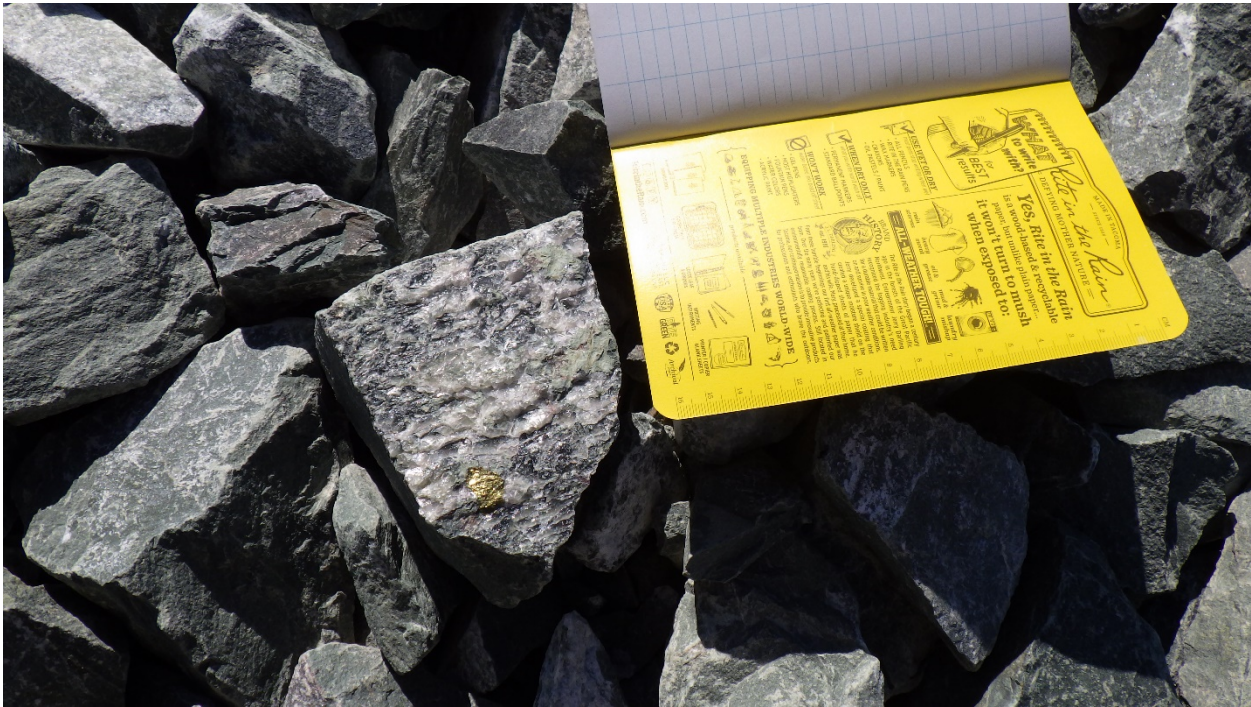
Photo: Sulphides observed at South Dam

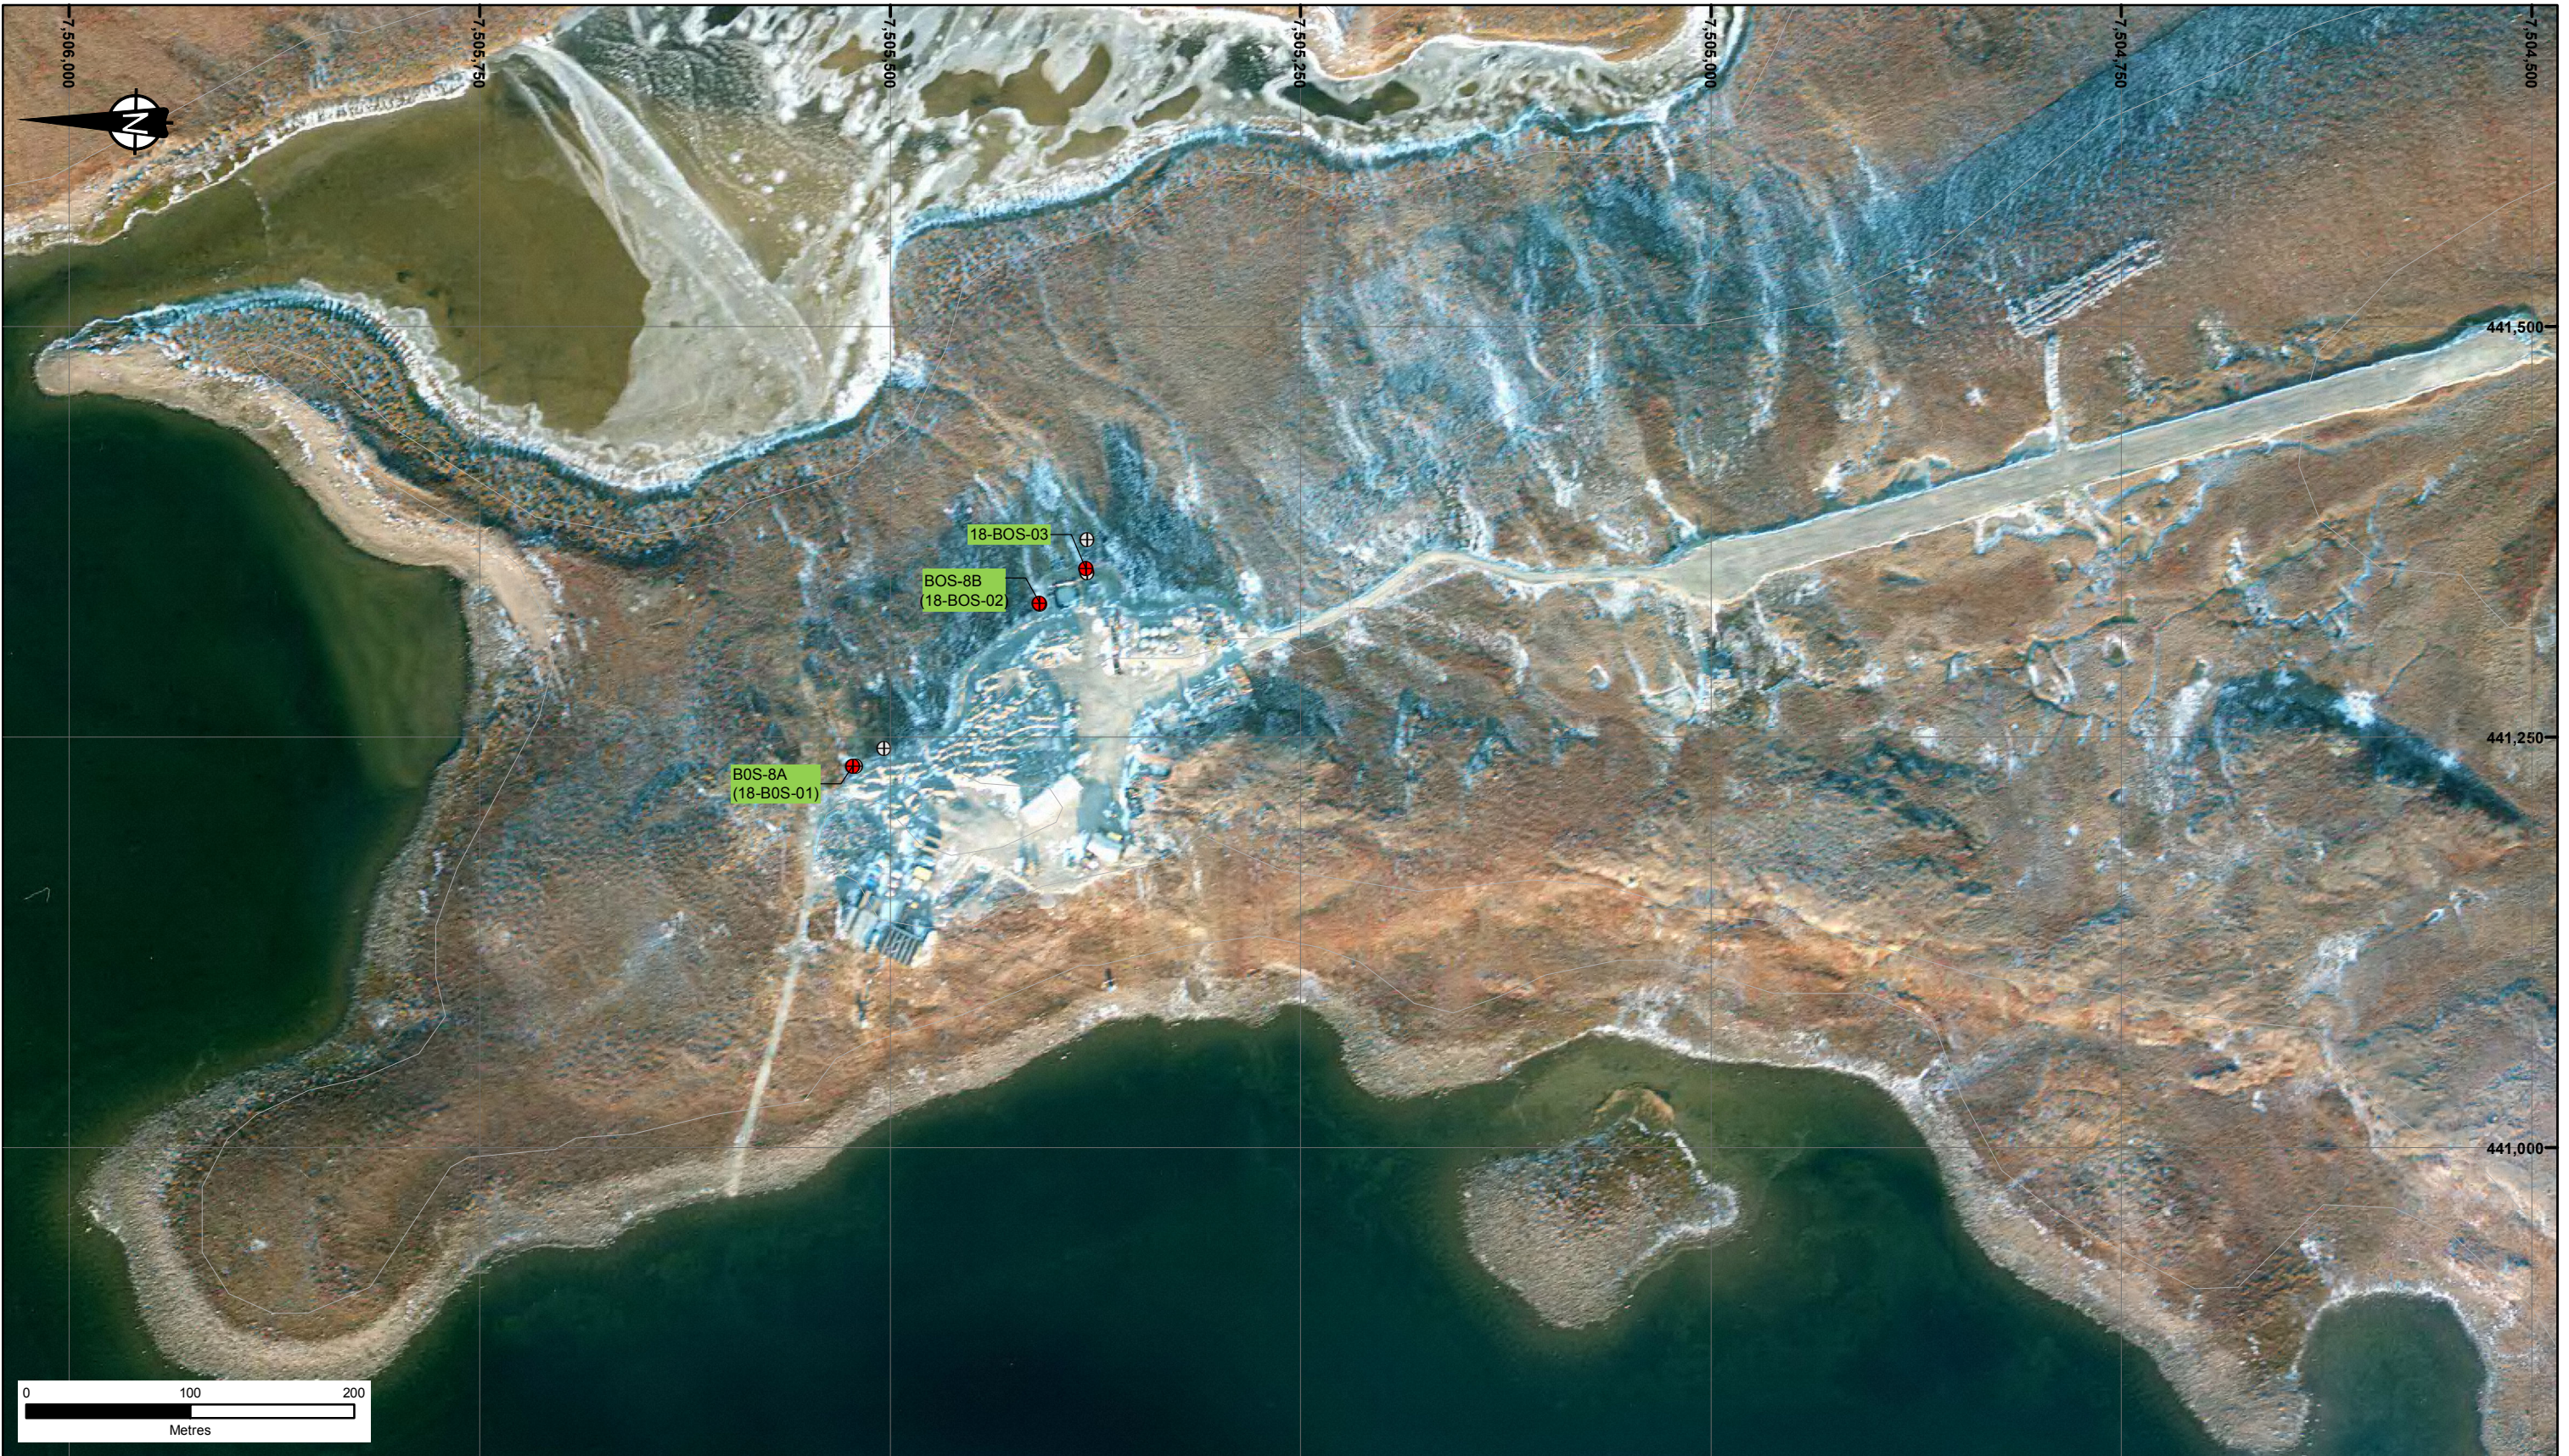
- Legend**
- 2018 Seepage
 - ⊕ 2017 Seepage

pH 6.0 to 6.9	pH 7 to 7.9	pH 8 to 8.9
EC ≤ 500 µS/cm			
500µS/cm < EC < 2000µS/cm			
EC > 2000µS/cm

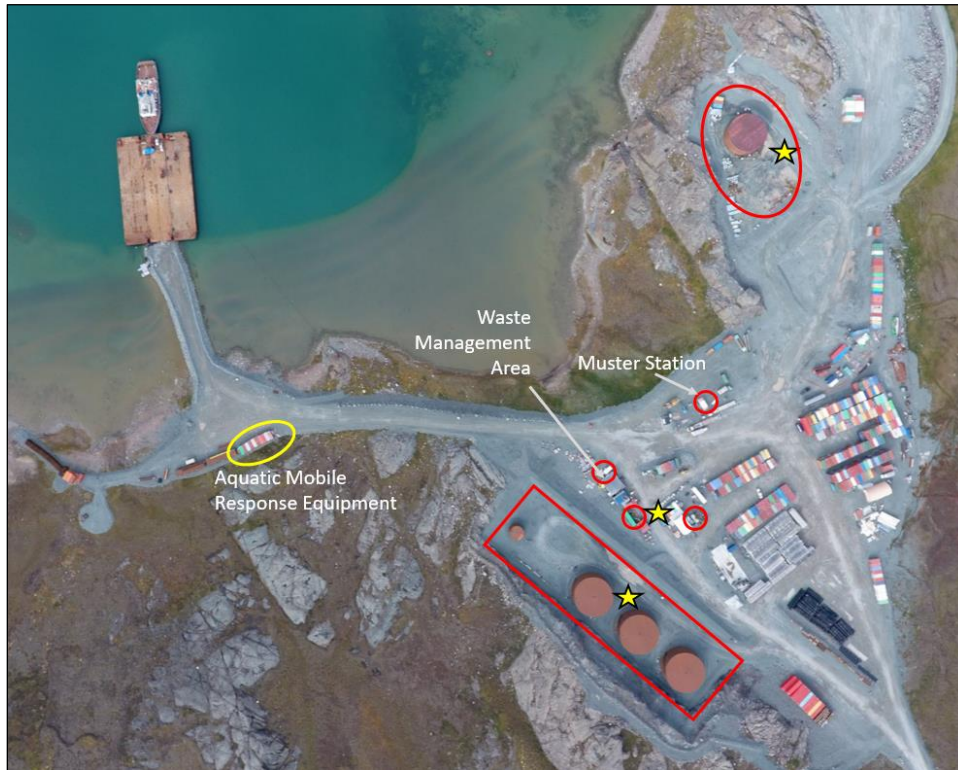
Plate A.1. Roberts Bay Laydown (Note: Red circles are fuel or chemical storage locations, smaller containment locations may vary. Yellow stars [or a yellow circle in the case of the aquatic mobile response spill equipment] indicate default spill kit locations.)

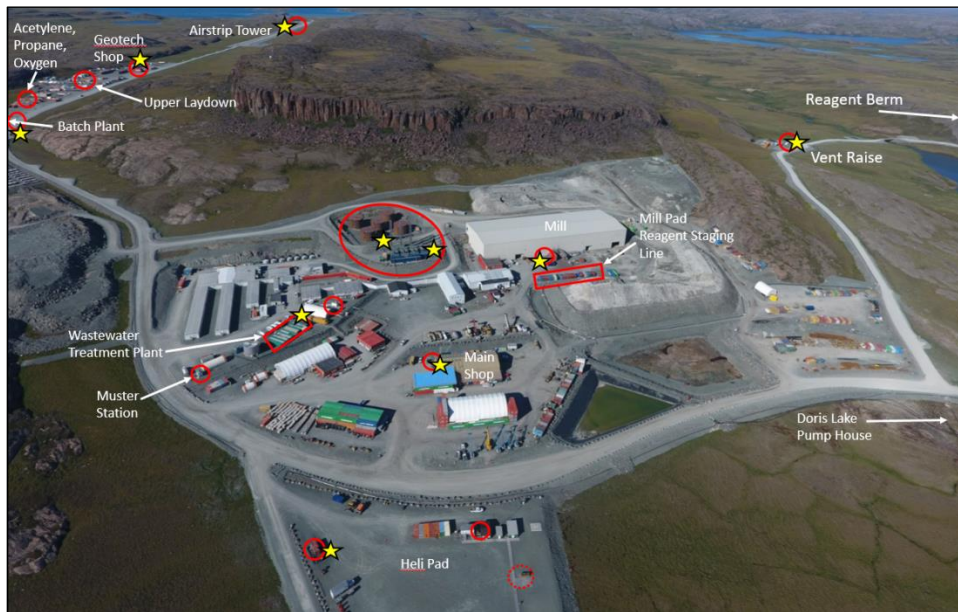
Plate A.2. Doris Camp (Note: Red circles are fuel or chemical storage locations, smaller containment locations may vary. Yellow stars indicate default spill kit locations.)

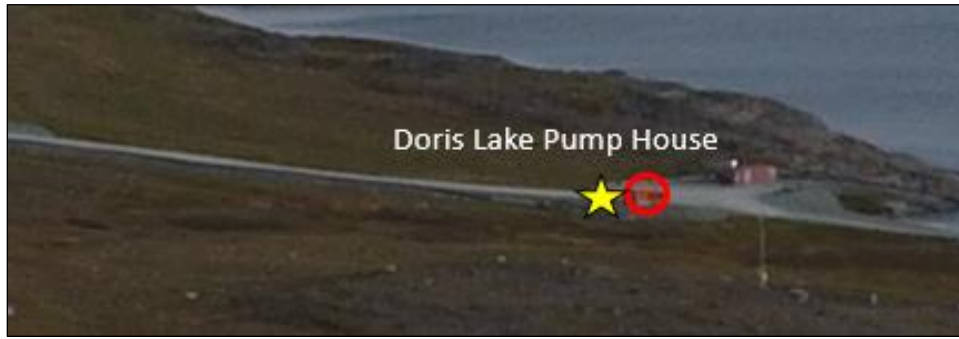
Plate A.3. Doris Lake Freshwater Pumphouse (Note: Red circles are fuel or chemical storage locations, smaller containment locations may vary. Yellow stars indicate default spill kit locations.)

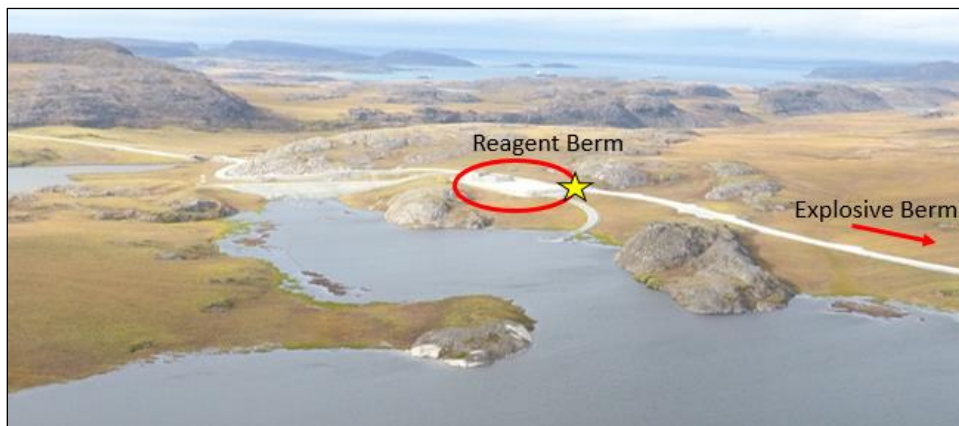
Plate A.4. Reagent Berm and Explosive Berm (Note: Red circles are fuel or chemical storage locations, smaller containment locations may vary. Yellow stars indicate default spill kit locations.)

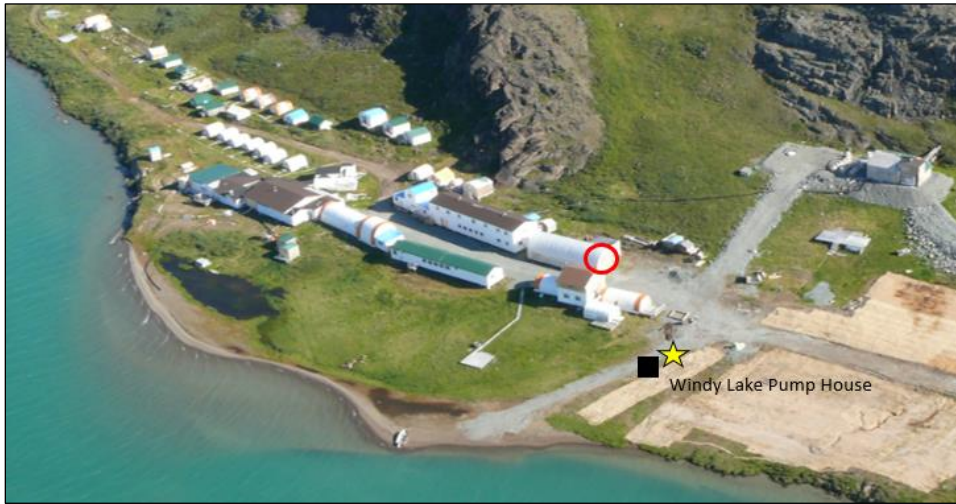
Plate B.1. Windy Camp (Note: Red circle is fuel storage location, smaller storages locations may vary. Yellow star indicates spill kit location.)

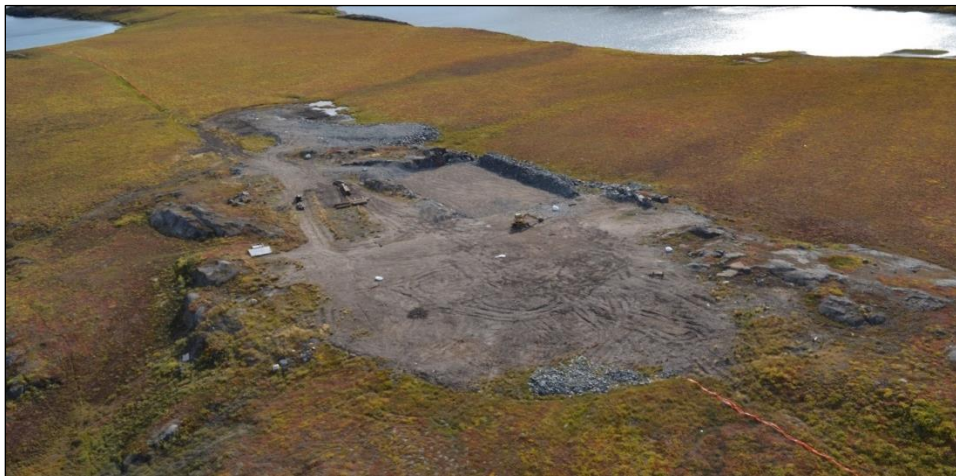
Plate B.2. Patch Laydown Facility (Note: Red circle is fuel storage location, smaller storages locations may vary. Yellow star indicates spill kit location.)

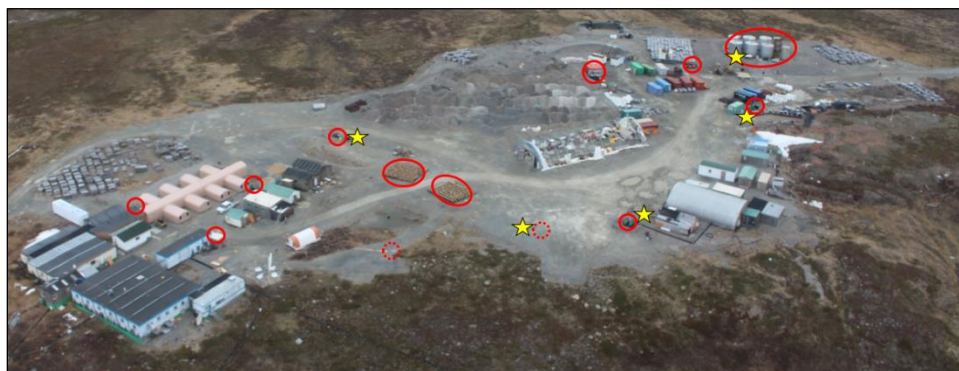
Plate D.1. Boston Camp (Note: Red circles are fuel or chemical storage locations, smaller storage locations may vary. Yellow star indicates spill kit locations.)

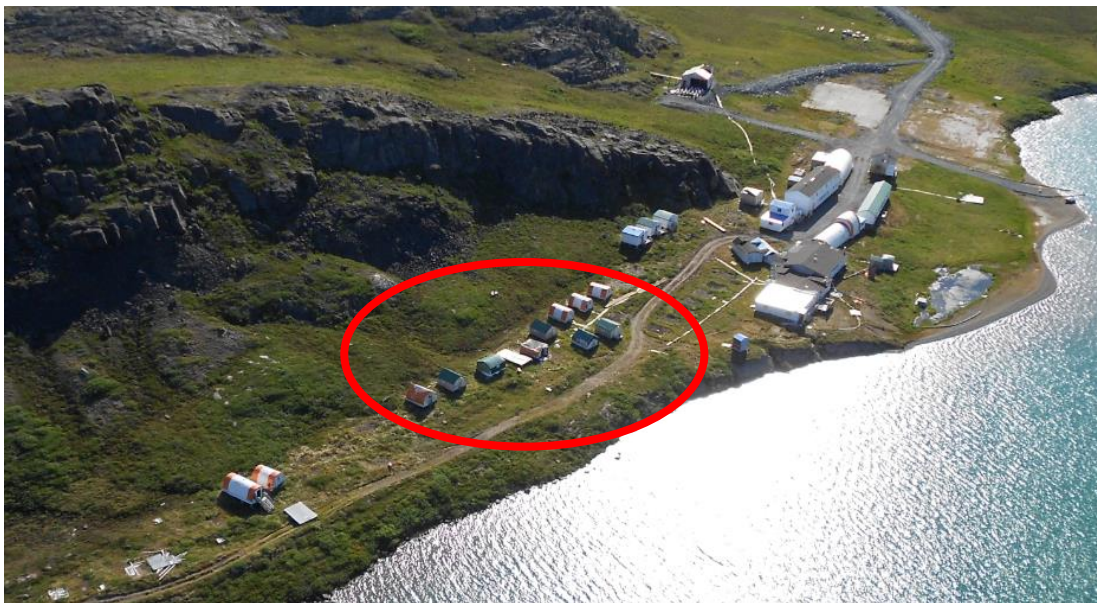
In the summer of 2018, TMAC Resource Inc's (TMAC) Environmental Affairs personnel completed reclamation activities at the Windy Camp property. The focus was to dismantle the Weather Haven tents and wood framed cabins at the north end of the camp (see Figure 2-1).

Figure 2-1: 2013 Aerial Photo with 2018 Reclamation Area Circled in Red

The 10 cabins and one (1) cabin foundation shown in Figure 2-1 were taken down in 2018.

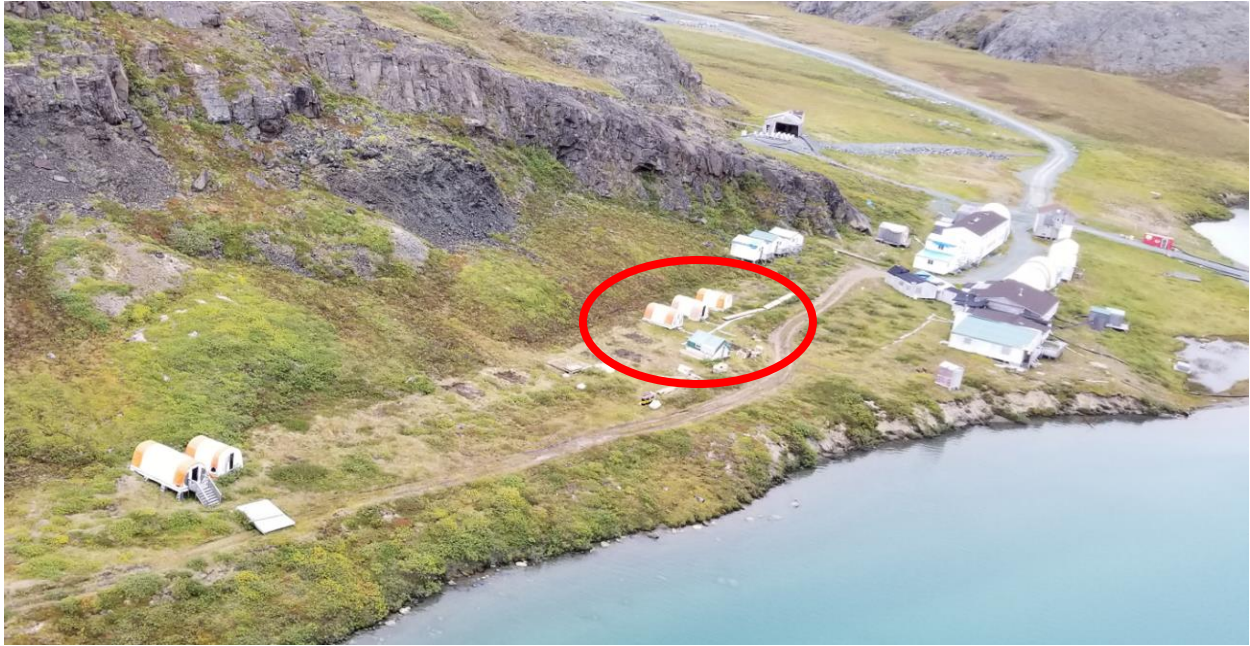
Figure 3-1 shows an aerial view of the reclamation in progress on August 26, 2018. Additional reclamation work was completed in early September and the cabins circled in red in Figure 3-1 were also dismantled in 2018.

Figure 3-1: Aerial Photo August 26, 2018. Windy Reclamation in Progress, Cabins Circled in Red Removed in September 2018.
