Madrid North Contact Water Pond As-Built Report, Hope Bay Project

TMAC Resources Inc.

SRK Consulting (Canada) Inc.
1CT022.043
March 2020

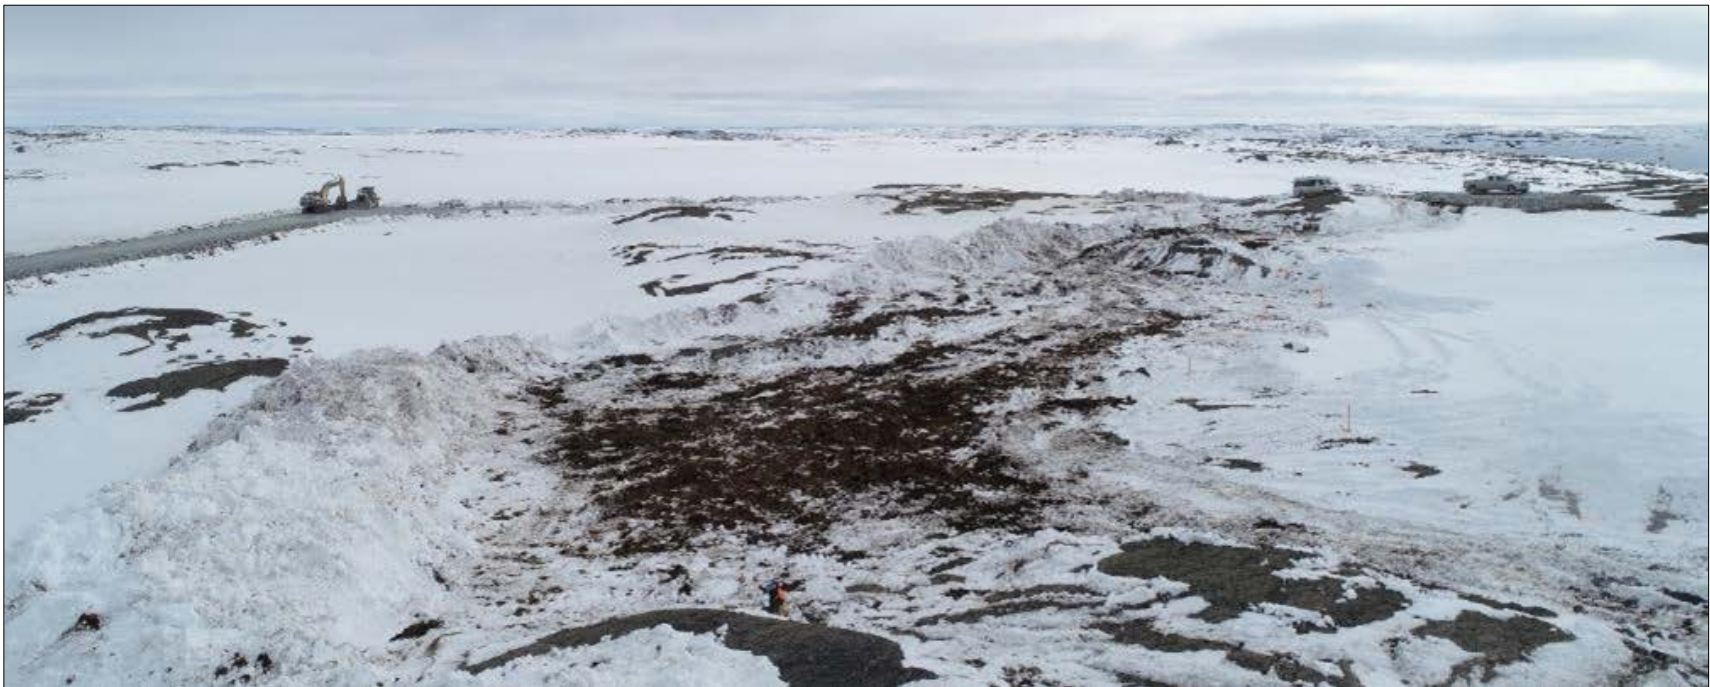
Snow clearing. Looking south from north abutment. May 27, 2019

Foundation preparation involved clearing snow from the CWP berm footprint. Snow clearing took place between May 25 to 27, 2019. Cleared snow was stockpiled at the downstream toe outside of the berm footprint area. SRK was not on site to observe the main clearing activities but was advised by TMAC that all foundation clearing activities was completed in accordance with the technical specifications (SRK 2018).

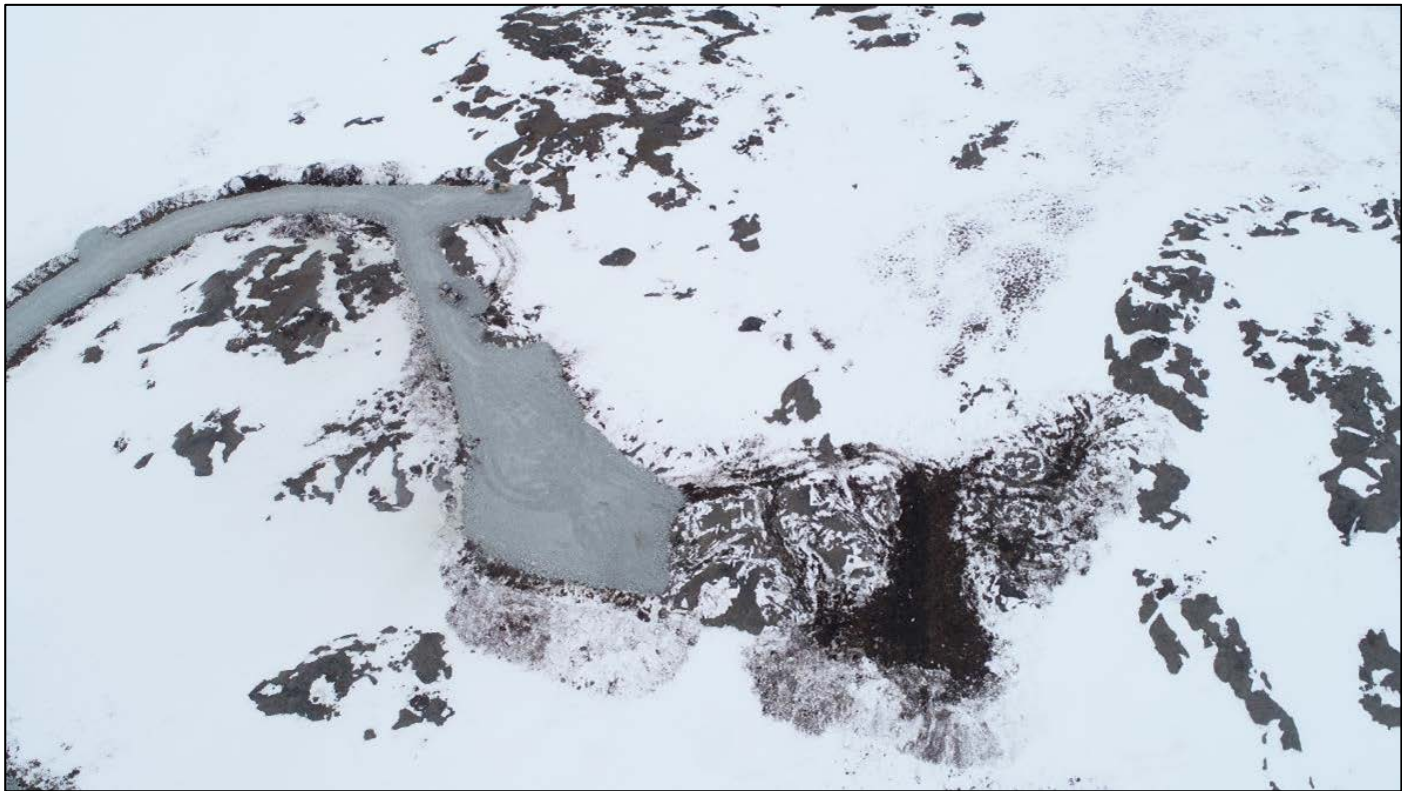
Aerial drone photo of ROQ placement. May 30, 2019
Note: Photo provided by TMAC site personnel.

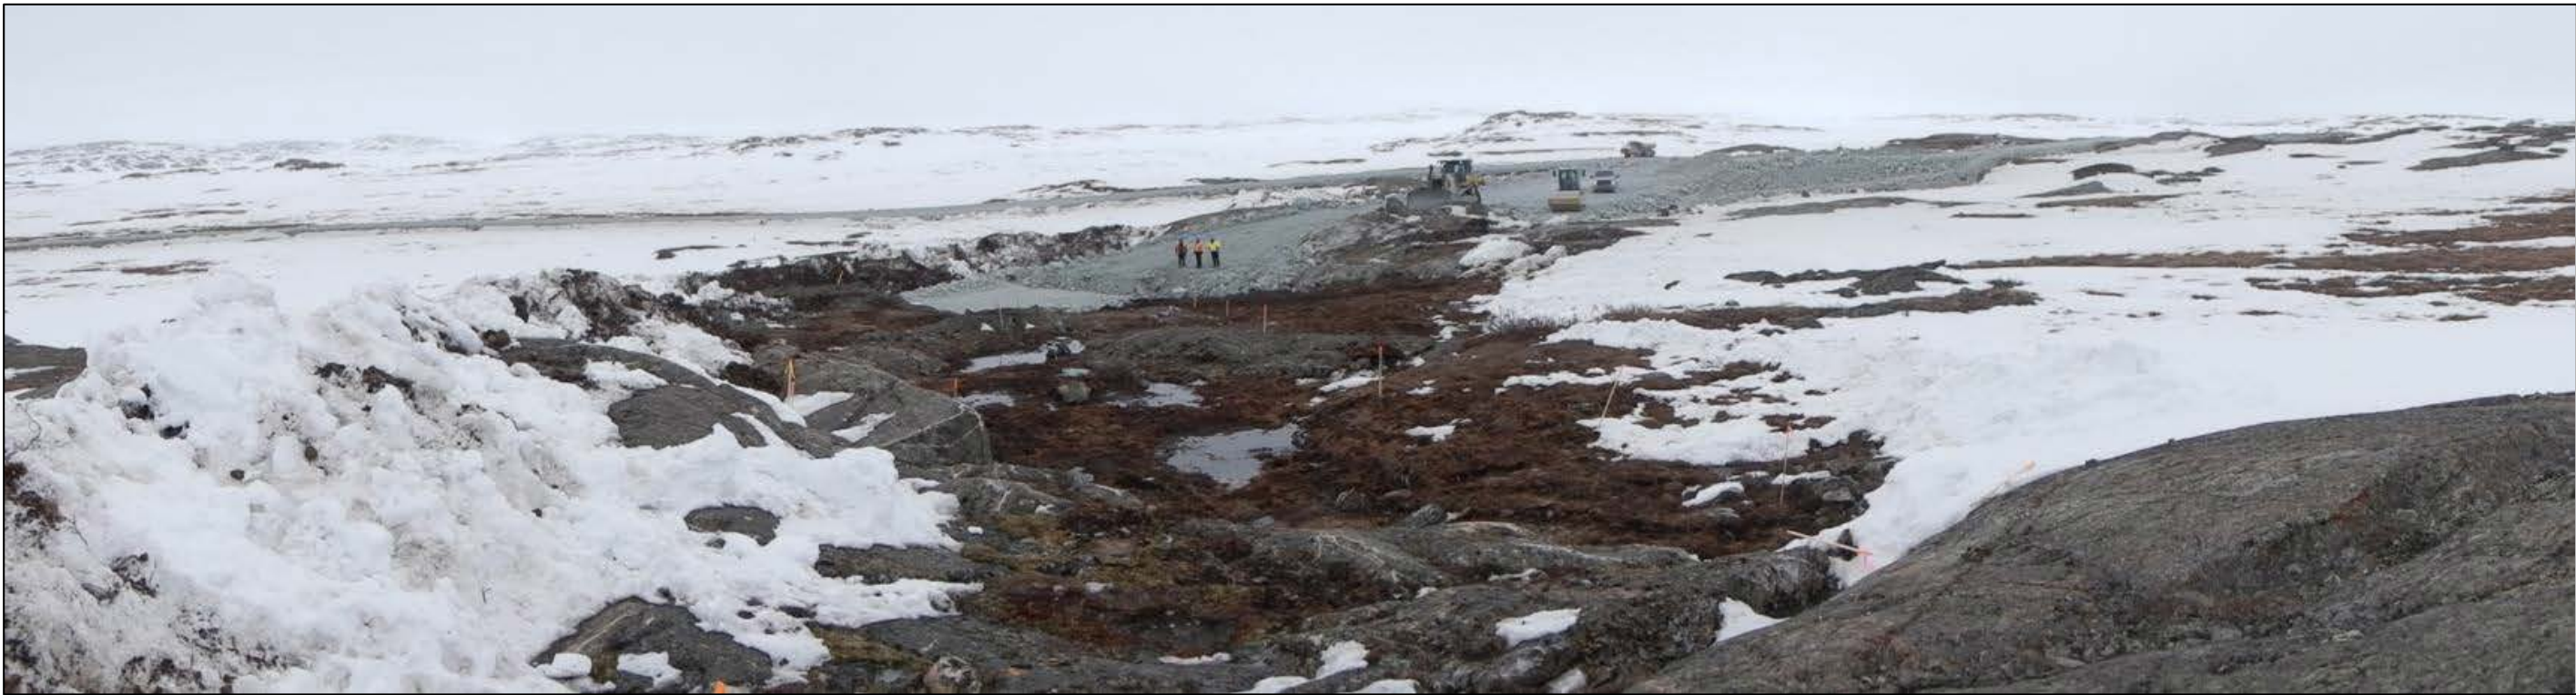
ROQ placement. June 3, 2019

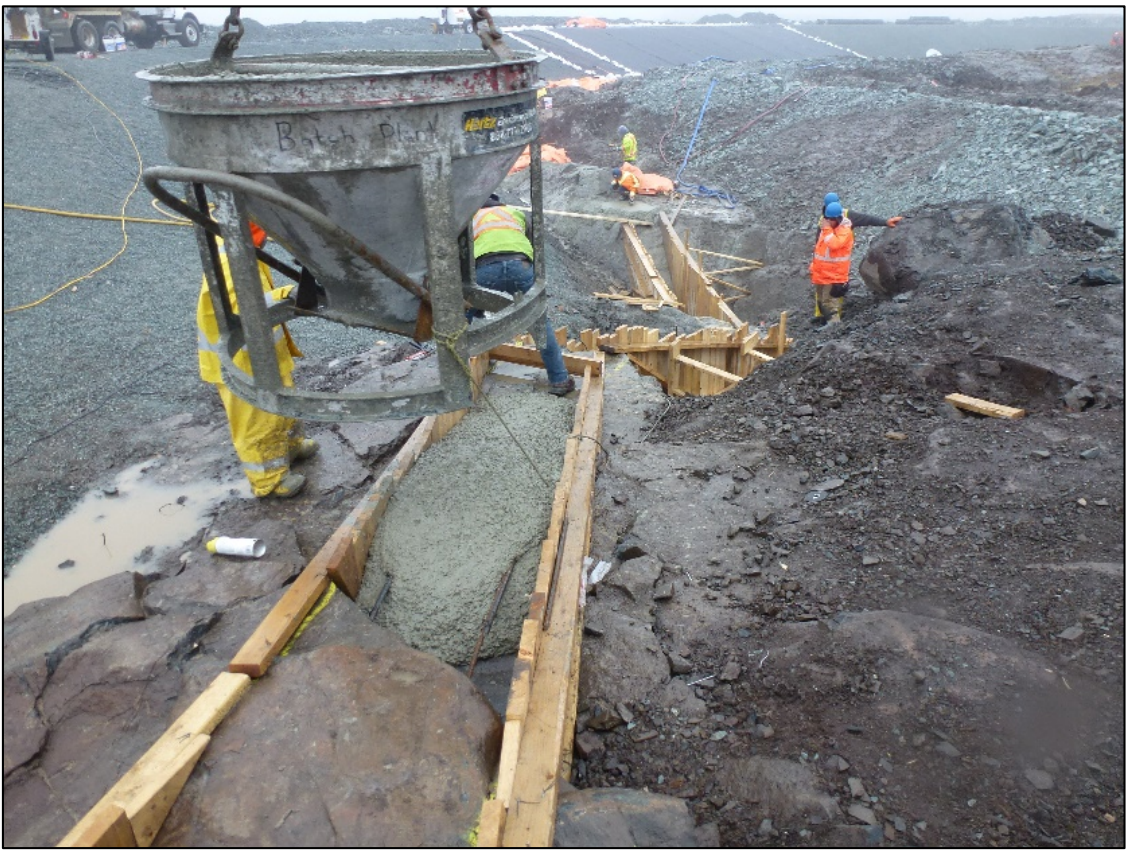
Concrete casting plinth 6 June 30, 2019

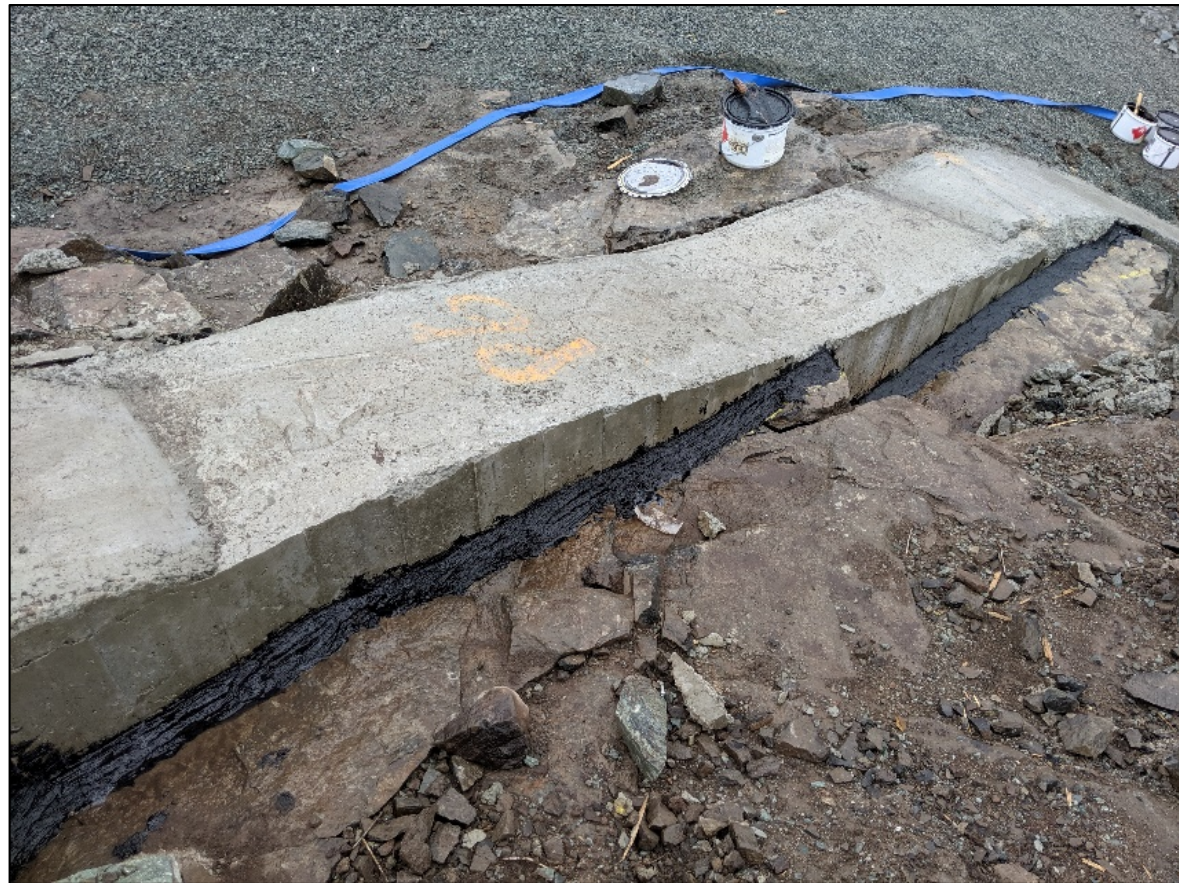
Sopramastic placed for voids plinth 6 July 16, 2019

plinth formwork. This issue was not identified by the construction team prior to the concrete pours. As a result, after removing the plinth formwork, a number of plinths were identified to have small voids at their base and an inadequate concrete to bedrock seal. Voids were identified by performing leak detection testing. This testing was done by pumping water from one side of the plinth and observing if the water level on the other side also dropped. If the water levels on both sides of the plinth decreased at the same time, this indicated the two sides were hydraulically connected and the presence of a void existed. Coloured food dye was also used in some of the leak tests to assist with visual observations. All leak detection testing for the concrete plinths was performed under supervision of the SRK Site Engineer.

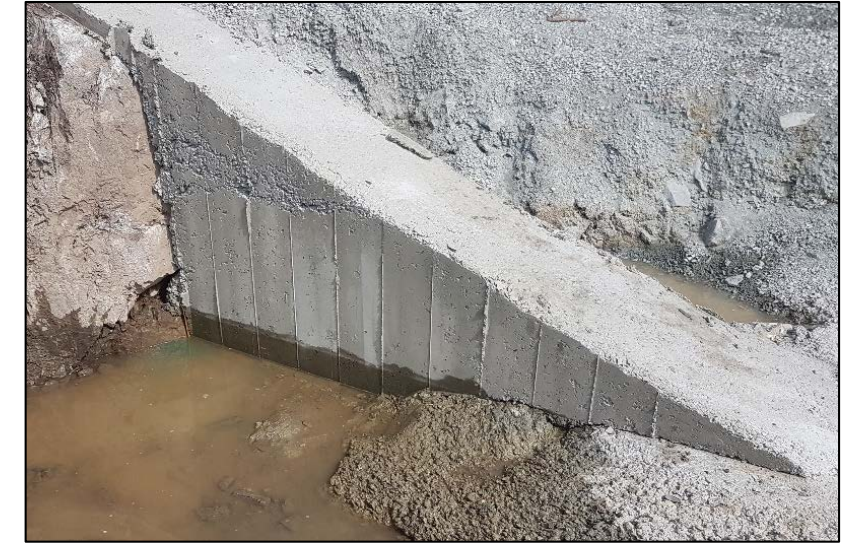
Formwork removed leak testing plinth 8. July 4, 2019

Prior to the concrete plinths being poured, water had continued to flow into the open excavations and was not adequately managed during the concrete pour. This is thought to have resulted in loose sediment on the sides sloughing into the base of the excavation and into the base of the

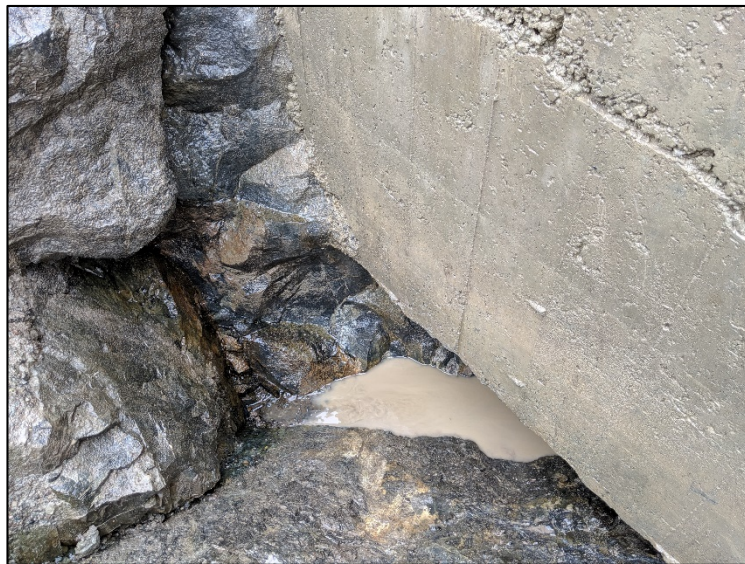
Void exposed plinth 8. July 13, 2019

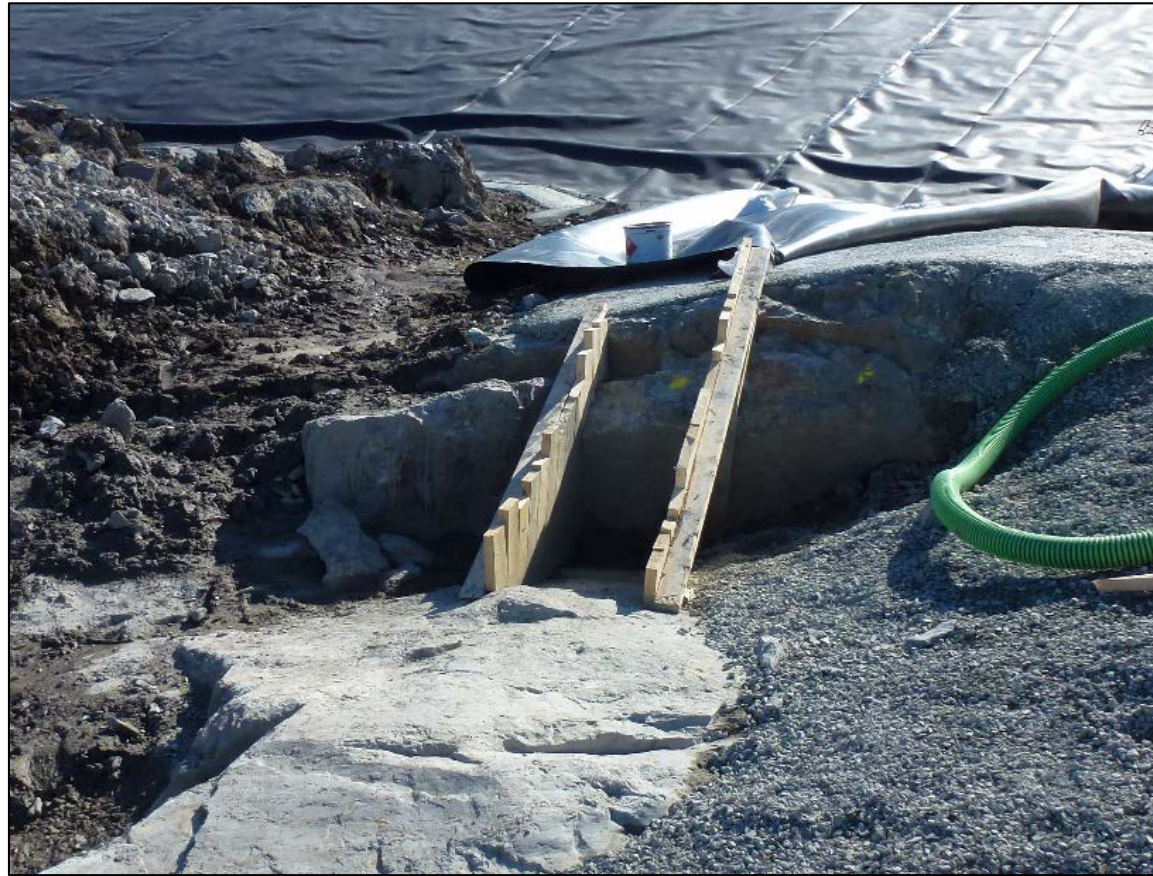
Contact rock cleaned and formwork placed plinth 9. July 2, 2019

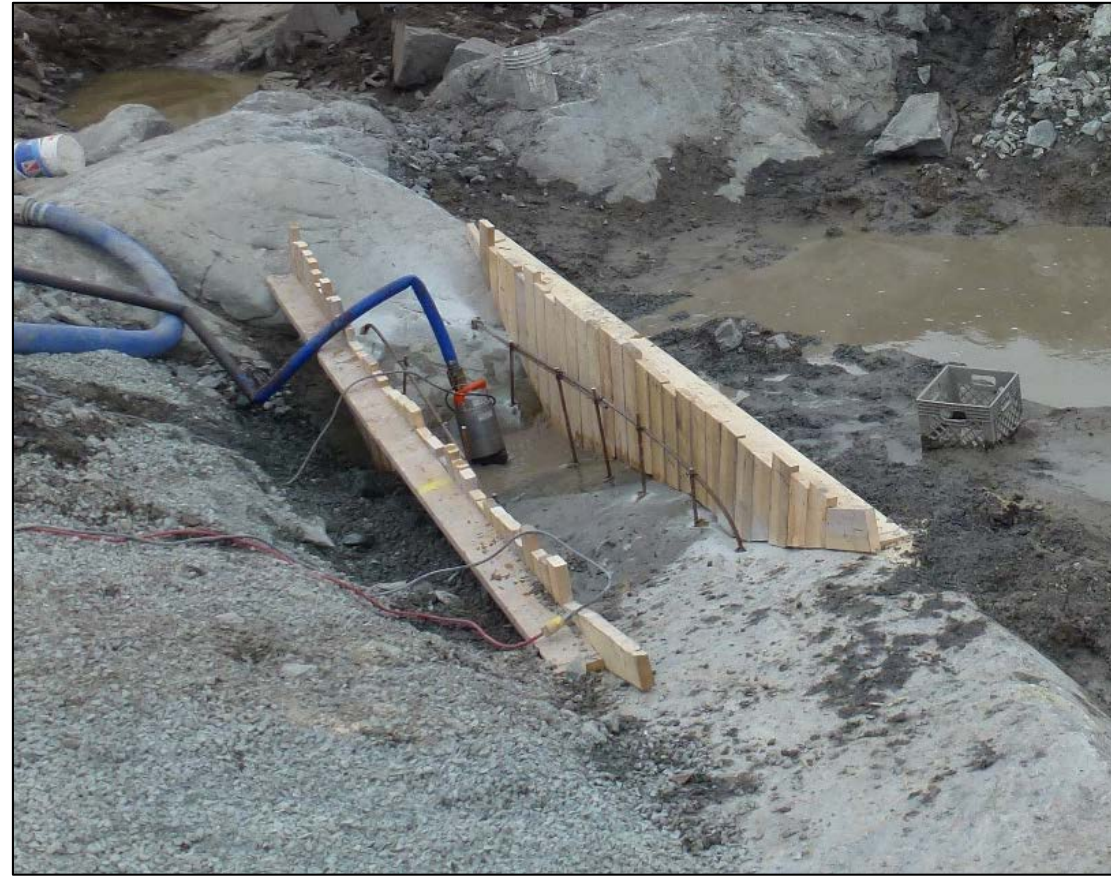
Contact rock cleaned and formwork placed plinth 10. July 2, 2019

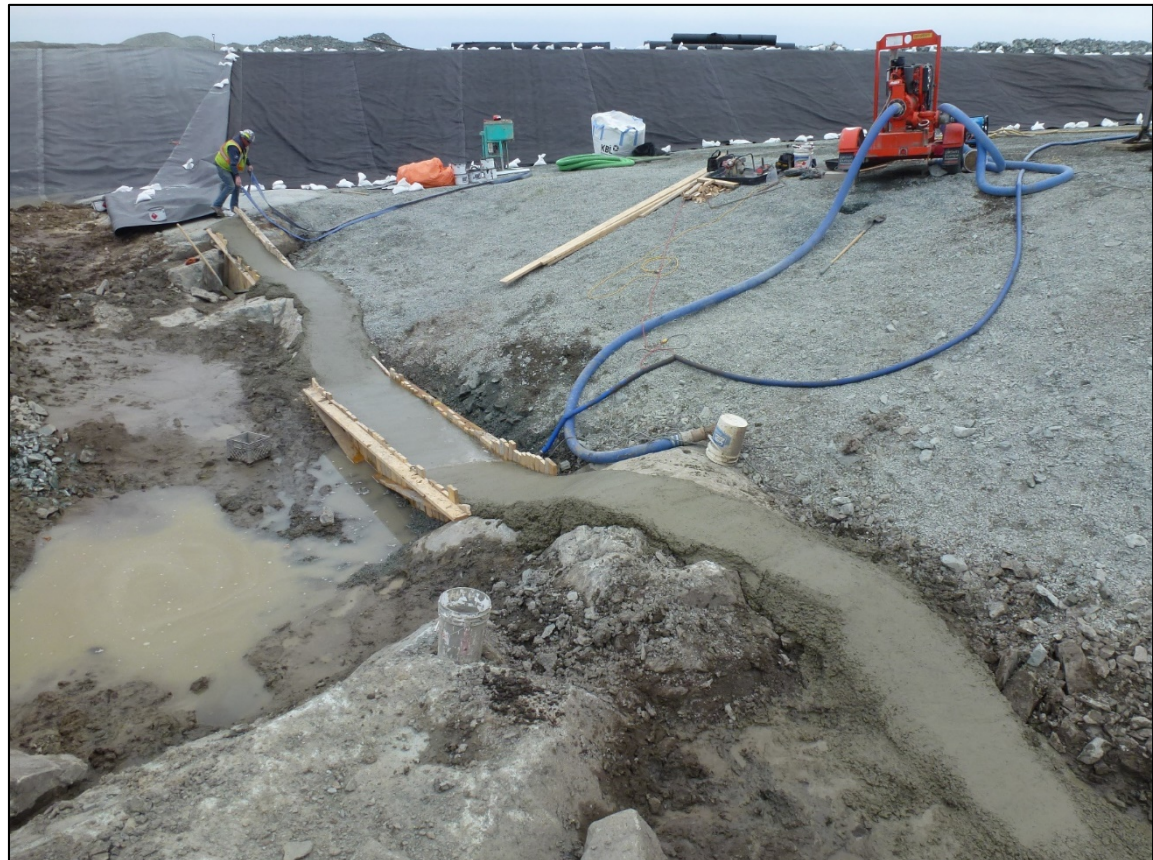
Plinth 9 and 10 cast July 2, 2019

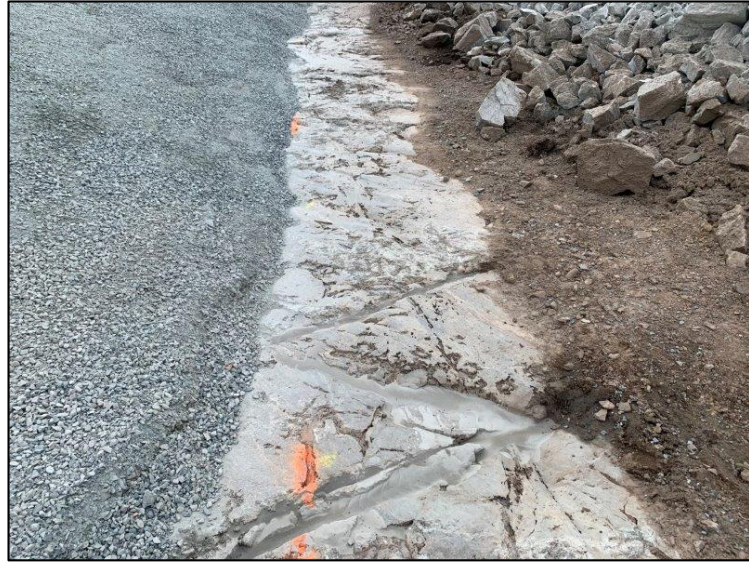
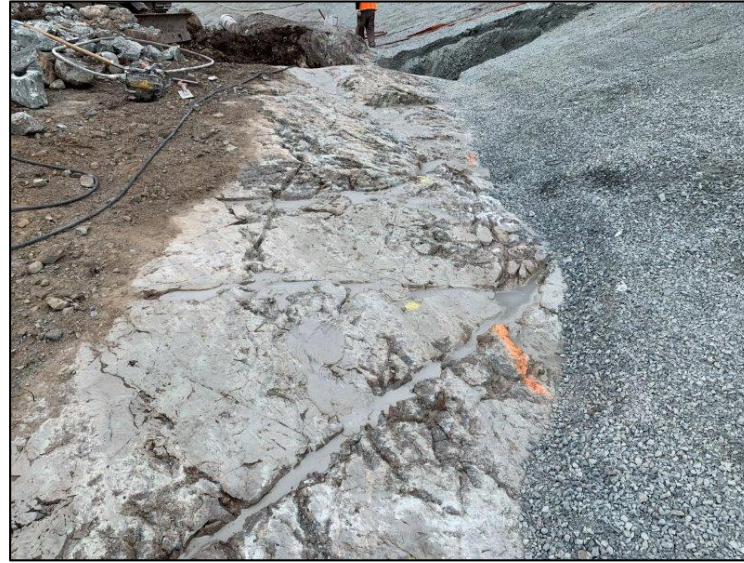
Grouting cracks. June 24, 2019

Multicrete Sub Zero Grout (manufactured by Multicrete in 20 kg bags) was used for filling deeper cracks in the bedrock beneath the liner tie-in point. Sikaset Plug mortar (manufactured by Sika in 1 kg bags) was used to repair small voids beneath the concrete plinths identified during leak testing. Both grout and mortar were mixed by hand in buckets by Nahanni using water and electric hand mixing tools. Only visual QA/QC was performed for these materials.

Once bedrock was exposed at the liner tie-in, it was cleaned of remaining overburden and loose material with manual labour. Air compressors and other hand tools were used to clean the tie-in surface. Areas of naturally fractured bedrock were scaled back using the 308 excavator to remove loose rock. Areas of fractured rock were also grouted with Multicrete Sub Zero Grout prior to dental concrete and liner tie-in. Generally the bedrock was found to be competent rock with minimal or fairly discrete fractured zones.

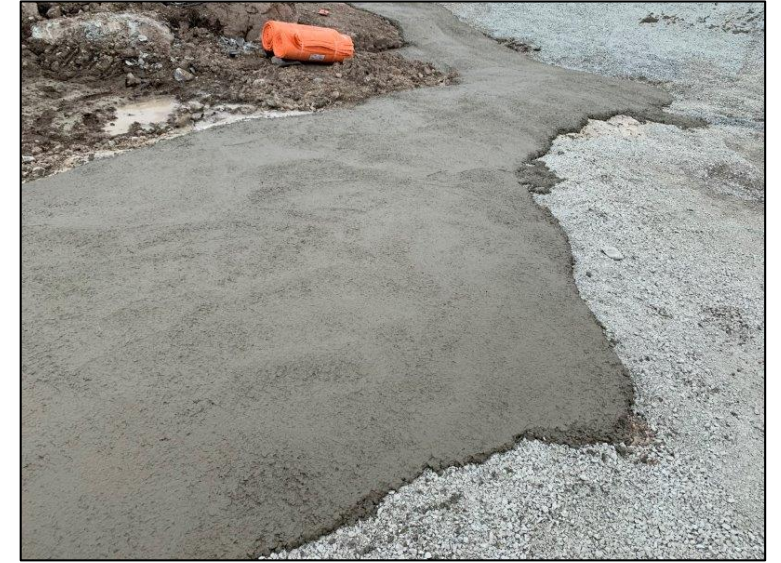
Concrete liner tie-in 0+050 to 0+100. June 24, 2019

Concrete placement (pours) included both dental concrete and concrete placement for plinths. Where the bedrock was relatively smooth, with minor irregularities, a layer of dental concrete approximately 5 to 10 cm thick was placed to provide a smooth, uniform surface for the liner tie-in. Where bedrock was found to be undulating and/or with steep (near vertical) sides, concrete plinths were constructed to bridge across the undulations or to provide smoother transitions for the steeper bedrock. The liner was then bolted directly into the top of the concrete plinth and sealed.

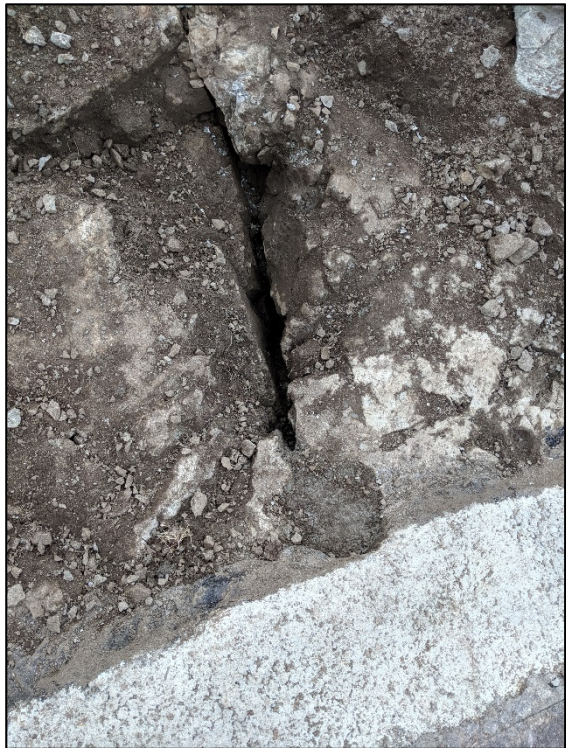
Crack/void identified. July 14, 2019

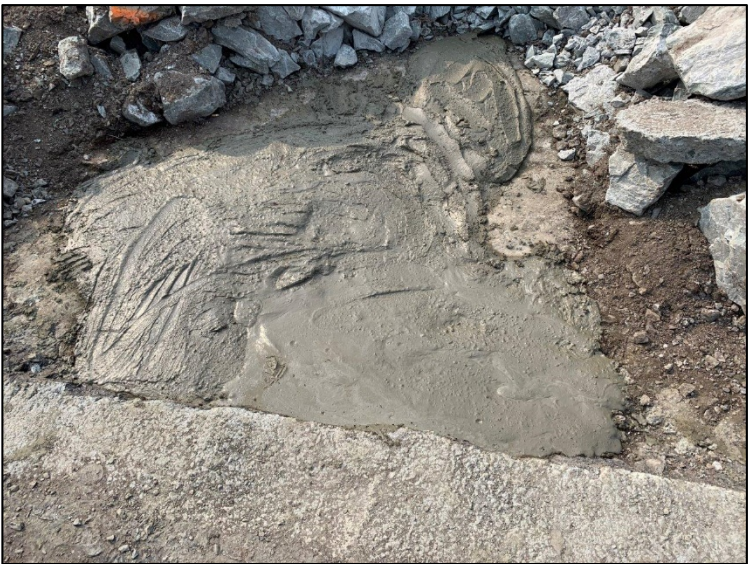
Crack/void grouted. July 25, 2019

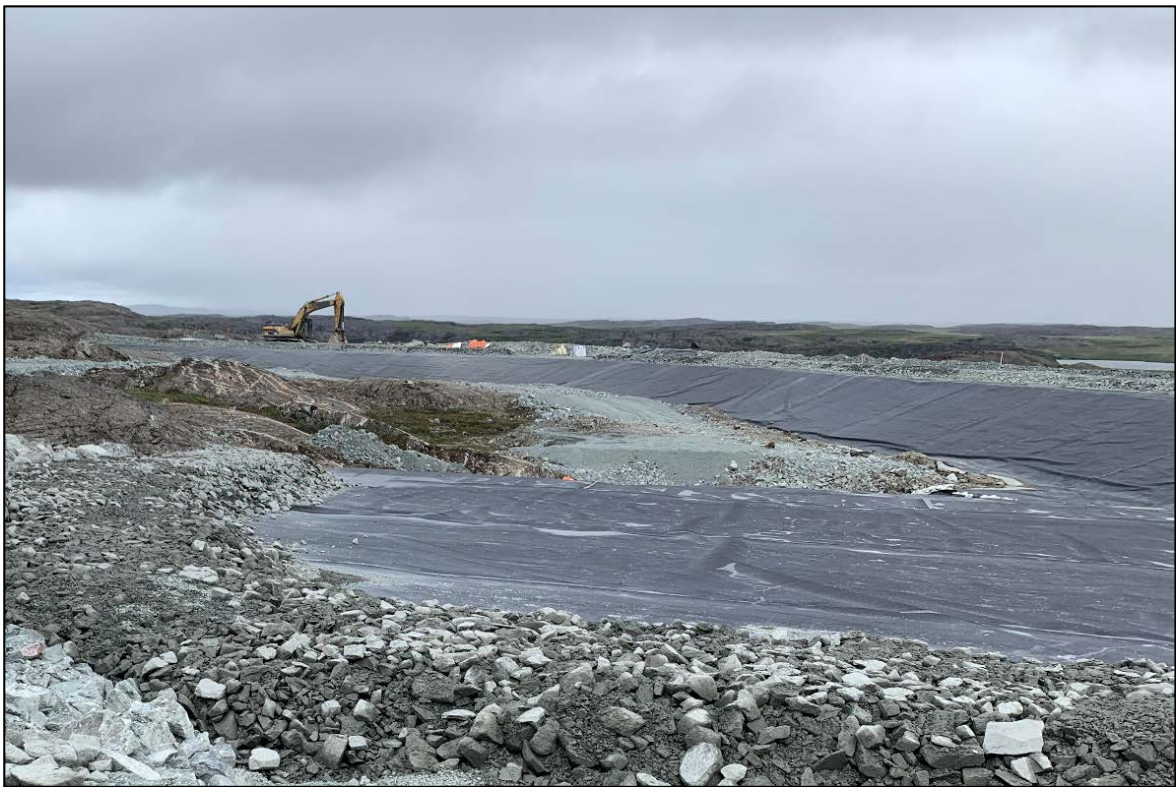
Liner anchor material 0+000 to 0+225. July 28, 2019

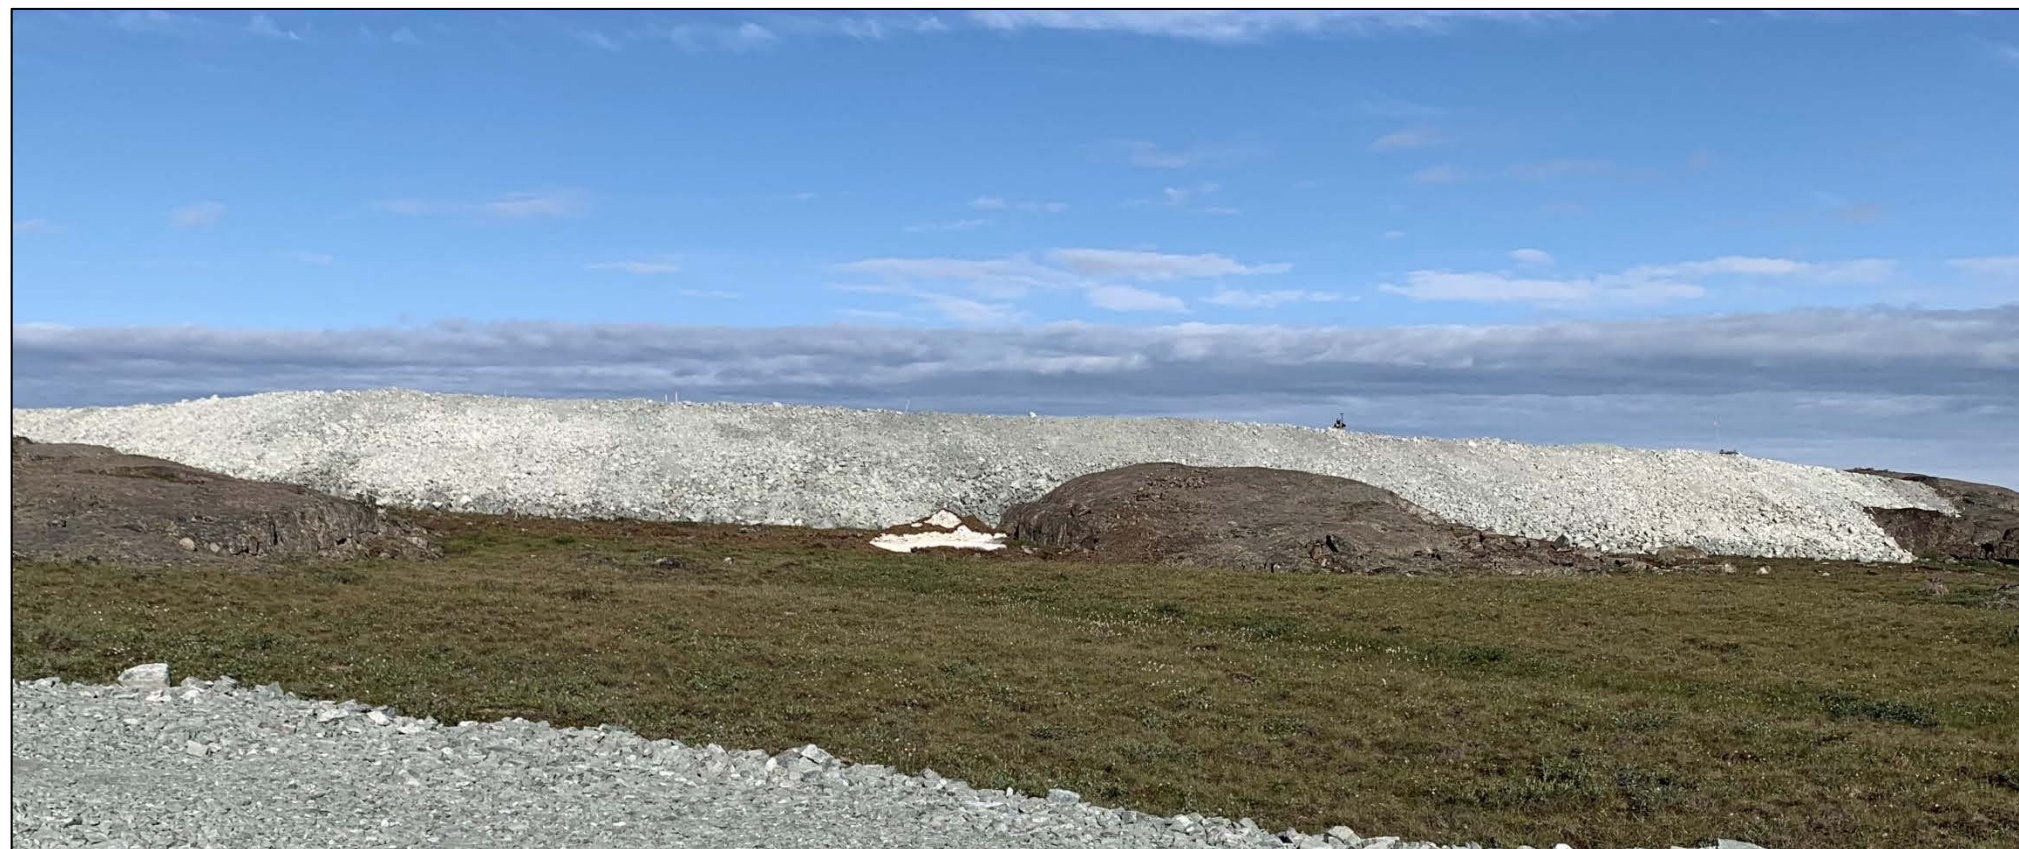
Downstream slope final shaping. July 28, 2019

After completion of earthworks and liner installation, the final CWP layout was surveyed by Sub-Arctic. SRK reviewed the as-built survey and identified that the downstream slopes were steeper than design slope of 2H:1V. The oversteepened slopes were also noted at various times during the ongoing QA checks by SRK whilst on site. The outside as-built slopes were typically between 1.7H:1V to 1.9H:1V, but some sections were as steep as 1.65H:1V. SRK instructed TMAC to place additional fill or regrade the slopes to achieve the design slope of 2H:1V. Instead, TMAC requested SRK to complete a stability analysis to determine if the steeper than design slopes were stable in the current arrangement to meet the minimum required factors of safety.

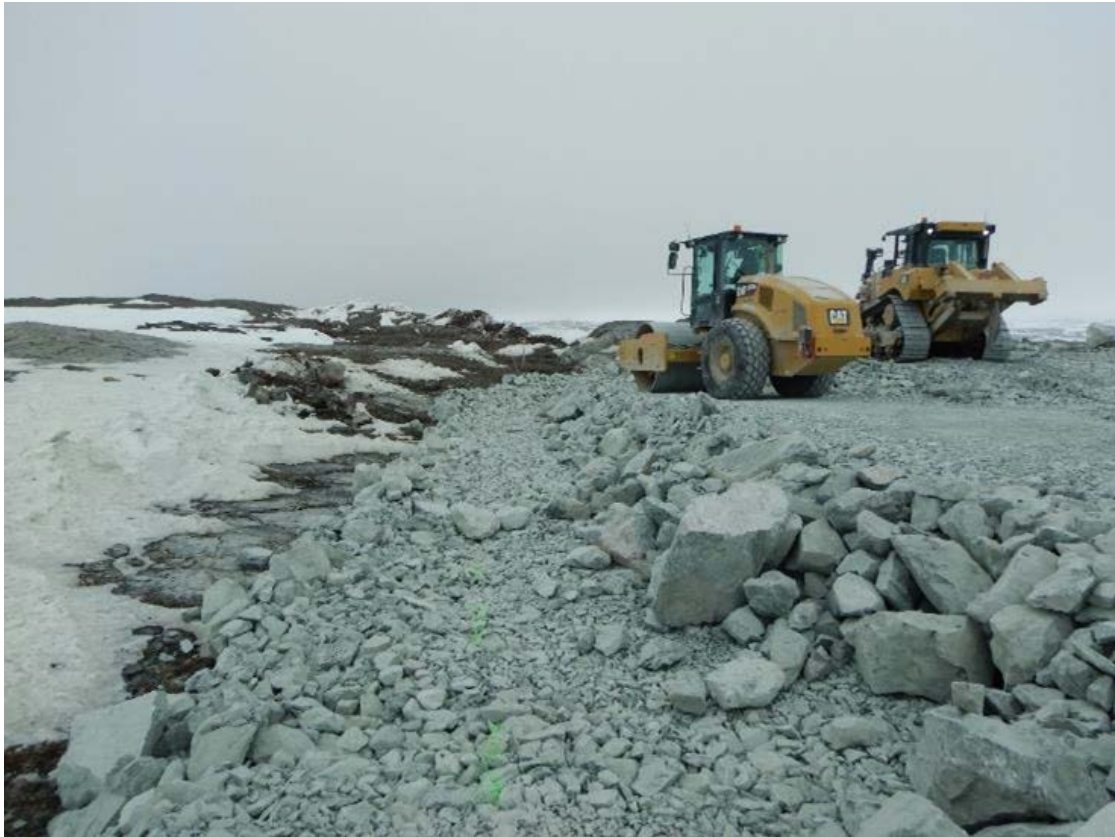
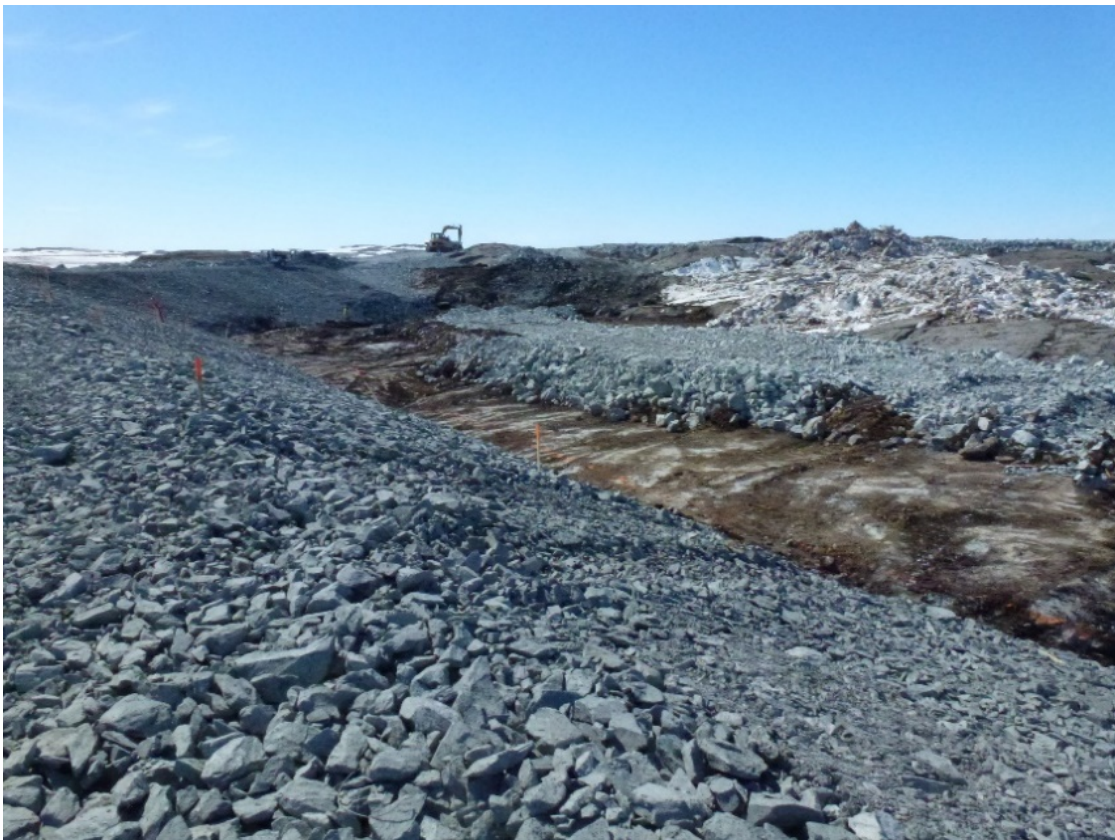
Scenario 3
Overburden Fully
Thawed

— Lower-Strength Rockfill Bound

Madrid CWP – As Built Slope Stability		
		Slope Regrading July 2019		
Job No: 1CT022.43 Filename: CWP_Stability_Figures.pptx	Hope Bay Project	Date: November 2019	Approved: RW	Figure: 5

SRK completed a stability analysis to assess the risk of geotechnical instability of the CWP berm in its as-built condition. The results of the analysis indicate that the berm is stable and meets minimum factors of safety (FoS), provided the overburden in the foundation remains frozen, or as a minimum, doesn't thaw beyond the average active layer thickness in this area (typically around 1 m). If the overburden completely thaws, the FoS may reduce below the criteria of 1.5 but this doesn't mean that immediate failure is expected. Therefore, the risk of failure is low. Additionally, if a failure were to occur it would be slow and progressive rather than rapid, i.e. there would be sufficient warning provided adequate monitoring is in place.
