Amaruq Exploration Project

Waste Water Treatment Plant

Situation Report

July 30, 2015

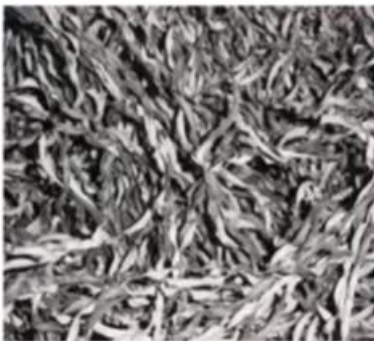
Figure 1: Media

In May, Agnico Eagle installed two (2) Kodiak Bionest systems to treat the waste water produced by the Amaruq camp. The Kodiak Bionest system is an advanced generation of onsite wastewater treatment systems. The biological process is a submerged fixed-film reactor. The biomass develops and firmly attaches itself to both sides of the “ribbon-shaped” plastic media (see Figure 1). It provides a huge surface area for bacterial growth, providing the reactor with an outstanding performance and resistance to hydraulic shocking. Constant aeration of the first 2/3 of the reactor with warm air from the mechanical room assures constant and optimal biological activity, independently of the outdoor weather conditions. Linear air diffusers (Figure 3) connected to a series of diaphragm air pumps (Figure 2) are used for aeration.

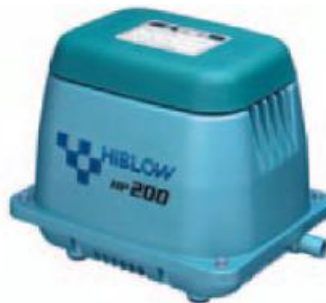
Figure 2: Diaphragm air pump

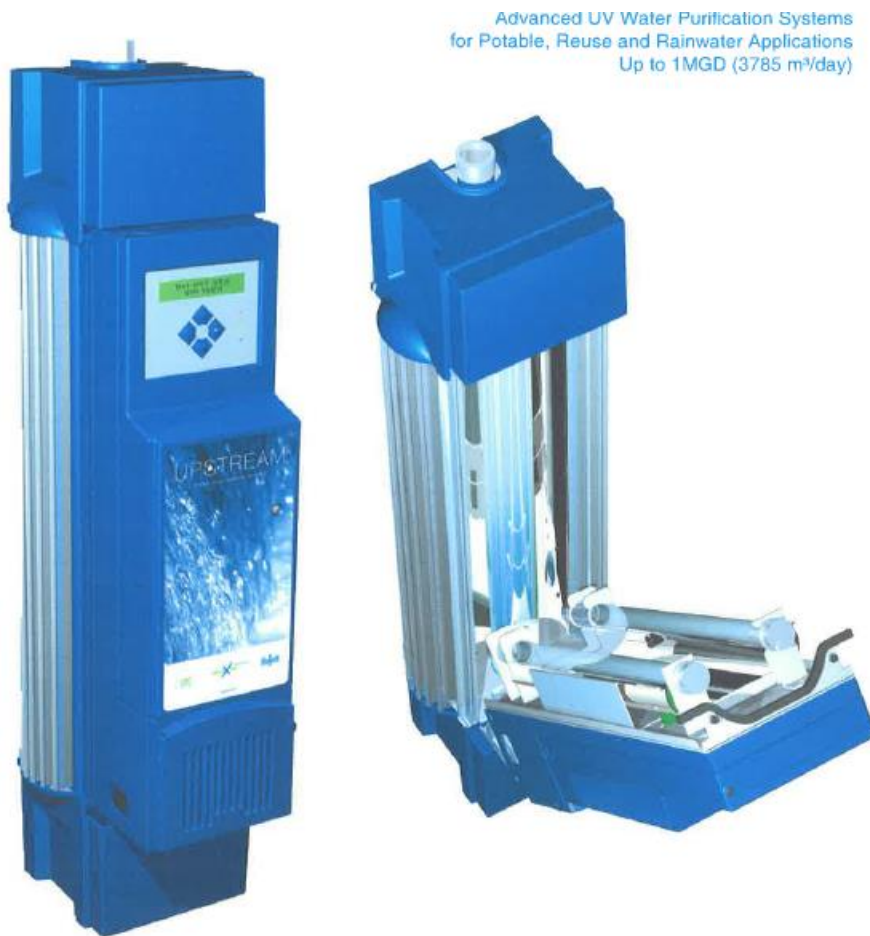
Figure 5: Upstream UV System

On July 28<sup>th</sup>, two (2) x 10 micron bag filter housings were ordered to install a polishing system for the effluent (Figure 4). A UV system designed to provide a more efficient disinfection was also ordered (Figure 5). This addition is over design because the Bionests are designed to achieve the quality needed in order to respect the water licence, but with this addition, Agnico Eagle will be more confident to have constant quality.

During the week of August 3<sup>rd</sup>, the additional disinfection UV and the polishing filter systems will be delivered to the Amaruq site. These additional systems are expected to be commissioned by August 14<sup>th</sup>.

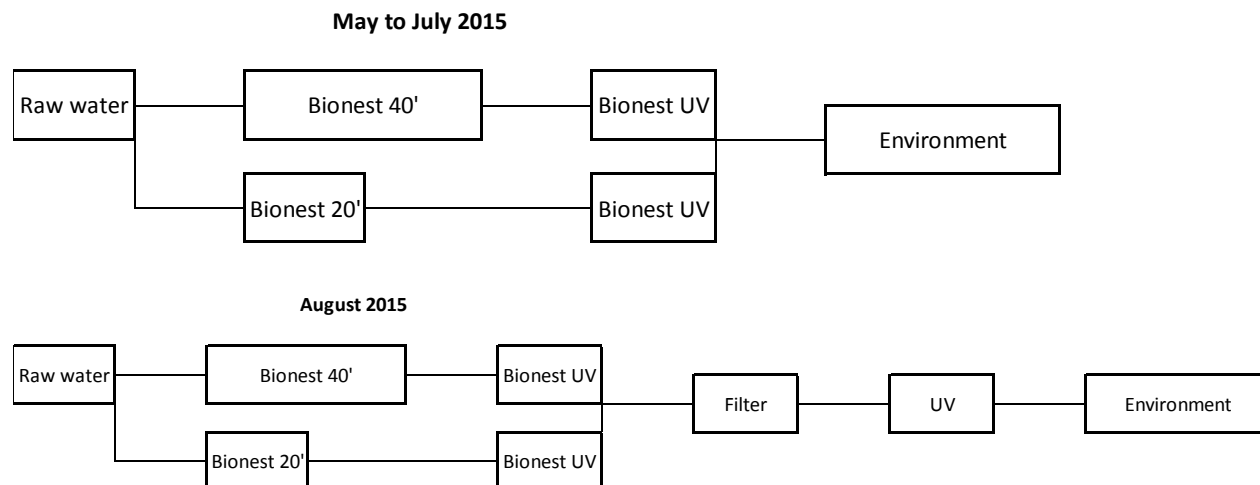
These flowsheets show the modifications that will be applied to the Waste Water Treatment Plan in August.

A 10 micron polishing filter system will be added after the Bionest treatment. This filtered water will then pass through a supplementary UV disinfection system before being released into the environment.

Figure 6: Flowsheets
