Re: Water License 2AM-MEA0813 AEM Response to 2009 Inspection Report

Subject: Action plan for Gray Water at the exploration camp

Memorandum: Forward camp contaminated soil removal

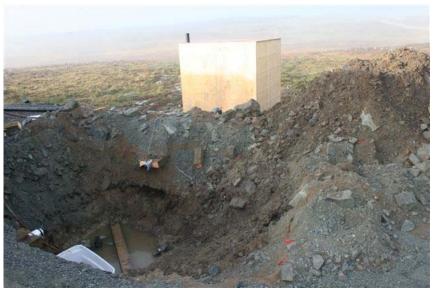
1. Construction of the new grease trap.

- 1. excavated to installed the grease trap (Pic. 1);
- 2. modified the grease trap (4' x 4'x 6') installed heat trace (Pic. 2);
- 3. Isolated the trap, foam and plywood (Pic. 3);
- 4. installation of the grease trap (Pic. 4, 5 6,7,8);
- 5. built the station in plywood around the trap and pipe to evacuate the water (Pic. 9);
- 6. installation of pump system to evacuate the water, another pump is installed as back up (Pic. 10, 11);

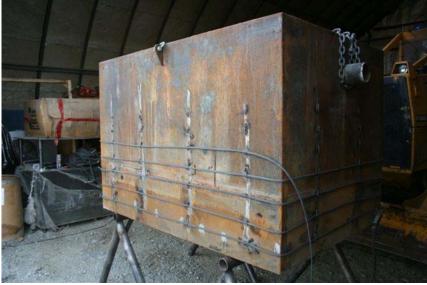
2. Grease trap with heat trace.

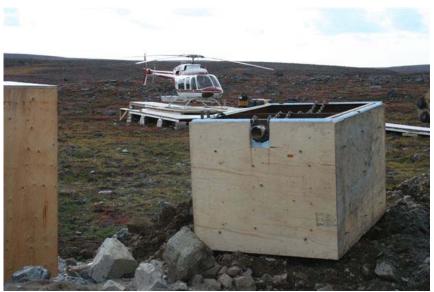
3. Grease trap before the installation; isolated 4' x 4' x 6'.

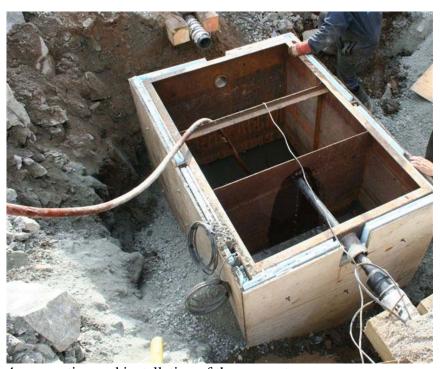
4. excavation and installation of the grease trap

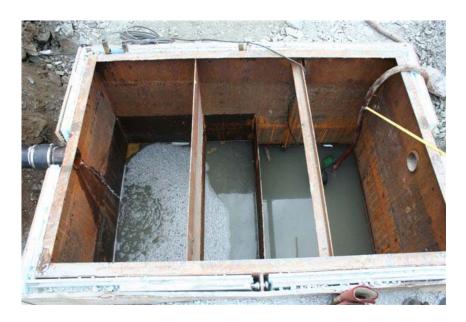
5. It's work; in the left corner we can see the grease.

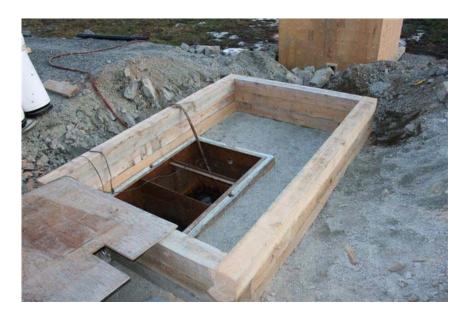
7. The base filled with 0-3/4".

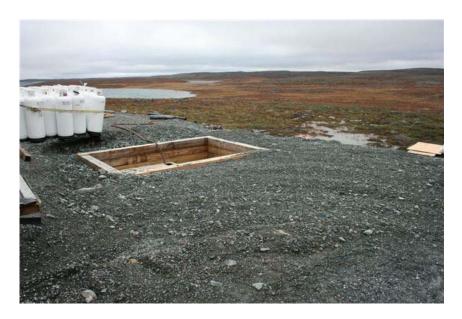
8. The base.

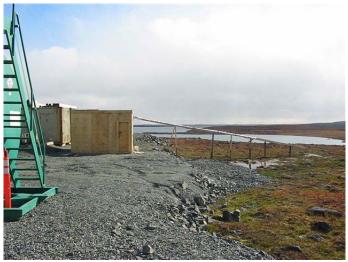
9. Final installation of the grease Station.

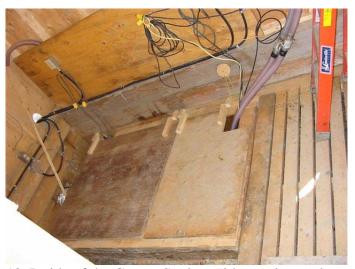
10. Inside of the Grease Station with panel over the trap.

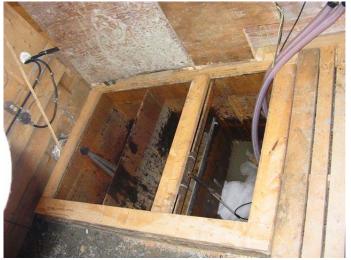
11. Easy access to the pump truk in the Grease Station.

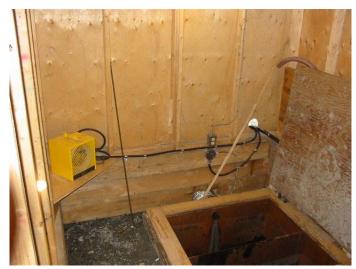
12. Heater inside of the station

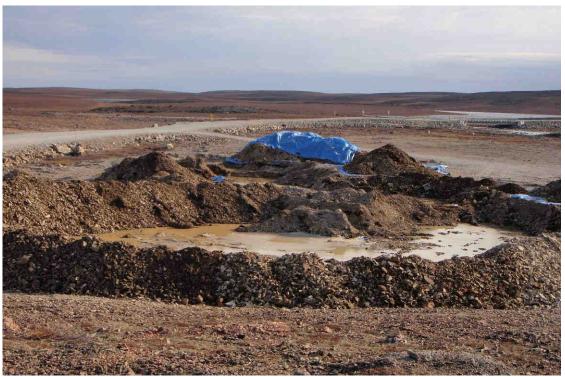
Photo 01: After completion of the contaminated soil exhumation last falls, banks on each side of the holes have been created to avoid any incident. – September 23rd 2008

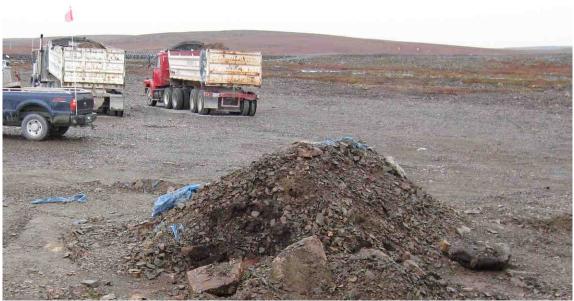
Photo 02: The semi-dump trucks used to hauled the material – August 31st 2009

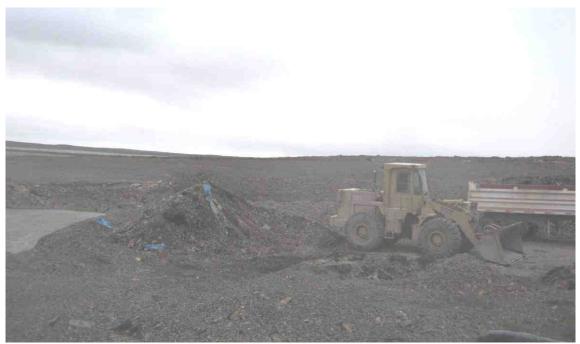
Photo 03: During the works; the soil was on tarps and both the soil and the tarps have been brought to the Quarry #22 – September 1st 2009.

This memo is to confirm that the contaminated soil piles at the Forward camp have been moved to the Quarry # 22. A Baker Lake contractor (BLCS) was hired to load and haul the material. It takes 35 loads from semi-dump tractor trailer to achieve this task. The haulage capacity for the semi-dump truck is 28 tonnes. Considering that information the estimated quantity of hauled material is 980 tonnes. The operations start on the August 27th and were completed the September 4th 2009 under the supervision of an Agnico-Eagle environment representative.

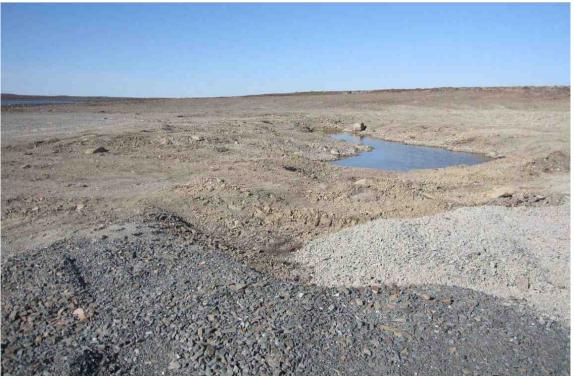
Photo 04: After completion of the haulage the area have been levelled with the loader The banks (non-contaminated material) were pushed to make sure there are no steep slopes – September 4th 2009.
