August 30, 2000 Water Licence Inspection - Report

INDUSTRIAL WATER USE INSPECTION REPORT

Date: 2000/08/30 Company Rep. (Name/Title): Brian Alexander / Project Manager
Licensee: Cumberland Resources Ltd., Meadowbank Licence No.: NWB2MEA0002

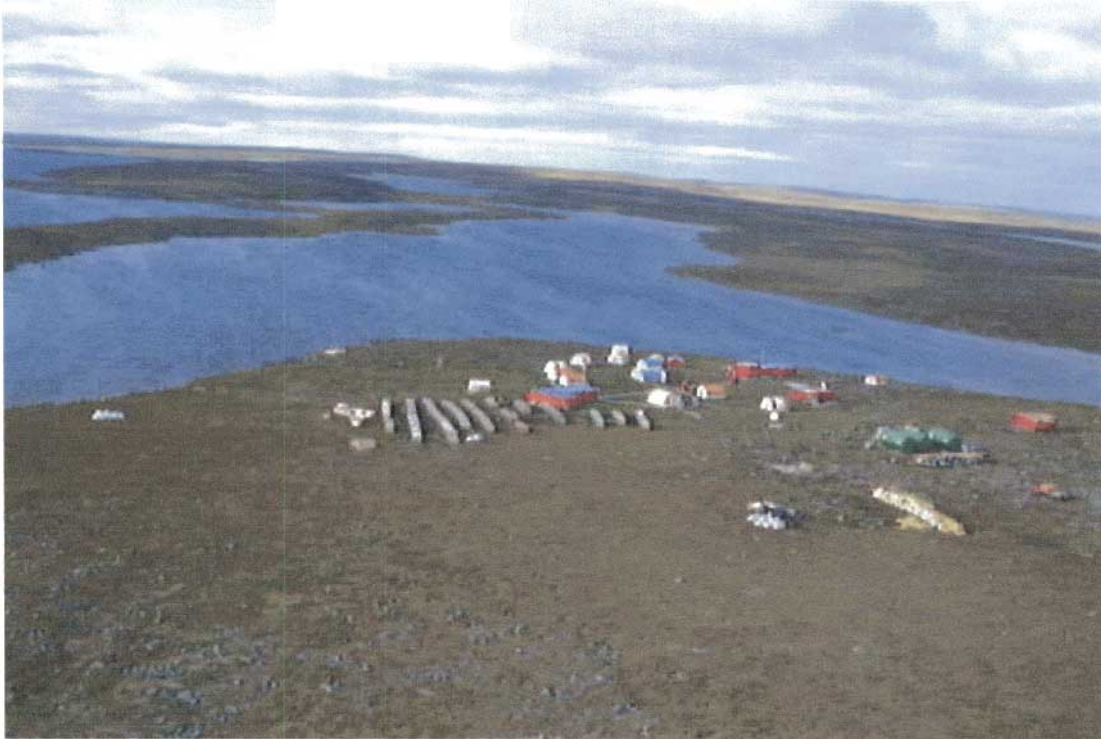
- **Water Supply:** At the time of the inspection, water consumption was roughly estimated according to the average amount of daily storage tank refills. While the Inspector recognizes that the needs of the modest camp (figure 1) more than likely fall within the permitted water usage, the Permittee should nevertheless endeavour to more accurately record domestic and total water use.

figure 1. Aerial view of camp; 2000/08/30.

Comments: Domestic water consumption is not measured, but is roughly estimated according to the amount of storage tank refills.

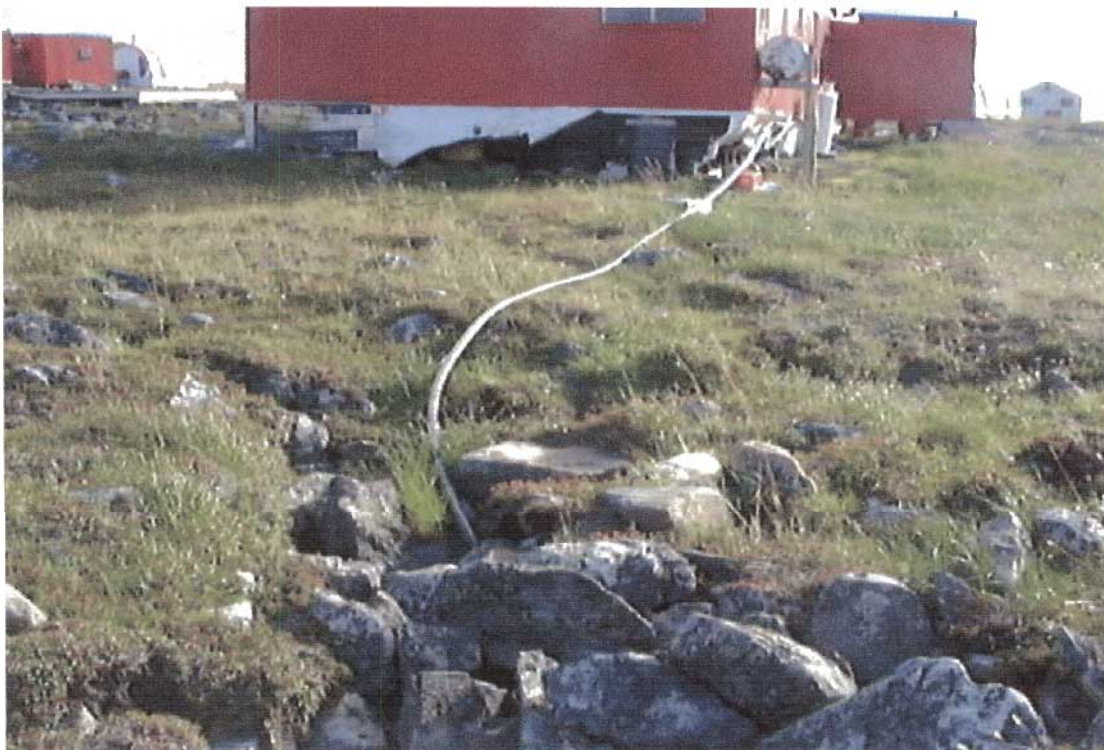
- **Greywater disposal:** Greywater from the kitchen facilities is directed to a natural depression converted into a sump (figure 2). While this setup proves satisfactory, a break along the discharge line was noted during the inspection (figure 3). Accordingly, the Permittee assured that this minor concern would promptly be addressed.

figure 2. Greywater sump; 2000/08/30.

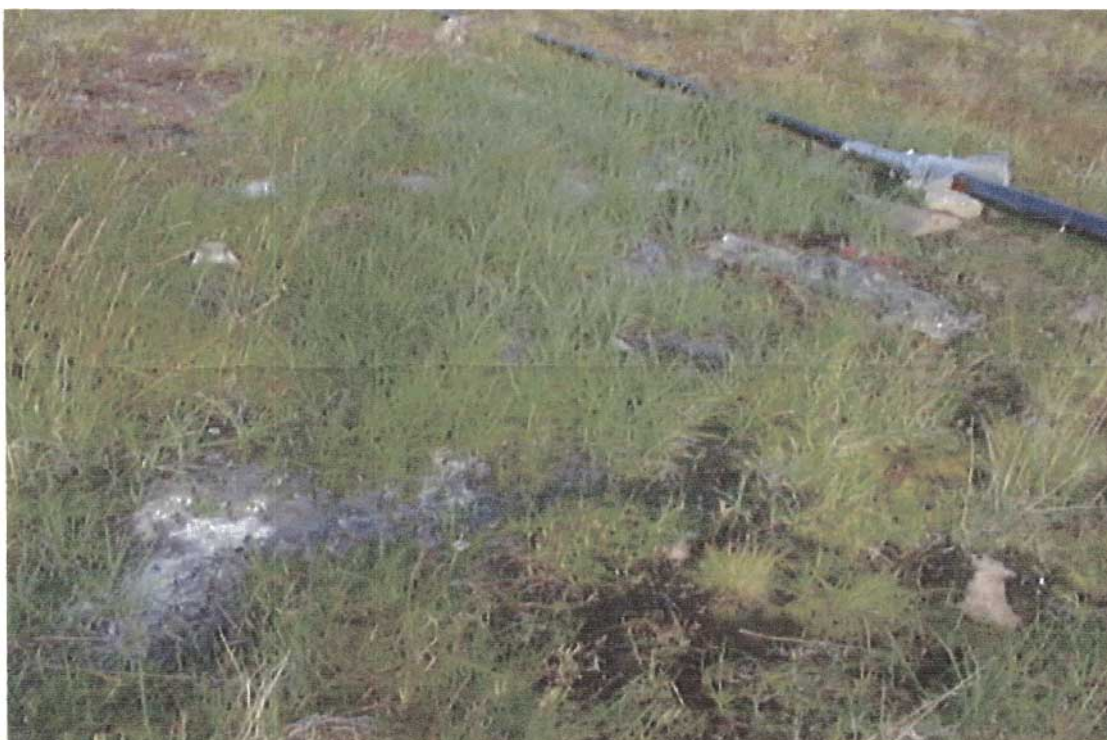
Comments: A break was noted along the greywater discharge line. Honeybucket bags from the two latrines are incinerated, as are all combustible wastes. Incinerator deployed on the old burn barrel site. Incineration ashes and non-combustible wastes are hauled to Baker Lake's solid waste disposal facility.

figure 3. Break in greywater discharge line; 2000/08/30.

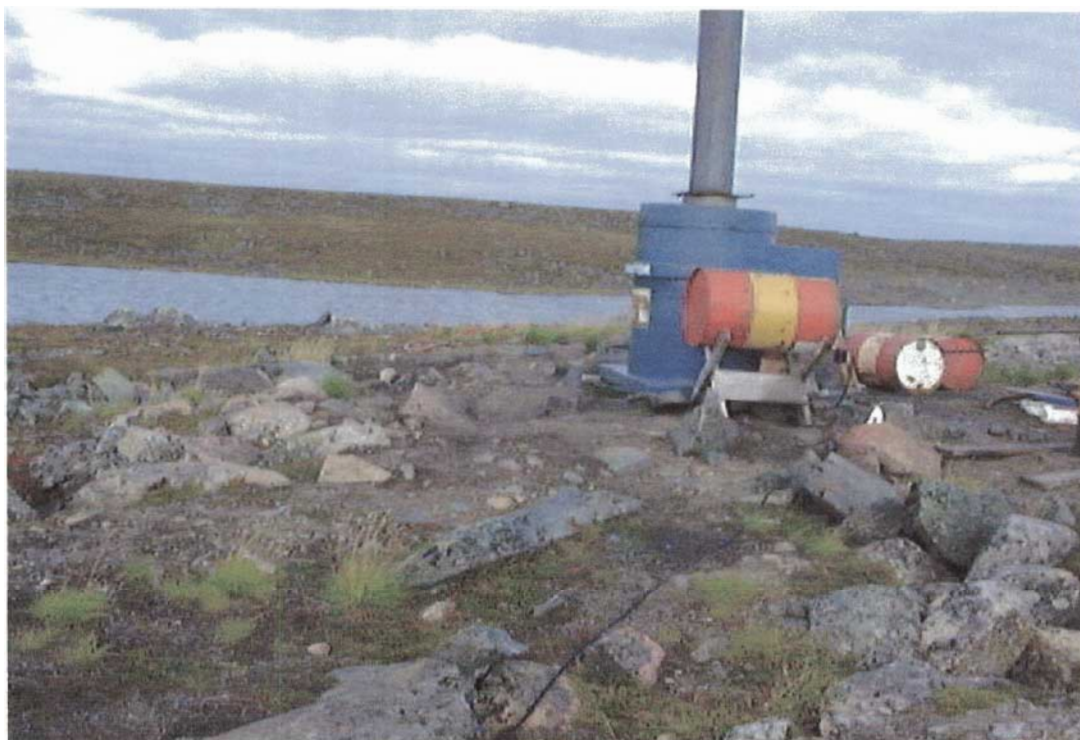
- **Solid waste disposal:** The Inspector acknowledges that the Permittee has responsibly deployed the incinerator at the location of the old burn barrel site (figure 4), thus minimizing the footprint of the combustible wastes disposal site.

figure 4. Combustible wastes disposal site; 2000/08/30.

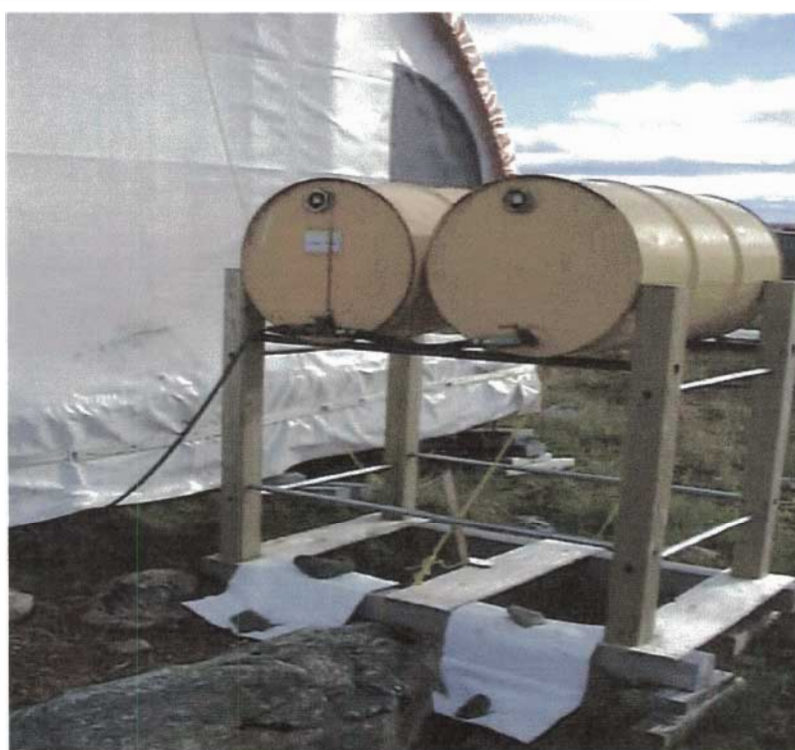
- **Fuel storage:** The Inspector commends the Permittee for its diligent approach to fuel storage. Indeed, the housing units fuel supply system (figure 5), and in particular the bulk fuel storage site (figure 6), constitute above average practices in northern exploration camps.

figure 5. Housing units fuel supply system; 2000/08/30.

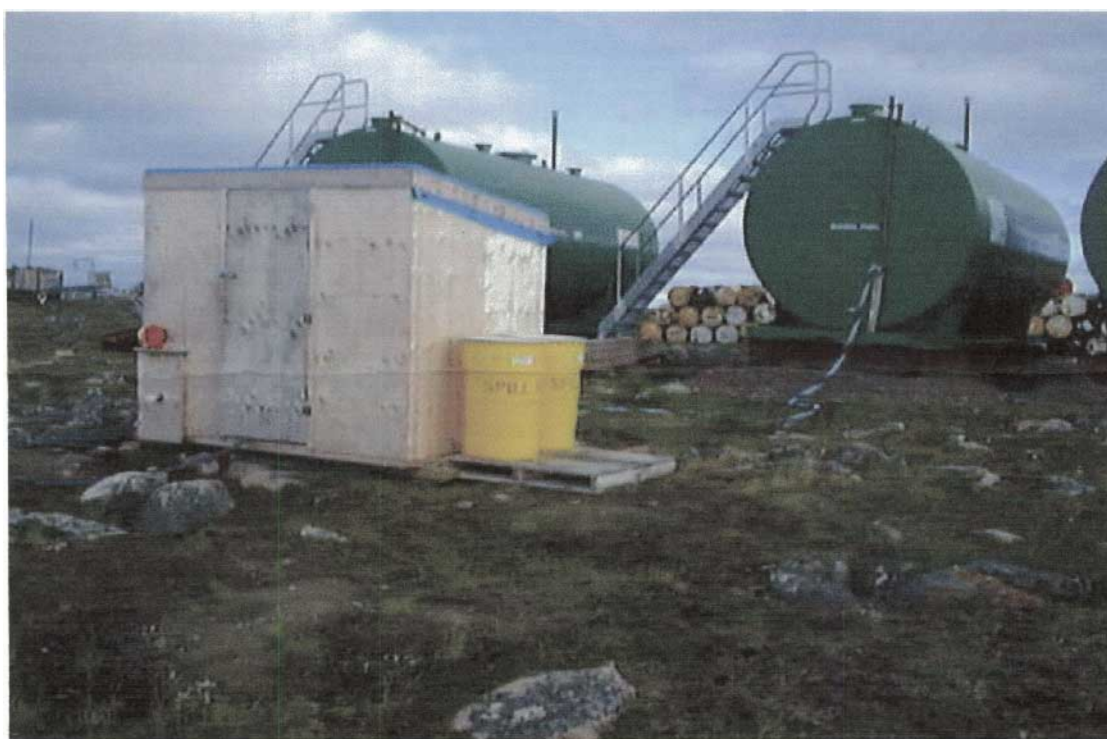
figure 6. Camp's bulk fuel storage site; 2000/08/30.
