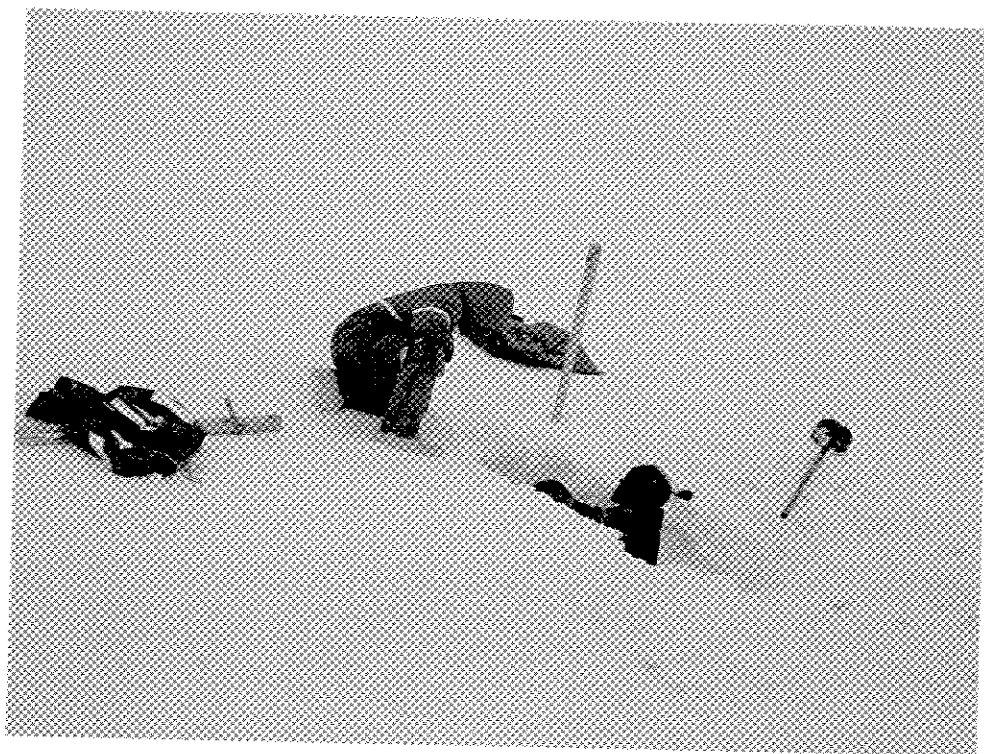
Photo 23 May 2003 snow survey. Digging snow pit in deep drift for staged snow tube sampling.

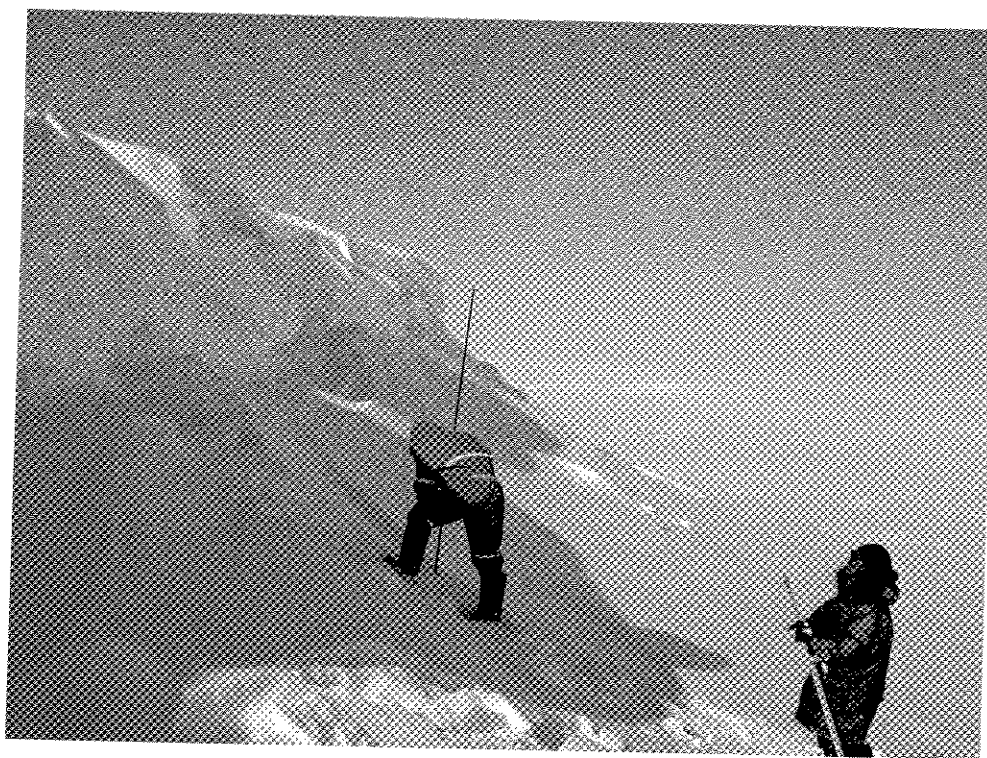
Photo 24 May 2003 snow survey. Probing snow depth on steep SE slope.

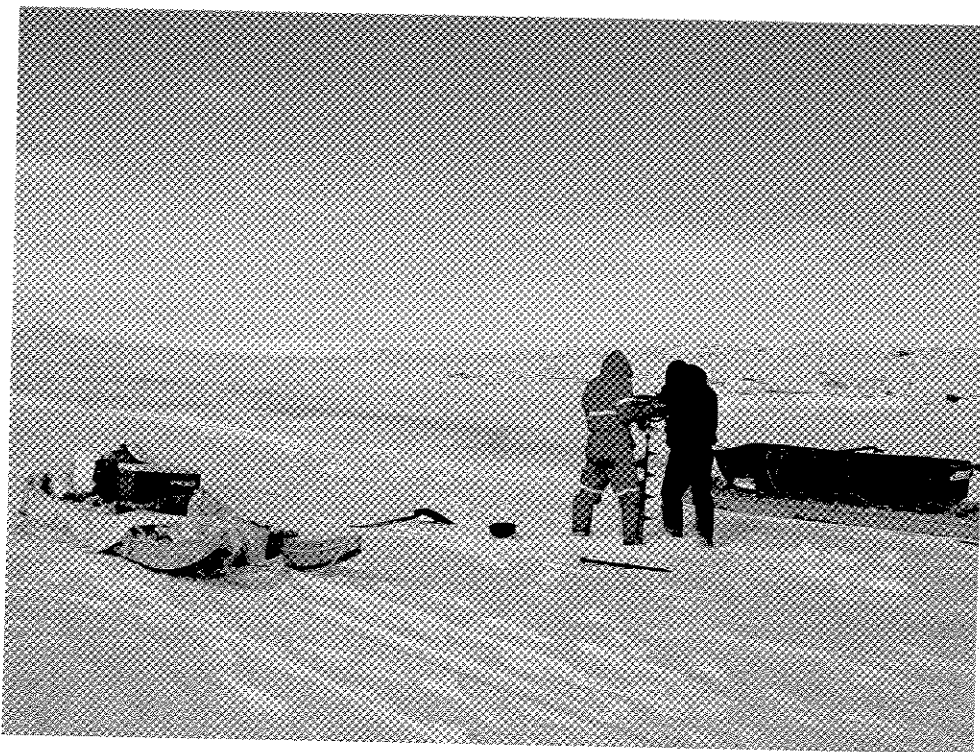
Photo 25 May 2003. Coring through lake ice to measure pre-runoff lake water level.

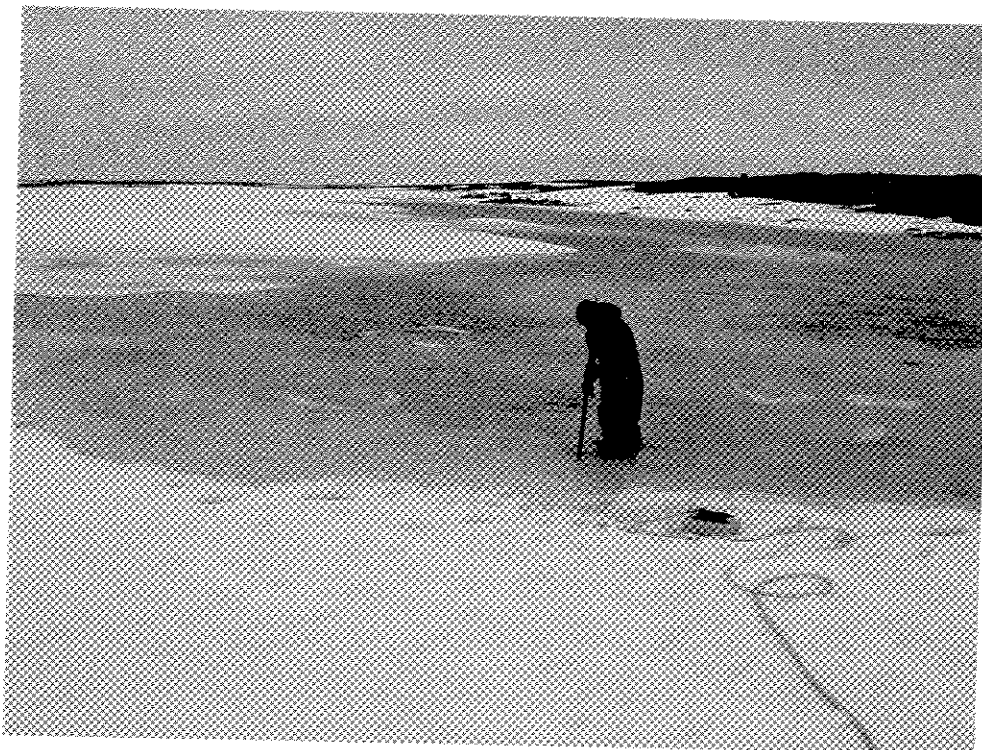
Photo 26 9 June 2003. Second Portage Lake attempting to place sensor orifice block through the ice to start station operation.
