FISH HABITAT ASSESSMENT AT A PROPOSED ROAD CROSSING NEAR MELIADINE WEST EXPLORATION CAMP

**FISH HABITAT ASSESSMENT
AT A PROPOSED ROAD CROSSING NEAR
MELIADINE WEST EXPLORATION CAMP**

October 2004

04-1373-027

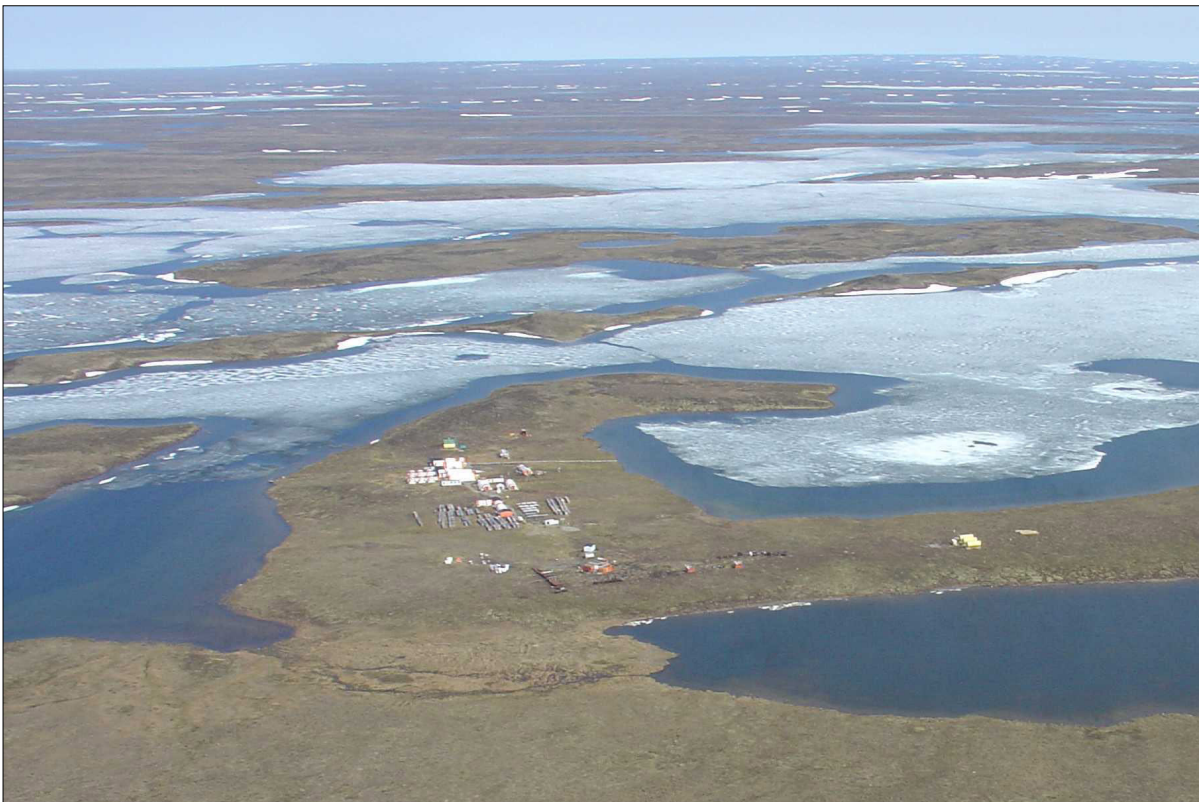
Cover Photo: Proposed road crossing location on an unnamed stream, which flows from a small lake (lower right of photo) into a bay of Meliadine Lake (lower left). The Comaplex exploration camp and the east basin of Meliadine Lake are in the background. *7 July 2004.*

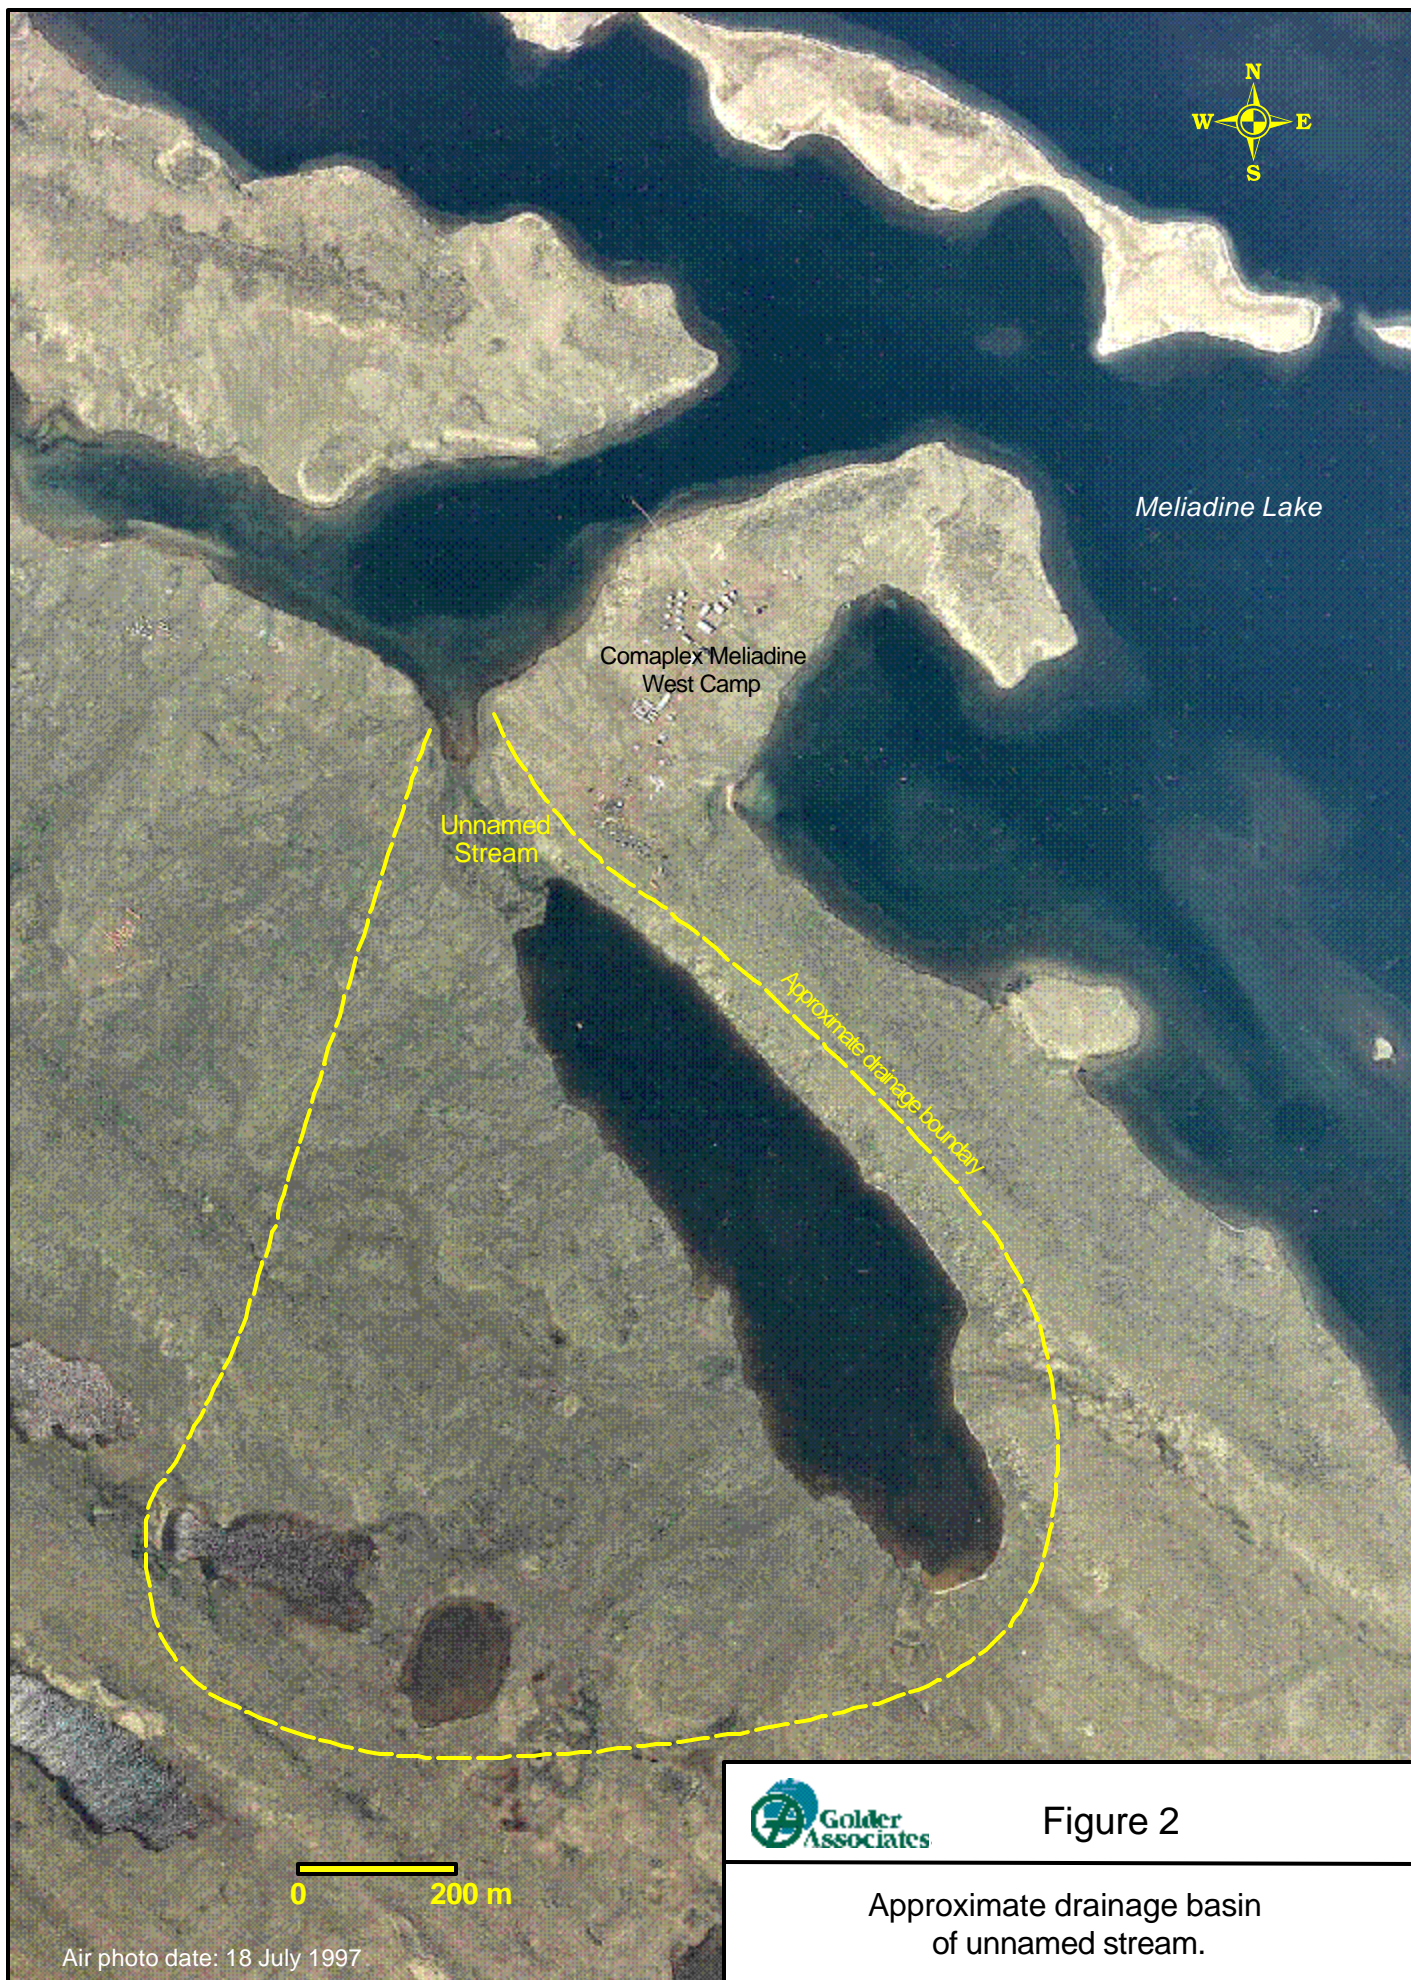
Figure 2

Approximate drainage basin
of unnamed stream.

The proposed road alignment crosses one such small drainage. The unnamed stream drains a small lake (17 ha in area), immediately south of the exploration camp. The entire drainage basin of this small watershed is about 75 ha in area. The UTM coordinates (NAD 27) for the confluence of the stream with Meliadine Lake are Zone 15, 541727 E 6988673 N. The proposed road crossing is located about 300 m southwest of the exploration camp (Figure 2).

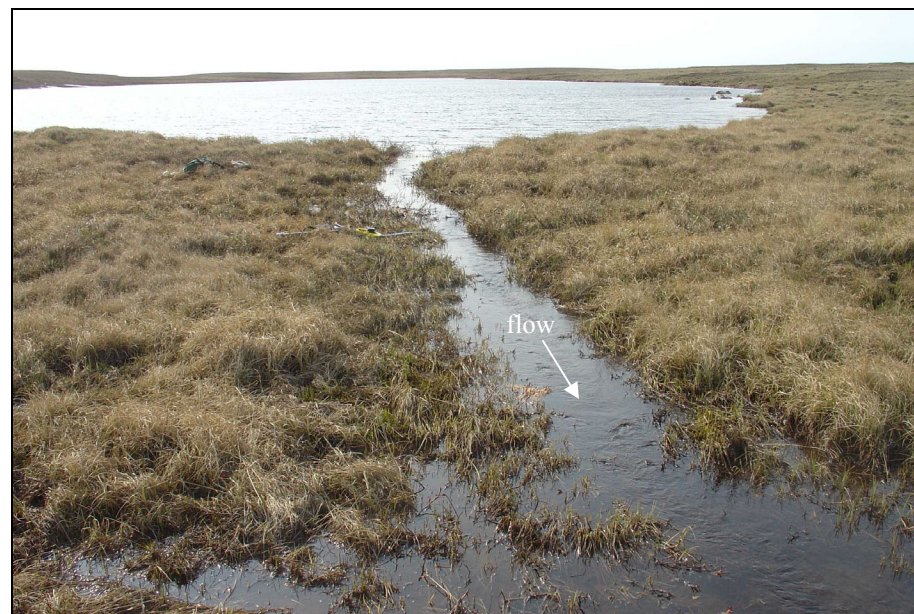
Reach #1 extended from the source lake to 16 m downstream of the lake. This reach was the only section of stream where the entire flow passed through a single, narrow channel. The average channel width was estimated at 0.7 m, and ranged from 0.4 to 1.2 m. The average channel depth was estimated at 0.10 m, with a maximum of 0.20 m. Aquatic habitat in this section was comprised entirely of shallow run. The substrate was composed of fines and detritus. Stream gradient in this section was low relative to the reaches farther downstream.

Plate 2 7 July 2004. Reach #1 was the only section of the stream where the entire flow passed through a single channel.

Instantaneous stream discharge was measured in Reach #1 on 7 July (Appendix D). This site featured a single channel carrying the entire flow. Discharge at this location was 0.012 m³/s.

- The alignment of the road crossing should be selected to cross the stream in Reach #4 or in Reach #1, where the width of the channels and the extent of channel braiding is lower relative to the other reaches. The selection of the crossing at these locations would minimize the need to install extensive diversion barriers to channel the flow through a central culvert under the road.

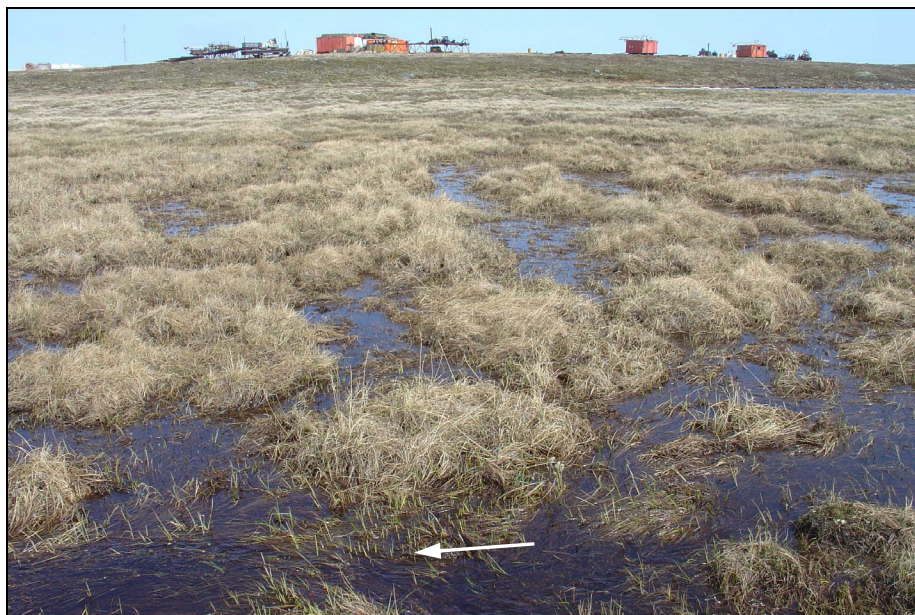
Reach #2 was 88 m in length; the longest of the surveyed reaches. Water depth in this section was shallow, with an estimated mean of 0.10 m and a maximum recorded depth of 0.15 m. Approximately 40% of the channel in this section featured multiple braids; however, most (60%) of the stream length consisted of dispersed flow over terrestrial vegetation and the stream banks were not well defined. Shallow run habitats contributed approximately 60% to the total reach area, with shallow flat habitat comprising the remaining 40% of the area. Substrate was dominated by detritus and flooded grass (98%), with fines (silt and sand) encountered in only 2% of the reach area.

Plate 3 7 July 2004. Habitat in Reach #2 was predominantly flooded grass with indistinct channel edges.

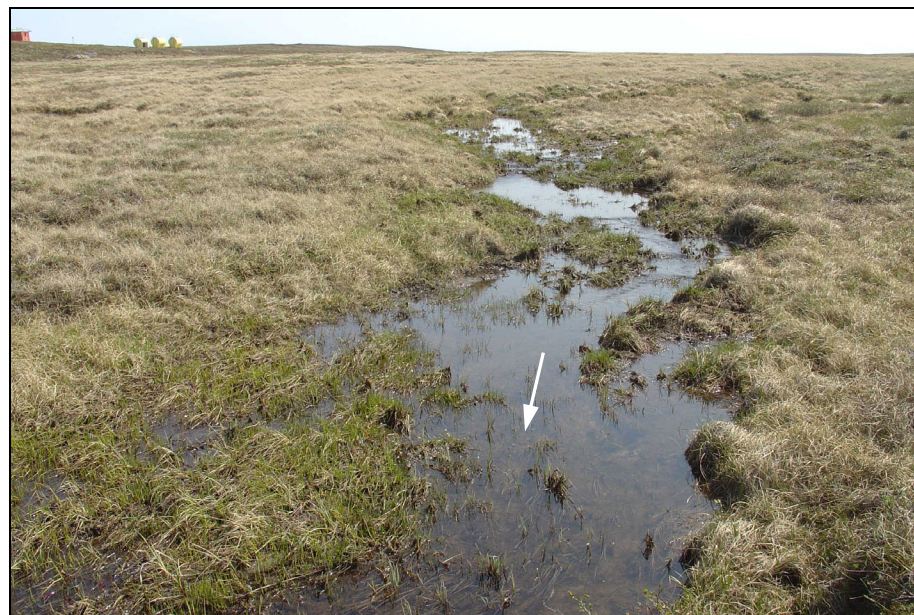
Reach #3 began 104 m downstream of the source lake and extended for 34 m in length. This section of stream was characterized by two main channels, separated by a gentle rise in terrain. Each main channel was composed of areas that featured either one or multiple channel braids. The channel width was about 2.5 m on average, with widths ranging from 0.5 to 4 m. Similar to the upstream reaches, the average depth in this section was low (about 0.10 m); however, the maximum recorded depth was slightly higher (0.26 m). The channels featured mainly shallow run habitats (90% of reach area). Shallow riffles and three small pools accounted for the remainder. Substrate was dominated by detritus, flooded grass and fines; however, small amounts of gravel and cobble were present in the riffle and pool habitats. Stream gradient in this section was higher than in the upstream reaches.

Plate 4 7 July 2004. Shallow run habitat through grass was the dominant habitat type in Reach #3; however, a few pools with gravel substrate were present.

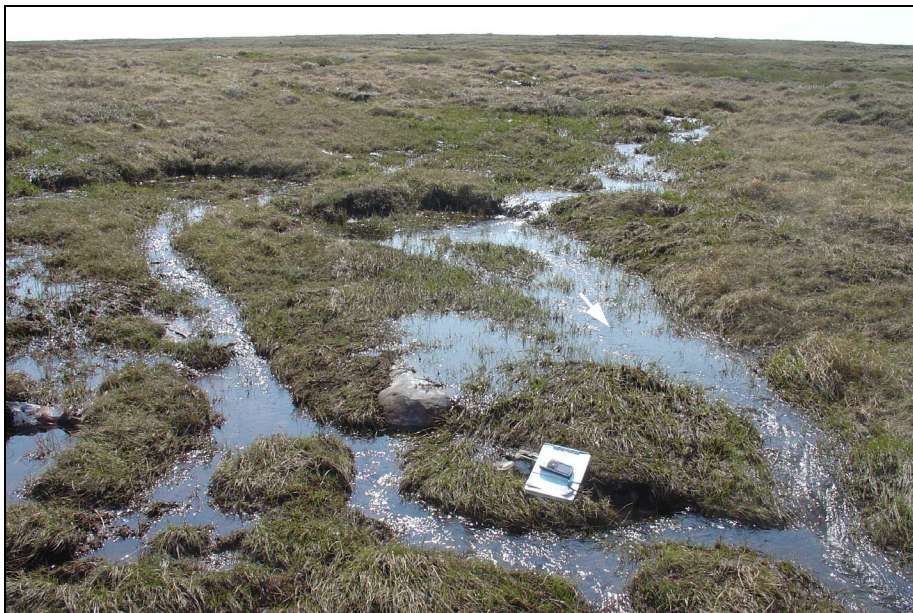
Reach #4 was 44 m long and composed entirely of multiple channel braids. The average width of individual channels was estimated to be 0.4 m, with channel widths ranging from 0.2 to 4.0 m. The average depth in this section was about 0.10 m; however, a single, small pool in this reach was 0.84 m deep. Channel type was 100% multiple braids. Habitat type composition in this section was similar to Reach #3 (mainly run habitats). The substrate contained greater amounts of gravel (3%), cobble (2%) and exposed fines (20%) than in the upstream reaches. Relative gradient in this section was high.

Plate 5 7 July 2004. Multiple narrow braids and a higher gradient than upstream sections characterized Reach #4.

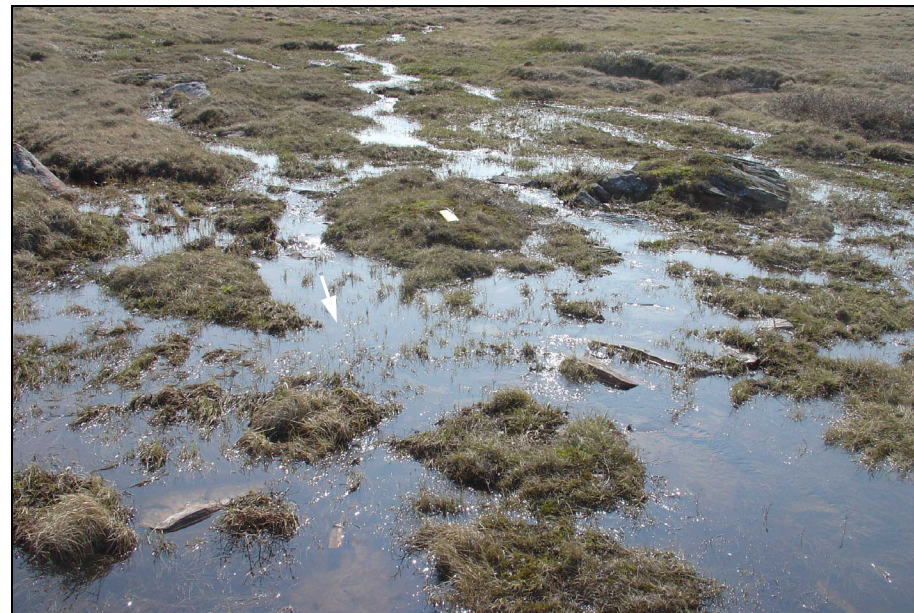
Reach #5 was 16 m in length and terminated at a shallow bay of Meliadine Lake. The average channel width in this section was about 10 m; width ranged from 6 to 15 m. The average depth was about 0.15 m, with a maximum of 0.25 m. The channel consisted entirely of multiple braids. Instream habitat was dominated by run (95%) and riffle (5%) sections. Substrate composition in Reach #5 was more diverse than in the other

reaches. Although detritus and grass covered 50% of the area, boulders were present (10%), as were gravel and cobble (5% each), with the remainder being fines.

Plate 6 7 July 2004. Reach #5 had the greatest diversity of substrate types, with 20% of the area covered by gravel, cobble, or boulders.

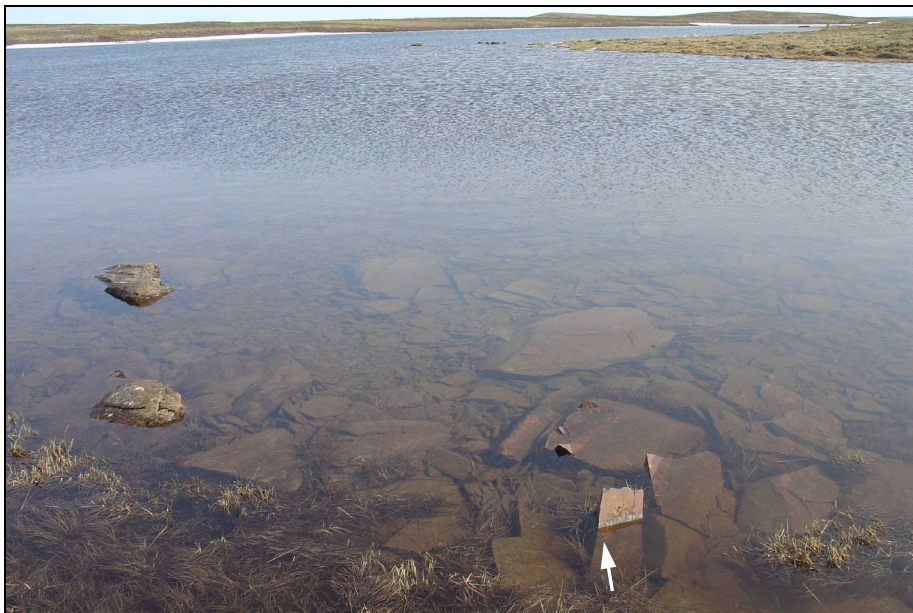
In an attempt to identify fish that may have been staging in the lake prior to moving into the stream, two electrofishing sampling runs (#1 and #2) were conducted along the shoreline of Meliadine Lake near the mouth of the stream. The combined sampling effort was 544 s of electrofishing time over a distance of 150 m. Off-shore lake habitat sampled during Run #1 varied in depth from 0.4 to 0.8 m, and contained boulder and cobble substrate. No fish were captured or observed. Near-shore lake habitat sampled during Run #2 was similar to much of the stream habitat, with shallow depths (0.05 to 0.25 m) and substrate consisting of fines and flooded grass. Fourteen ninespine stickleback were captured.

Plate 7 7 July 2004. Substrate in Meliadine Lake, near the mouth of the stream, was fractured boulder and cobble.

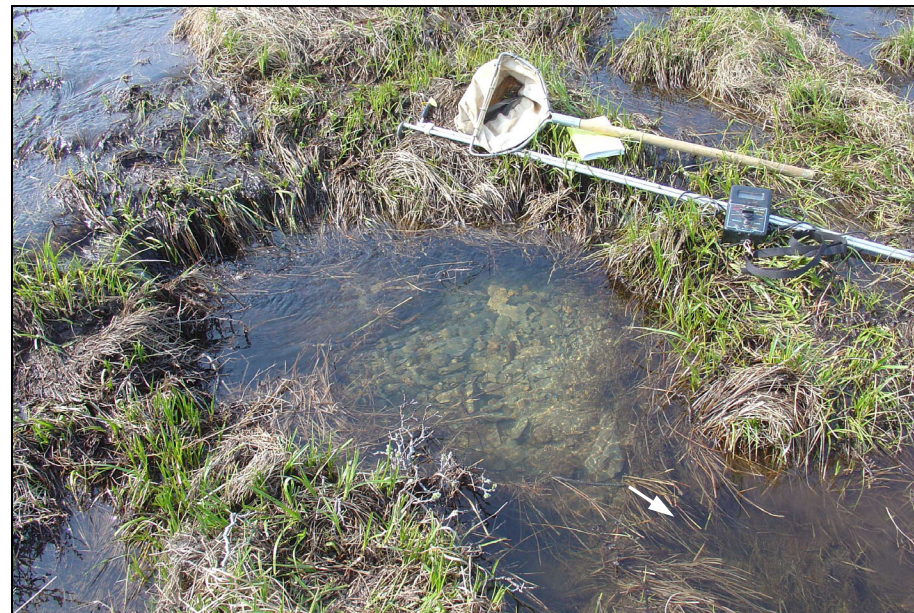
Sampling for fish eggs was conducted on 7 July. Five small pools (total area of 1.3 m²) were sampled in reaches #3 and #4 (Appendix C). These were the only likely locations for Arctic grayling spawning, based on the presence of gravel substrate at these sites. No eggs were encountered during sampling. As the sampling was conducted shortly after the stream temperature reached the optimal thermal conditions for Arctic grayling spawning (i.e., 3 to 6°C; RL&L 1999), the absence of deposited eggs suggested that Arctic grayling do not use this stream for spawning.

Plate 8 7 July 2004. Tiny pool habitats were the only areas with gravel substrate suitable for sampling for the presence of Arctic grayling eggs.
