## MELIADINE ROAD CROSSING: M2.1

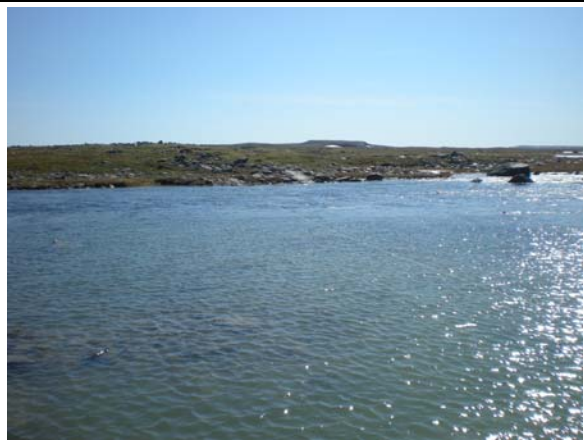
10 July 2008. Downstream view of watercourse crossing looking at left downstream bank.

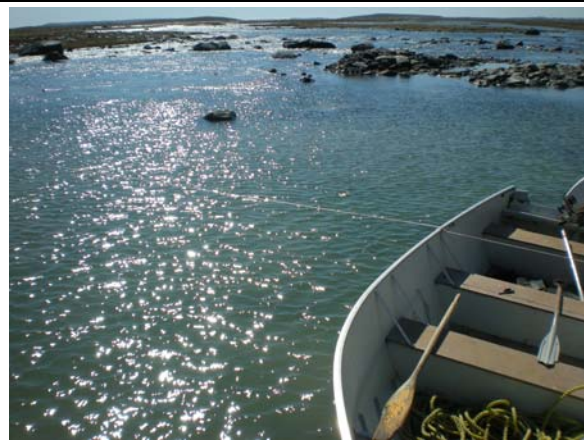
10 July 2008. Downstream view of watercourse crossing.
