AGNICO EAGLE

MELIADINE GOLD PROJECT

ANNUAL REPORT: LICENCE 2BB-MEL1424

PRESENTED TO THE NUNAVUT WATER BOARD

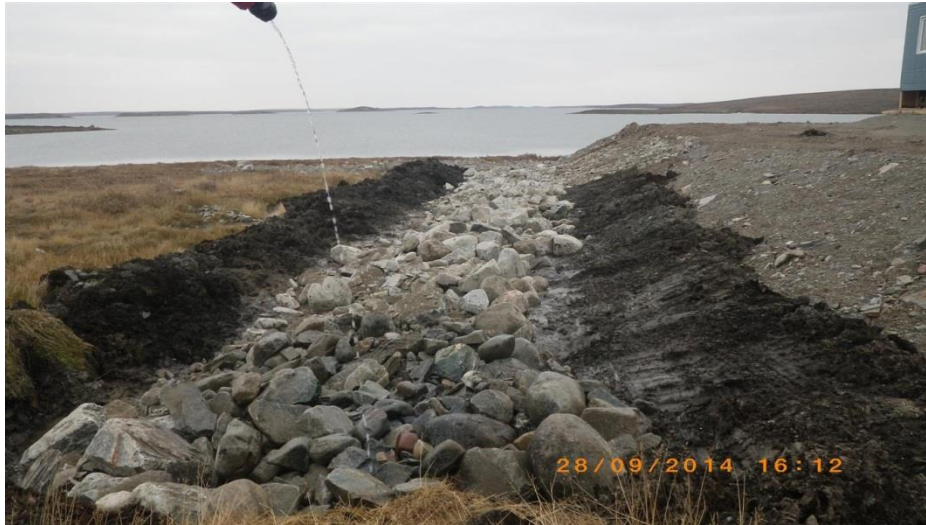
Figure 1: Dissipation channel

Erosion caused by the effluent of the STP system was noted by the inspector. To correct the situation, a dissipation channel was constructed. This channel, constructed with rocks, slows down the water and stops soil erosion.
