Follow Up Report: #21-109 & 21-110

March 29, 2021,

Oil on Lake A8 – Drill Rigs

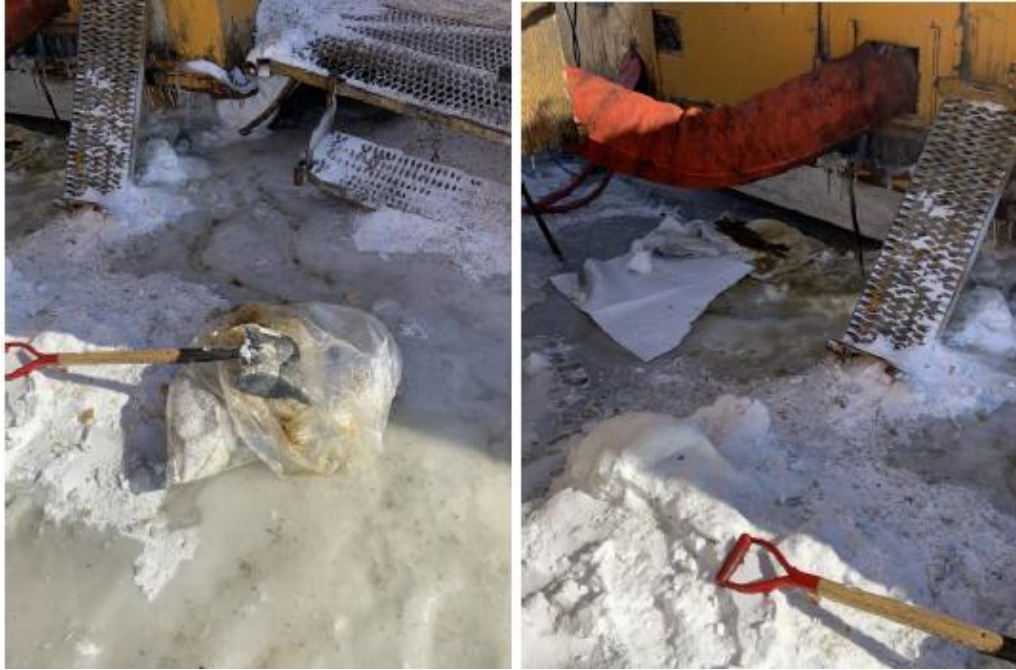
On March 29, at approximately 16:00 Environment Technicians were called to conduct an inspection of the surface drill rigs, operated by contractor Orbit Garant. Two drill rigs were operating on Lake A8 (Figure 1). During the inspection both rigs were found to have areas with small amounts of hydraulic oil dripping from inside the rigs onto the lake ice. Drill #1 was estimated to be approximately 20L (Figure 2), and Drill #7 was estimated to be approximately 3L (Figure 3).

Figure 2: Contaminated snow outside of Drill #1.

During the inspection, Environment technicians notified the drillers of the issues. Absorbent pads were placed beneath the drips immediately. The Orbit Garant supervisor was notified and the drills were shut down in order to address the issues. The leaking hose fittings were repaired on each drill, and the contaminated snow/ice was chipped up and disposed of in hazmat bags.

The leaking fittings on the exterior hoses were repaired, and drip pans were installed beneath the ledges where oil was leaking from inside the rigs. The Orbit Garant supervisors held meetings with both shifts to discuss the importance of routine, regular inspections of their rigs. Due to the high worker turnover rates of Orbit Garant drillers, supervisors will ensure to reiterate these messages to new workers, and the Environment department will continue conducting regular inspections.

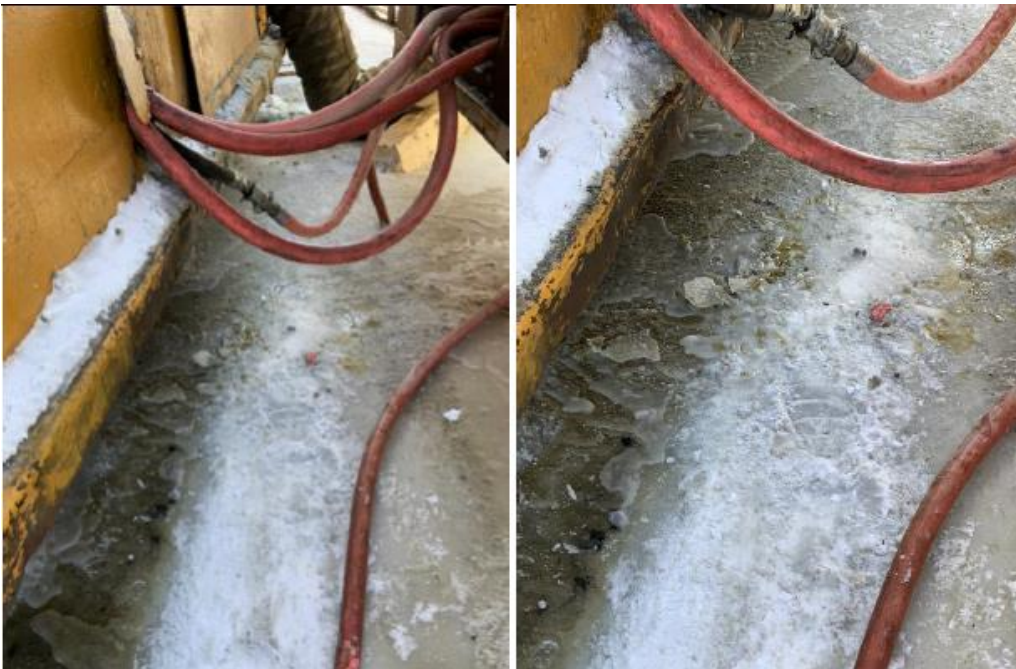
Figure 3: Hydraulic oil dripping from hoses outside of Drill #7.

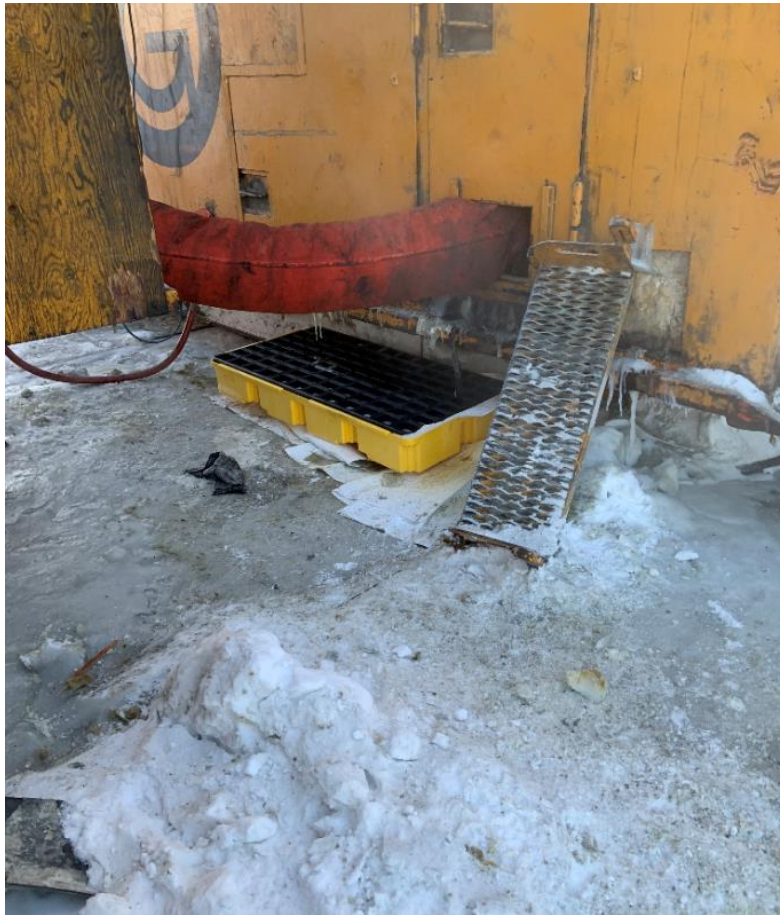
Figure 4: Drill #1 on March 30 after clean up and installation of drip pans and absorbents.
