Follow Up Report: #21-217

May 31st, 2021 – 5 L Hydraulic Oil Spill

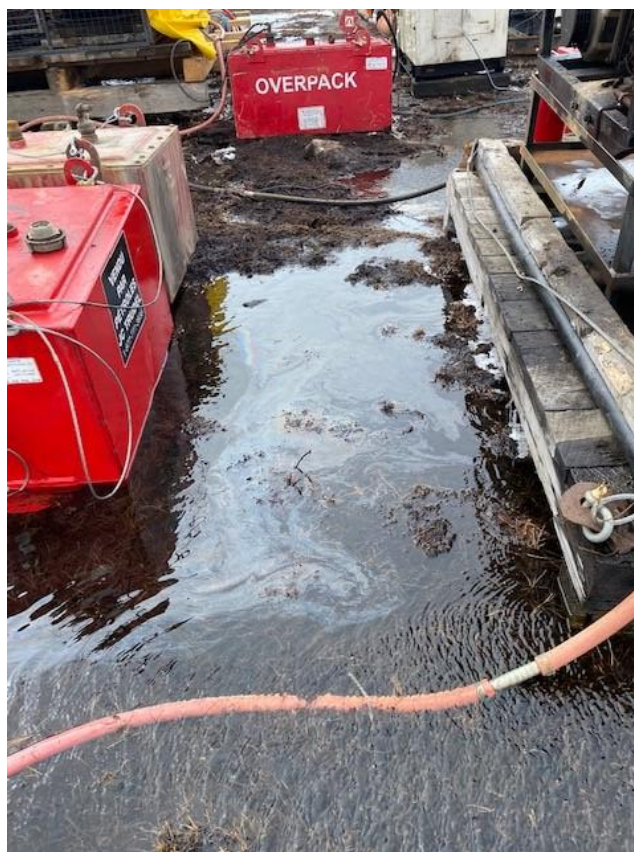
During an exploratory drilling campaign near local lake B5, workers noticed a hydrocarbons sheen on the surface runoff surrounding the drill. The drill was set up approximately 39m from the ordinary high water mark of the lake, in a low-lying area prior to freshet, which later encountered substantial surface runoff as temperatures warmed. Hydrocarbon residues on the components and surfaces of the drill equipment were being washed off by the freshet runoff towards B5 lake. The spill volume was approximated at 5 L.

Figure 2: Hydrocarbons sheen on the surface of water by the drill

The drill was shut down on May 31st to address the issue and materials such as fuel tanks, hoses and other equipment which may present hydrocarbon contaminated surfaces were moved to higher ground away from freshet runoff. Absorbent pads and booms were put in place to capture the hydrocarbons at the surface of water. The contaminated absorbent materials were recovered into Quatrex hazmat bags.

The specific cause in this incident is attributed to the selection of the location and timing for drilling (in relation to freshet onset). In this case and as previously mentioned, the drill was shut down and materials such as fuel tanks, hoses and other equipment which may contain hydrocarbons contaminated surfaces were moved to higher ground away from freshet runoff. The Environment department will continue conducting regular inspections. Orbit Garant supervisors will ensure to reiterate the importance of inspections of their rigs to their workers to prevent any environmental incident. The procedure for drilling just prior and during freshet is being modified to ensure that drills are not operational during this period where large freshet inflows can be problematic.

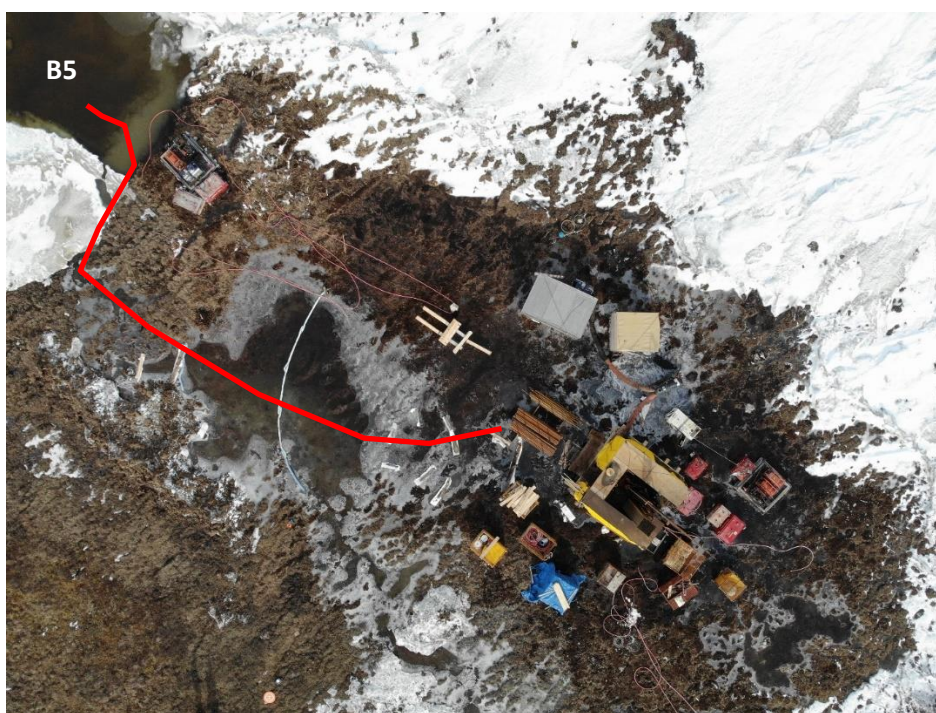
Figure 3: Observed hydrocarbons sheen flow path between drill and B5 Lake.
