# Follow Up Report: #2022029 February 8<sup>th</sup>, 2022, Engine Oil on Water Body B38 – Drill Rig#10

### **Description of Incident:**

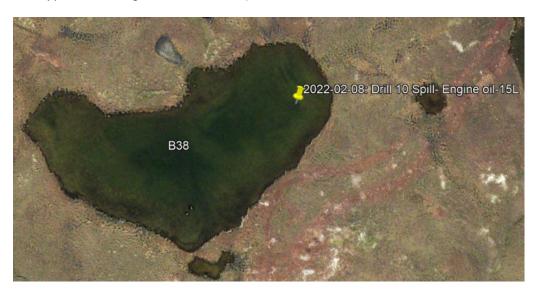
Figure 1: Incident Location

On February 8<sup>th</sup>, at approximately 14:00, Environment Technicians were conducting an inspection of surface Drill# 10, operated by AEM's contractor Orbit Garant. During the inspection, areas with small amounts engine oil dripping from inside the rigs onto the lake ice were observed. The drill released approximately 15 L of engine oil. The coordinates of the spill are: 63° 0′ 28.93" N, 92°12' 31.50"W, on the Water body B38, which is a shallow pond with a maximum depth of 1.5 m (therefore it is generally assumed to freeze completely to the bottom and would not support fish through the winter season).

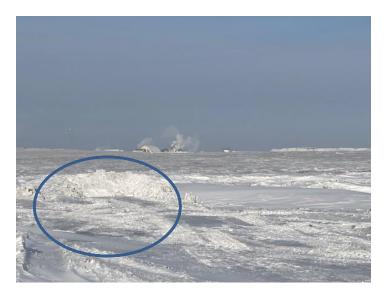
The drill was completed to another borehole location on February 14<sup>th</sup>, and the site remediation was performed during the following night. A dozer was used to scrape the contaminated snow and ice and a composite sample was collected on the ice surface of Pond B38 on February 15<sup>th</sup> in the incident area. The ice sample was sent to the laboratory for analysis of the following parameters: BTEX, F1-F4 Hydrocarbons, Oil & Grease, total metals, Conductivity, pH, and Total Suspended Solids (TSS).

Results showed concentrations below detection limit for BTEX and F1-F4 Hydrocarbons, while total Oil & Grease concentration is of 0.8 mg/L. For reference, the maximum concentration of any grab sample applicable to Effluent discharge in Meliadine Lake at monitoring station MEL-7 is of 5 mg/L for Oil & Grease and no visible sheen, as per Water Licence 2BB-MEL1424 Part D Item 11. The certificate of analysis is attached and identified as Appendix A.

Figure 2: Area after remediation efforts

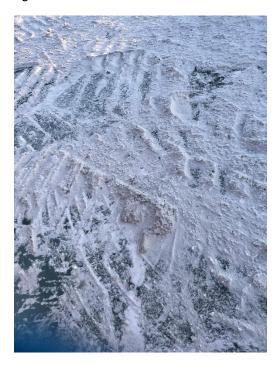
Figure 3: Ice surface after remediation efforts

Although the spill occurred on the lake ice, it is expected that minimal impacts occurred to the water body itself because all the contaminated ice was removed, as demonstrated by the quality of the post clean-up surface sample, and because the lake was frozen to the bottom.

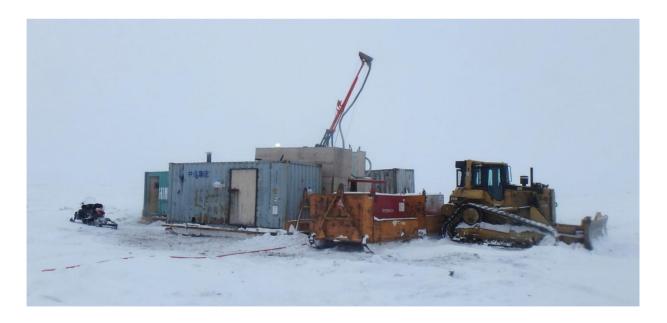
### 5.1a Mobile drills

Mobile drills are the ones that are tracked behing a dozer. Normally used during the winter they can also be used without snow cover while tracked on existing civil invrastructures or on production leases.

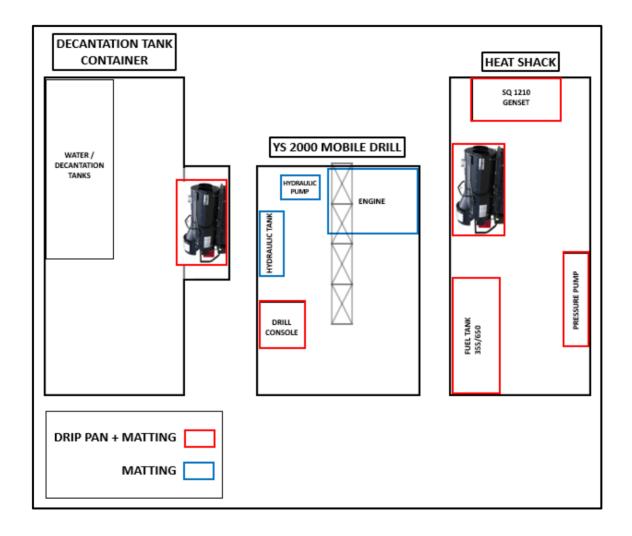
Orbit Garant Drilling made a sketch about where containment spill pans need to be installed inside and around the drills when setuped:

The *Spill Retainment's at the Drills and Pump Shack* procedure applicable to drill rig investigation (attached as Appendix B) was thoroughly reviewed with both Orbit Garant shifts to remind crews of the importance of routine, regular inspections of their rigs (as per the section 5.2 of the attached procedure).

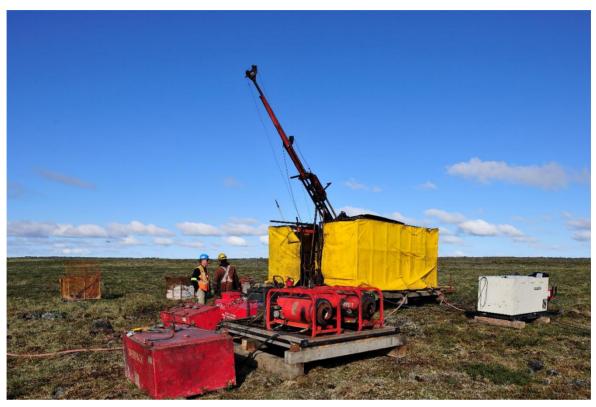
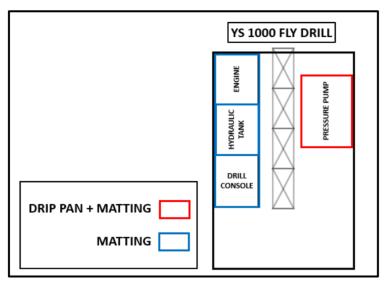
## 5.1b Fly drills

Fly drills are the ones that are moved from one site to the other by dismantelling in into slingable parts with the use of a helicopter.

Extra care is necessary to empty containment pans and to remove all matings that may fly away during this operation. This following sketch is showing the location for containment pans and for the matting to be verified.

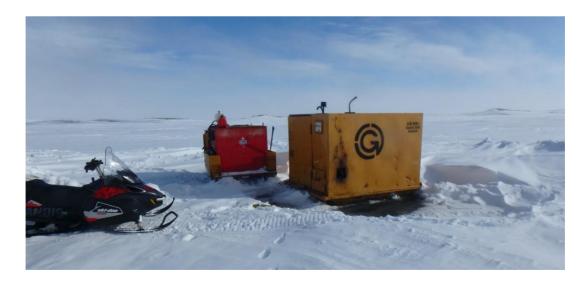
## 5.1c Mobile & Fly pump shacks

Mobile pump shacks are small cabins on skids, closed by roof and walls to protect the equipment inside from the cold weather, that are hosting pumping system to furnish water to the drills.

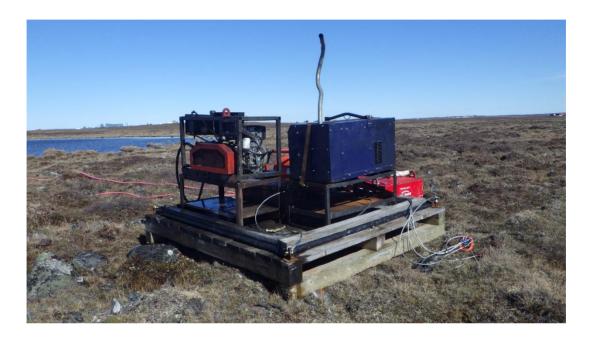
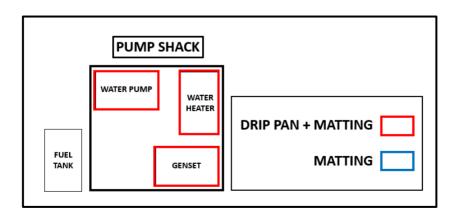
Fly Pump shack are the same but without the skidded cabin. Pumping equipment are disposed on small wood beam floor by the water body on which it's pumping the water to the drill.

Both are composed of a genset, a heater and an electric pump. These tree elements need to pocess an incorporated drip pan hosting matting absorbents that need to be verified frequently.
