Follow Up Report: #2022105

20 L Drilling Recirculation Water on Waterbody A8

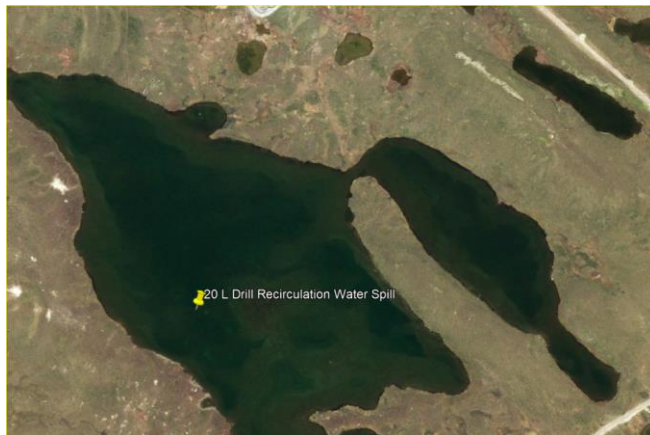
On March 29th, 2022 during an environmental inspection of the Orbit Garant drill rigs located on waterbody A8, a worker identified that 20 L of drilling recirculation water had overflowed from the decantation tank to the surface of the ice.

The coordinates of the spill are: 63° 0' 43.04" N, 92°12' 25.15"W, which is on waterbody A8.

Figure 1: Drilling recirculation water spill location

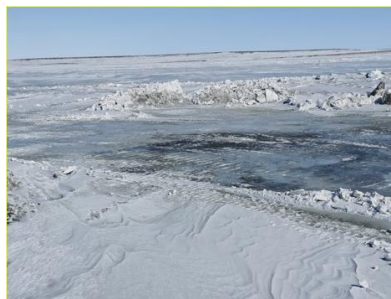
At the time of inspection, the decantation tank was no longer overflowing, and drilling recirculation water was no longer spilling onto the ice. The cleanup of the spill was completed as part of the final site cleanup as all drilling operations were complete at the site. During the drill site cleanup all impacted snow and ice was removed and sent to the drill cuttings disposal area with the remaining drill cuttings.

Figure 2: Spill Location- Post cleanup

The release was a result of an equipment failure as the fresh water supply valve failed and could not be put in the closed position to stop filling the decantation tank. The decantation tank overflowed spilling recirculation water onto the surface ice. Orbit Garant stopped the flow of fresh water into the decantation tank and replaced the failed valve.

As an effort to mitigate the frequency of spills on lake ice, Orbit has committed to implementing a series of actions aimed at reducing the risk of spills from drills. One of these actions is to install water level sensors on the decantation tanks which will be connected to a signal light system installed in the drill shake. The intention to implement this action was communicated via a Letter of Intent provided by Orbit to Agnico Eagle on April 28th, 2022 and is available upon request of regulatory bodies.
