# Follow Up Report: #2022109

## April 1<sup>st</sup>, 2022,

### 100 L Drilling Recirculation Water on Waterbody A8

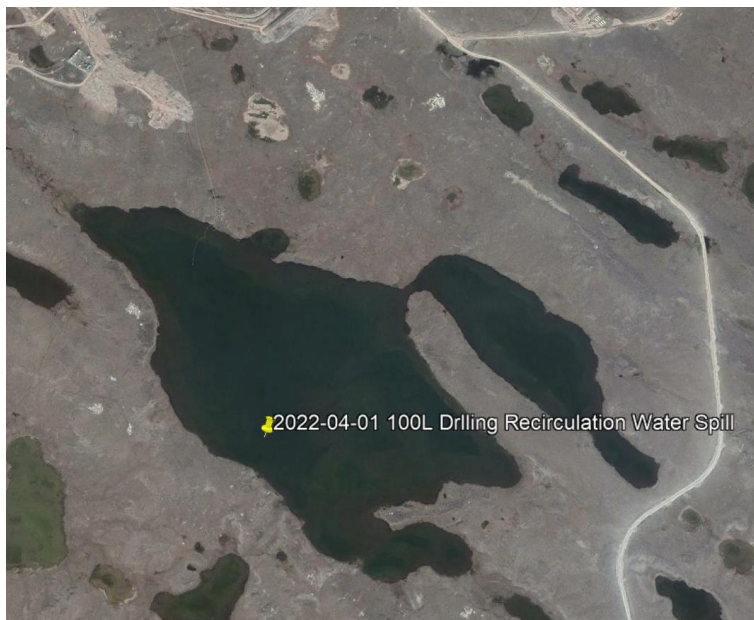
The coordinates of the spill are: 63° 0' 41.27" N, 92°12' 25.91"W, which is on waterbody A8.

**Figure 1:** Drilling recirculation water spill location

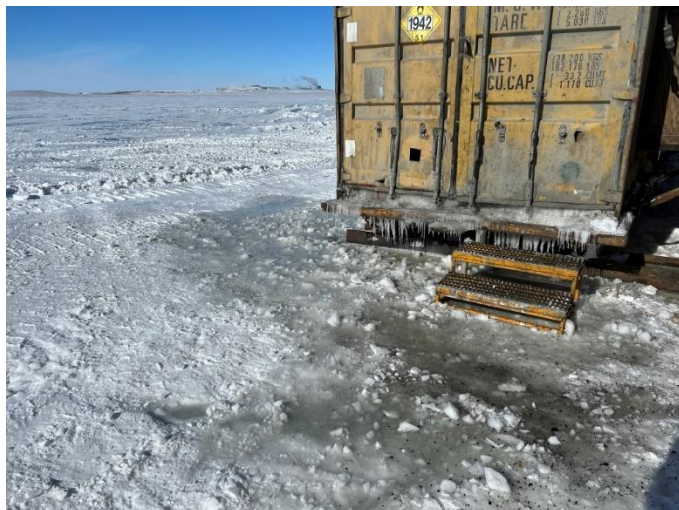
On April 1<sup>st</sup>, 2022, during an environmental inspection of the Orbit Garant drill rigs located on waterbody A8, a worker identified that 100 L of drilling recirculation water had overflowed from the decantation tank to the surface of the ice.

**Figure 2:** Spill Location- Pre-cleanup

The release was a result of a human error as the worker didn't stop the pump that was filling the tank. The decantation tank overflowed spilling recirculation water onto the surface ice. Orbit Garant stopped the flow of fresh water into the decantation tank immediately after the overflow was observed.

At the time of inspection, the decantation tank was no longer overflowing, and drilling recirculation water was no longer spilling onto the ice. The cleanup of the spill was completed as part of the final site cleanup as all drilling operations were complete at the site. During the drill site cleanup all impacted snow and ice was removed and sent to the drill cuttings disposal area with the remaining drill cuttings.

As an effort to mitigate the frequency of spills on lake ice, Orbit has committed to implementing a series of actions aimed at reducing the risk of spills from drills. One of these actions is to install water level sensors on the decantation tanks which will be connected to a signal light system installed in the drill shake. The intention to implement this action was communicated via a Letter of Intent provided by Orbit to Agnico Eagle on April 28<sup>th</sup>, 2022 and is available upon request of regulatory bodies.

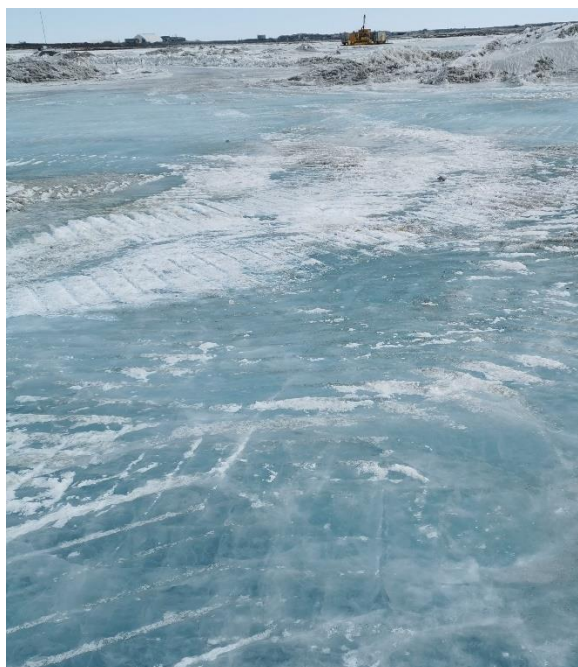
**Figure 3:** Spill Location- Post cleanup
