Follow Up Report: #2022132

April 14th, 2022,

0.5 L Diesel Fuel on Water Body A8 – Drill 4

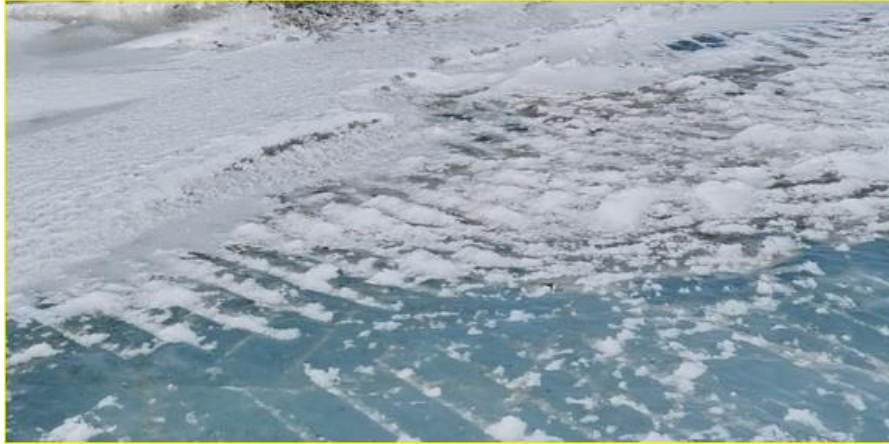
Figure 3: Spill location after completion of cleanup

It is expected that no impacts occurred to the water body as the spill occurred on the lake ice, facilitating the recovery of the contaminated material – the contaminated ice was scrapped off.

The cause of the spill was identified as equipment failure. The fuel hose was damaged by normal use. The fuel hose was immediately changed to prevent another spill.

Preventive inspections continue to be completed by the Environment Department, Geology Department and the drill crews to identify potential concerns.
