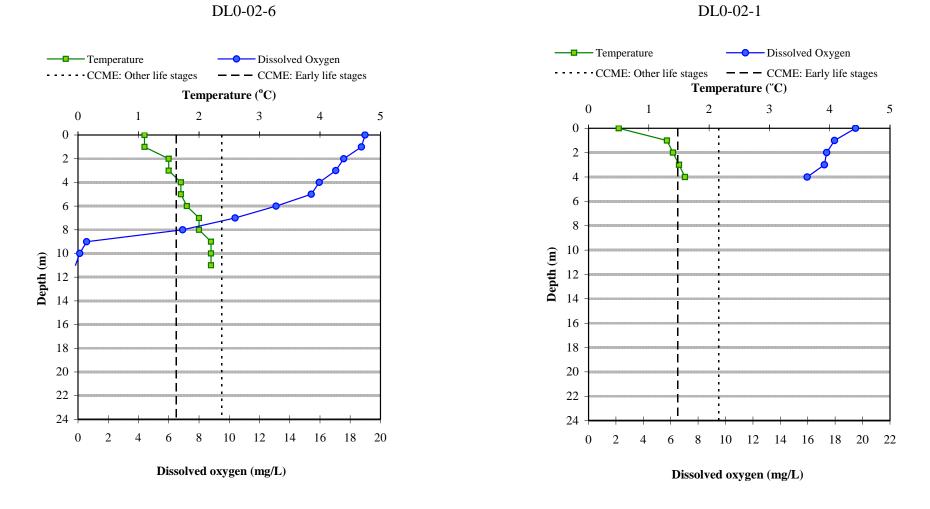
Figure 6. Temperature and dissolved oxygen depth profiles for the southeast basin of Sheardown Lake, May 2007.

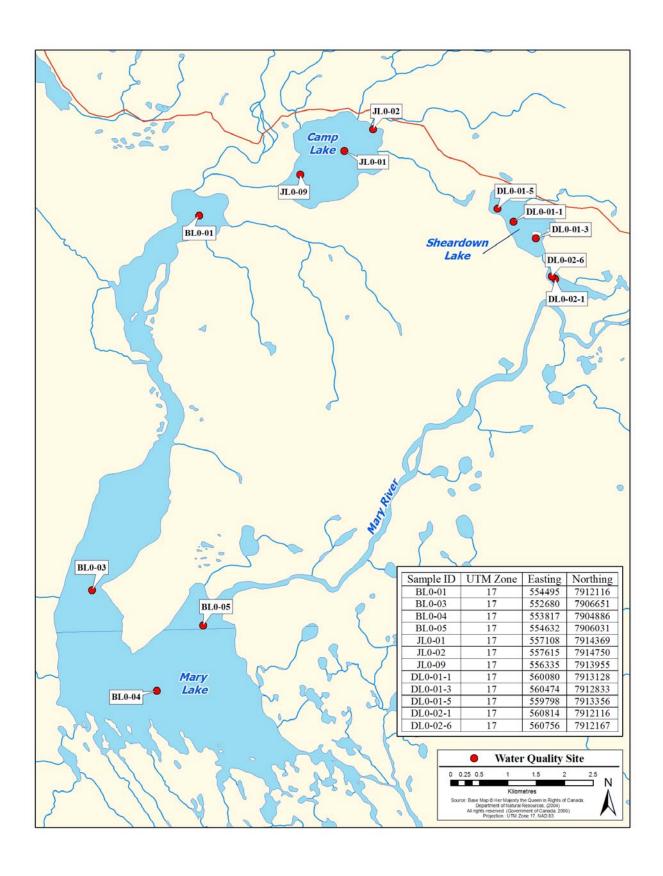
Figure 7. Water quality sampling sites: May 2007.

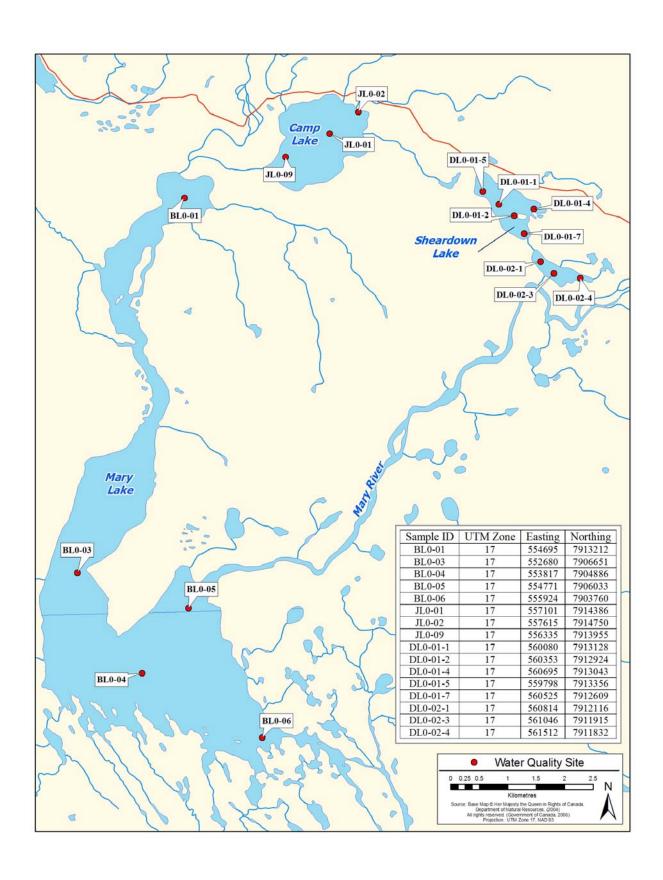
Figure 8. Water quality sampling sites: August 2007.

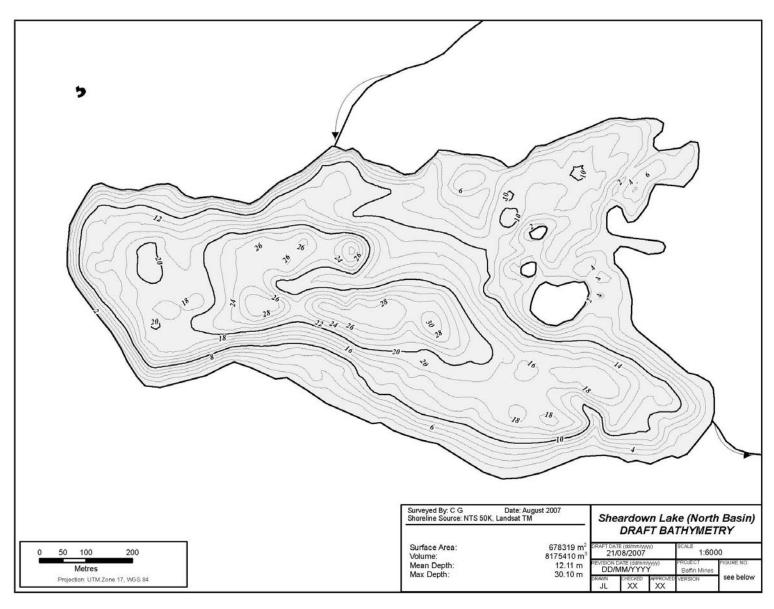
Figure 9. Bathymetric map of the northwest basin of Sheardown Lake.
