## **Fisheries Assessment of the Proposed Mammoth Channel Crossing**

AGNICO EAGLE MINES LTD. - MEADOWBANK DIVISION – WHALE  
TAIL PIT PROJECT

FISHERIES ASSESSMENT OF A PROPOSED TEMPORARY BRIDGE  
ACROSS THE WATERCOURSE BETWEEN WHALE TAIL AND  
MAMMOTH LAKES: EXISTING CONDITIONS AND PREDICTED  
EFFECTS

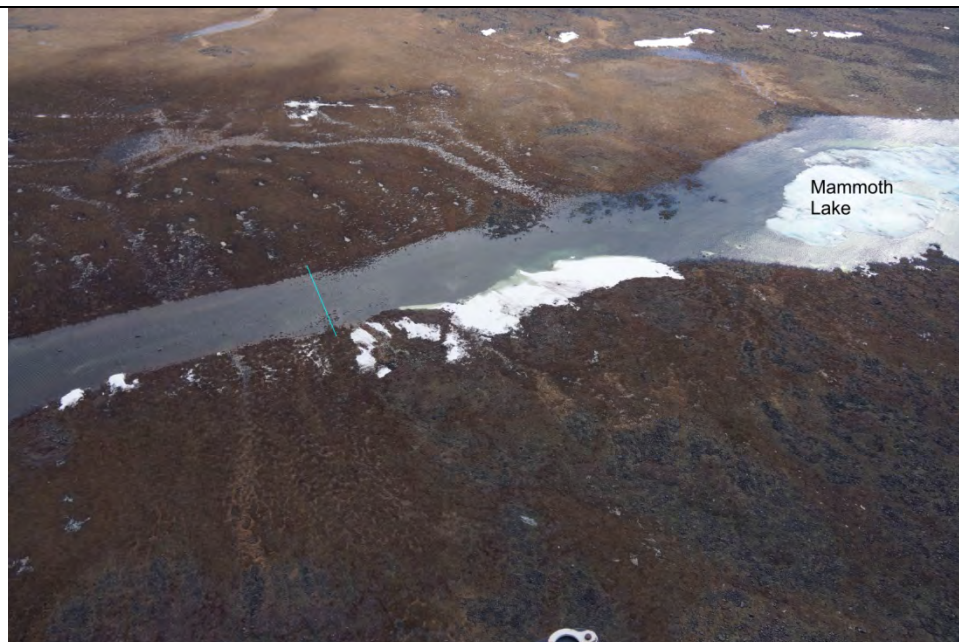
Photograph 1. Aerial view of the connecting channel between Whale Tail Lake (Lake A17) and Mammoth Lake (Lake A16). June 19, 2016. The blue line represents the approximate centre line of the proposed bridge.

Photographs are presented in Appendix A that show the crossing location under a variety of water level and flow conditions. The substrate at the proposed crossing location is a mixture of boulders and cobbles. The proposed crossing location is shown from the air on June 19, 2016, when the water level

The photographs show that, with the exception of a few protruding boulders, there was surface water present across the entire connecting channel on June 19, 2016, during the spring freshet. As water levels fall, boulder and cobble are exposed across more of the channel. On July 9, 2016, there was very little water visible at the surface between waypoint 802 and the north side of the channel and it was estimated that there was water above the boulders and cobbles over approximately 40% of the area between waypoint 802 and the south side of the channel. At low water levels there is no water above the boulders and cobbles. The channel is completely frozen during the winter.

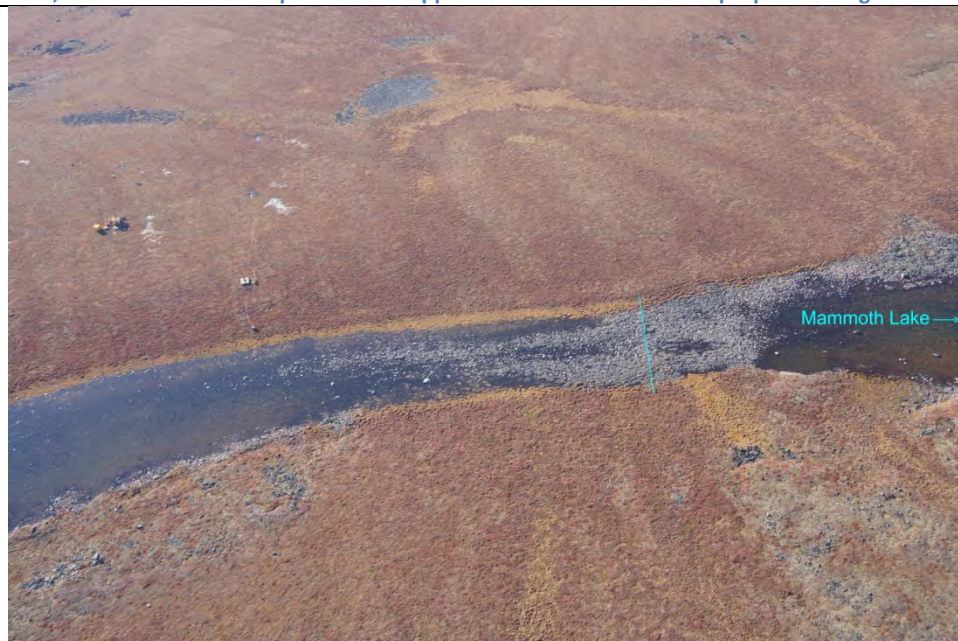
Photograph 4. Aerial view of the connecting channel between Whale Tail Lake (Lake A17, on the left) and Mammoth Lake. September 2, 2014. The blue line represents the approximate centre line of the proposed bridge.

and flow was high (**Error! Reference source not found.**), on July 3, 2016, at an intermediate water level and flow (**Error! Reference source not found.**, and on August 31, 2016, and September 2, 2014, when the water level was low (**Error! Reference source not found.** and 4). The crossing location was photographed from the ground at Waypoint 147 on July 4, 2015, when the water level was relatively high (Photographs 5 and 6), from Waypoint 802 (Photographs 7 and 8) and waypoint 803 (Photograph 9) on July 9, 2016, at an intermediate water level, and from Waypoint 438 on August 25, 2015 when the water level was low (Photographs 10, 11, and 12).

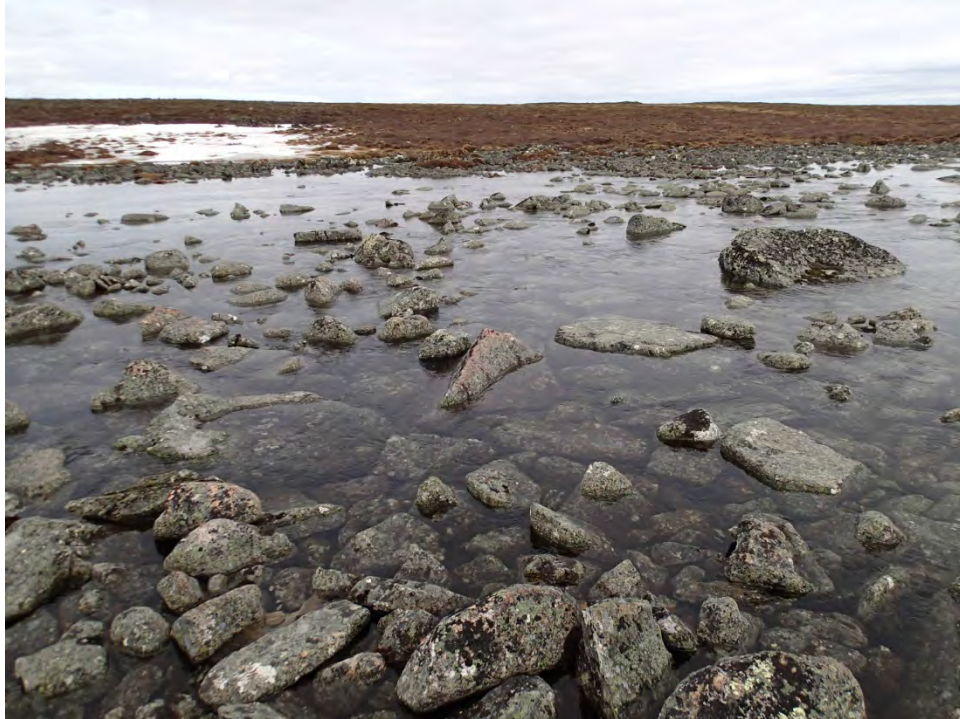
Photograph 5. View looking across and upstream from Waypoint 147 (refer to Figure 2) on July 4, 2015. The proposed bridge tie-in location on the bank is to the right of centre in this photograph.

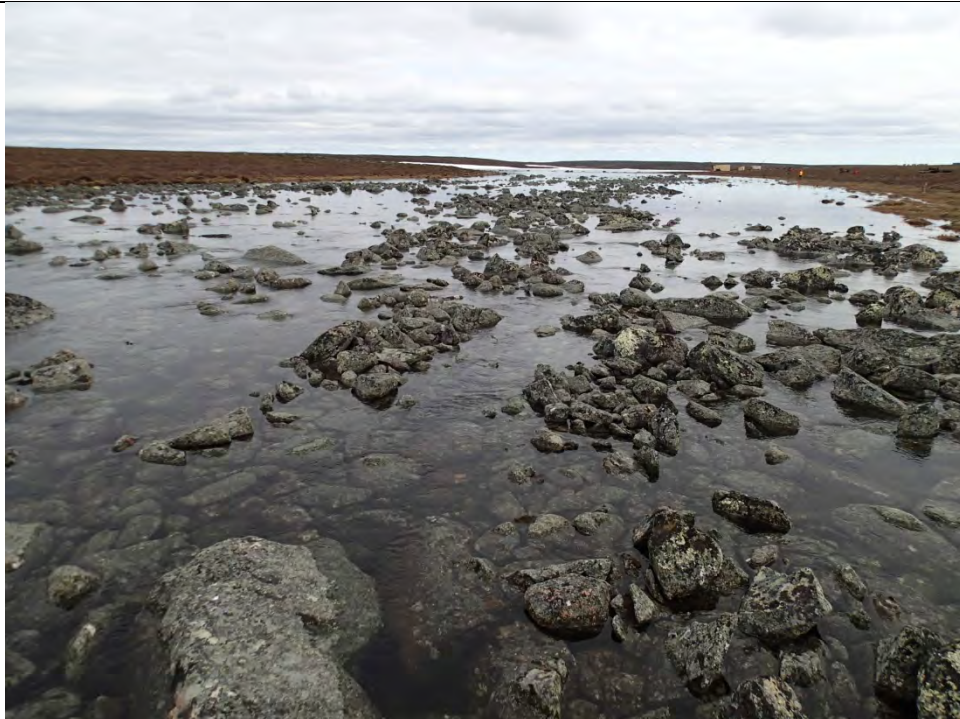
Photograph 6. View looking upstream across the proposed crossing location from Waypoint 147 (refer to Figure 2). July 4, 2015.

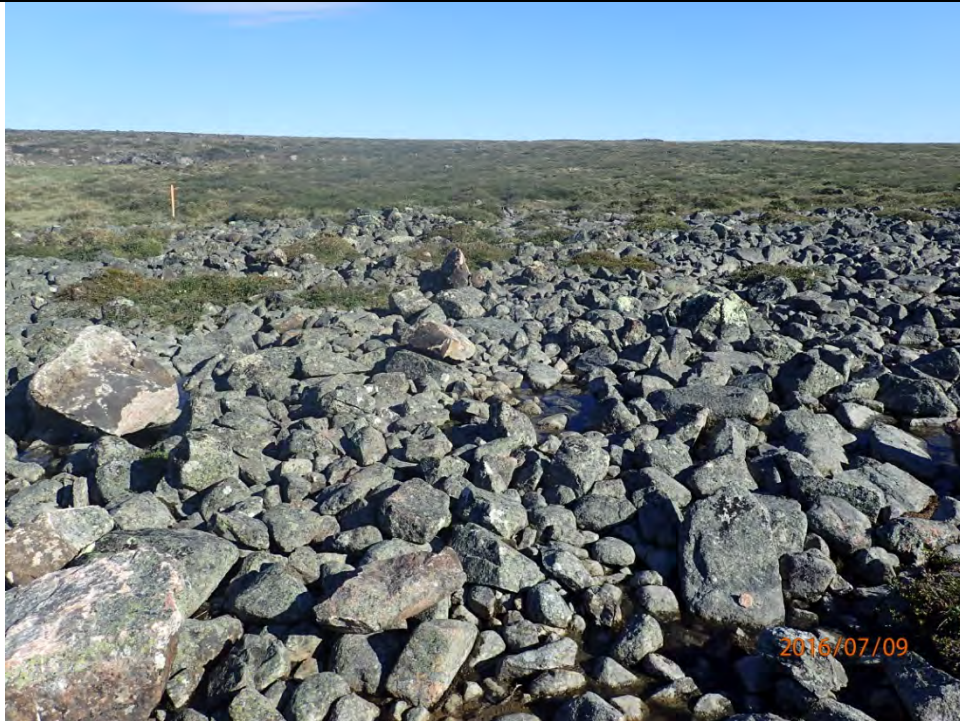
Photograph 7. View looking north-west across the proposed bridge location from Waypoint 802 (refer to Figure 2) on July 9, 2016.

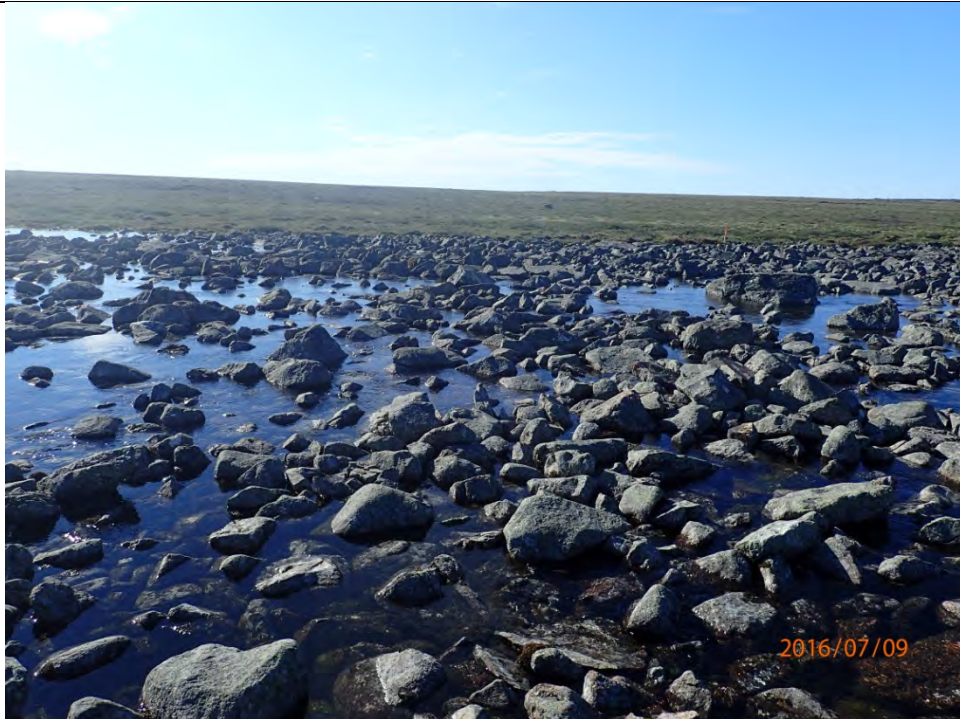
Photograph 8. View looking south-east across the proposed bridge location from Waypoint 802 (refer to Figure 2) on July 9, 2016.

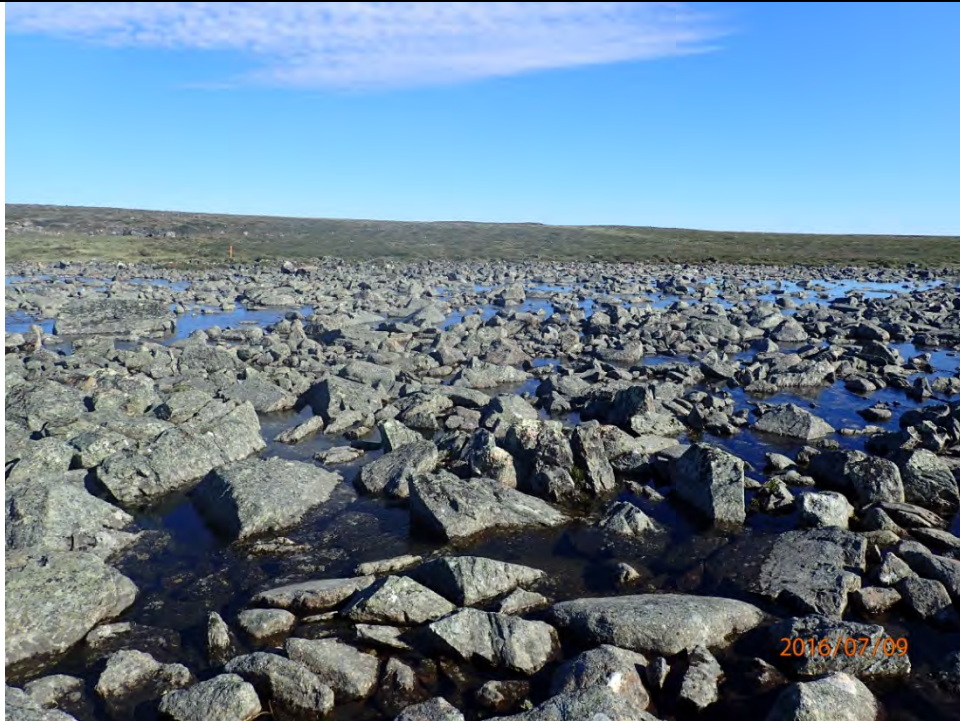
Photograph 9. View looking north-west across the proposed bridge location from Waypoint 803 (refer to Figure 2) on July 9, 2016.

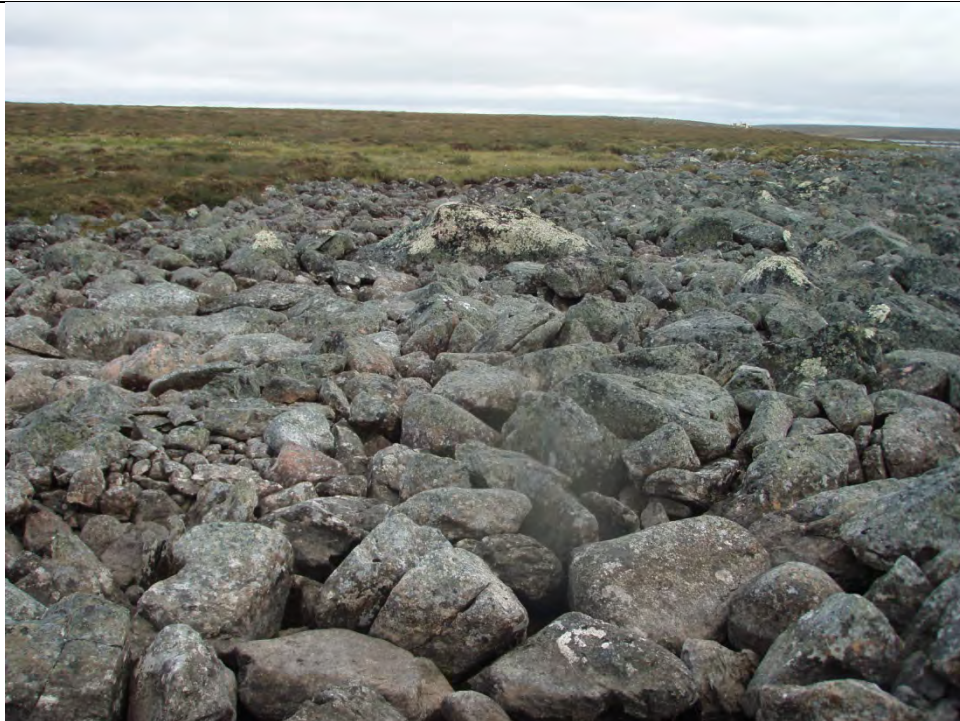
Photograph 10. View looking upstream across the proposed crossing location from Waypoint 438 (refer to Figure 2) along the left side of the connection between Whale Tail and Mammoth Lakes. August 25, 2015. Photograph 11 shows the area immediately to the right.

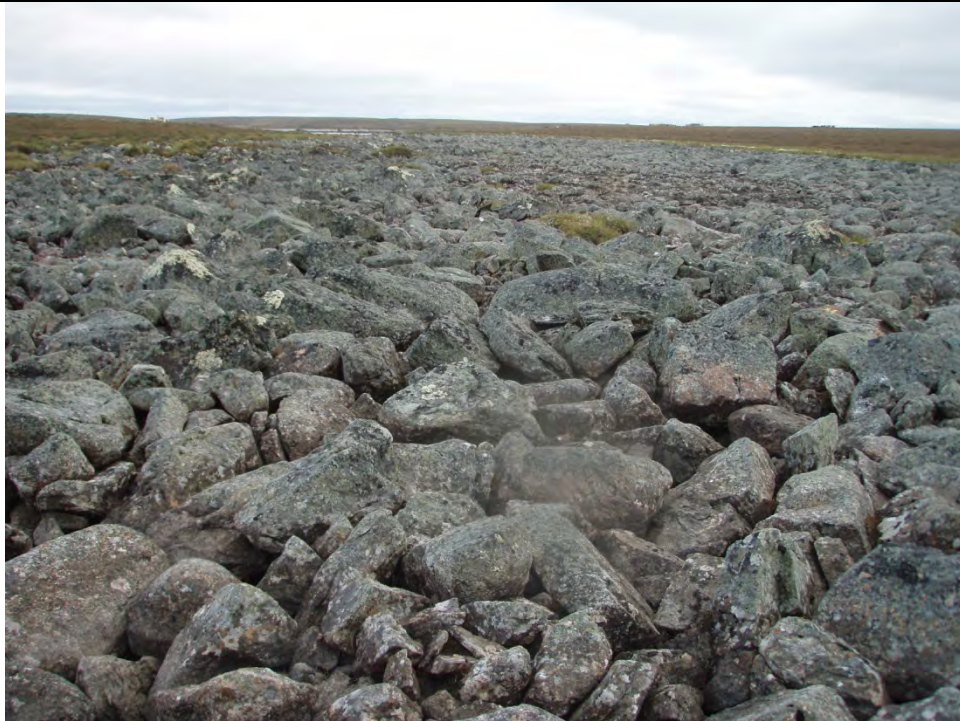
Photograph 11. View looking upstream across the proposed crossing location from Waypoint 438 (refer to Figure 2). August 25, 2015. Photograph 10 shows the area immediately to the left and Photograph 12 shows the area immediately to the right.

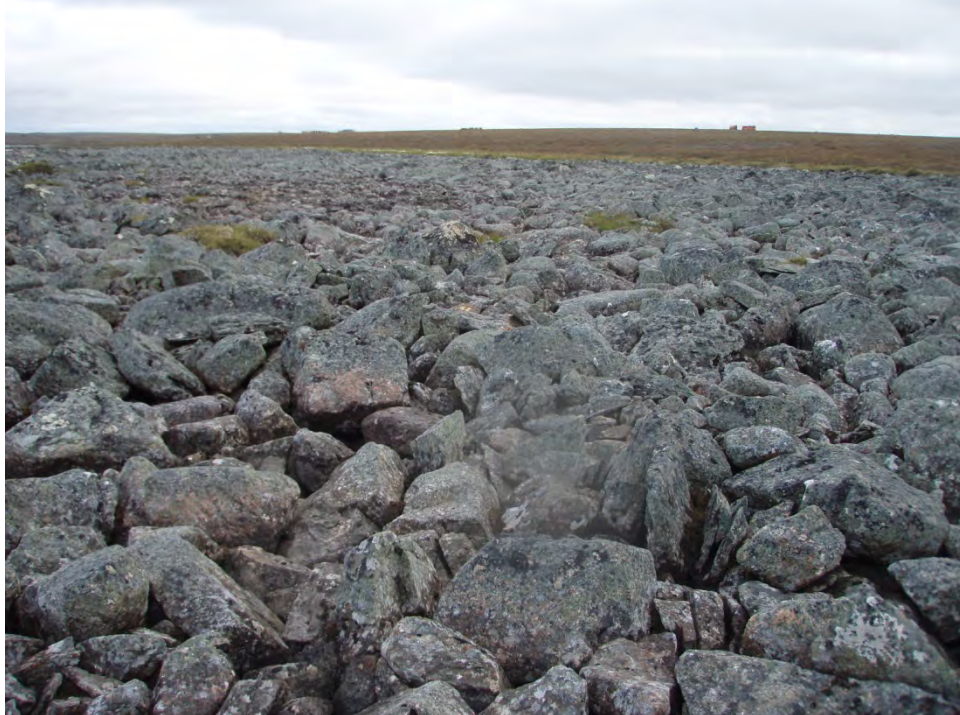
Photograph 12. View looking upstream across the proposed crossing location from Waypoint 438 (refer to Figure 2) along the right side of the connection between Whale Tail and Mammoth Lakes. August 25, 2015. Photograph 11 shows the area immediately to the left.

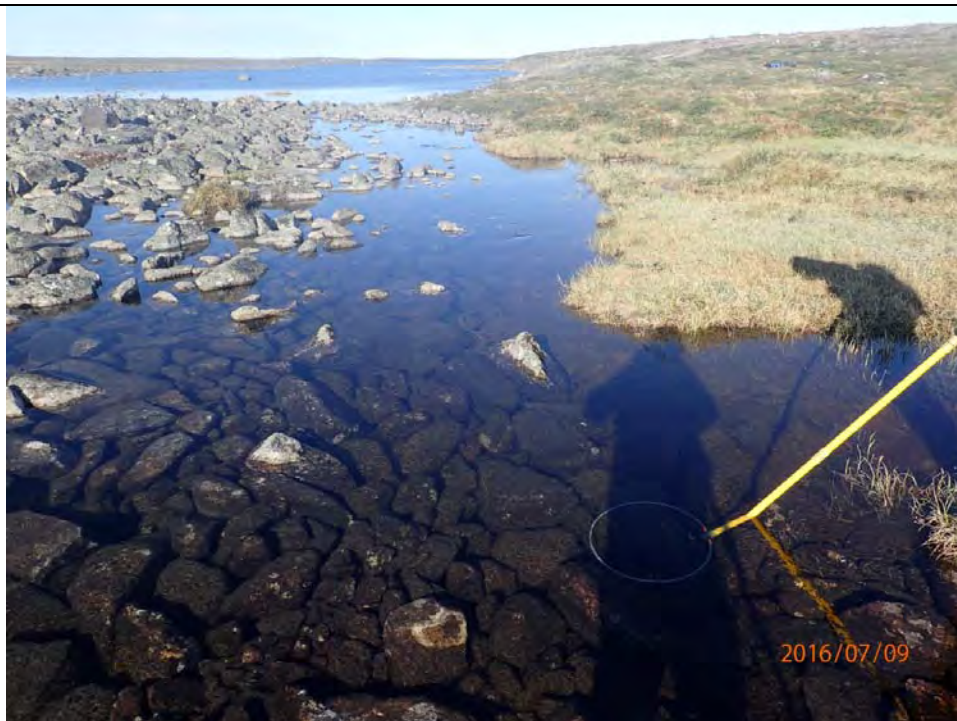
Photograph 13. View of electrofishing site 2016-A looking downstream toward Mammoth Lake from Waypoint 799. July 9, 2016.

Electrofishing was conducted in the vicinity of the proposed crossing on August 25, 2015, and July 9, 2016, by two-person crews using a Halltec backpack electrofisher set at 950 volts and 250 hertz (Figure 2, Table 2; Photographs 13 and 14). In total, three juvenile lake trout, one juvenile round whitefish, five slimy sculpin and one ninespine stickleback were captured.

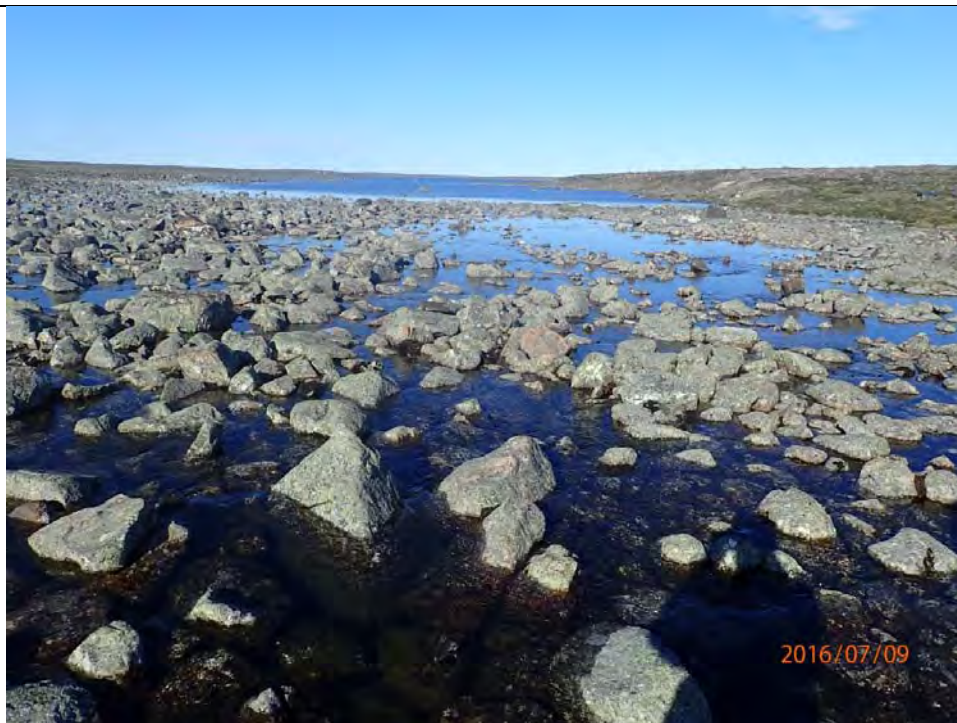
Photograph 14. View of electrofishing site 2016-B looking downstream toward Mammoth Lake from Waypoint 801. July 9, 2016.
