WATER LICENCE INSPECTION FORM

Authorization Holder	Authorization Holder Representative
Latitude Uranium	Philo Schoeman
Authorization No. / Expiry	Representative's Title
2BE-ANG2227/April 11, 2027	Camp Manager
Other Authorization No. / Expiry	
N2019C0013/July 31, 2026	
Date of Inspection	Inspector
July 14, 2024	RMO Kyle Amsel
Activities Inspected	
<input checked="" type="checkbox"/> Camp <input type="checkbox"/> Roads/Hauling	<input checked="" type="checkbox"/> Drilling <input type="checkbox"/> Other: Exploration
<input type="checkbox"/> Mining	<input checked="" type="checkbox"/> Construction <input type="checkbox"/> Other:
<input type="checkbox"/> Reclamation	<input checked="" type="checkbox"/> Fuel Storage

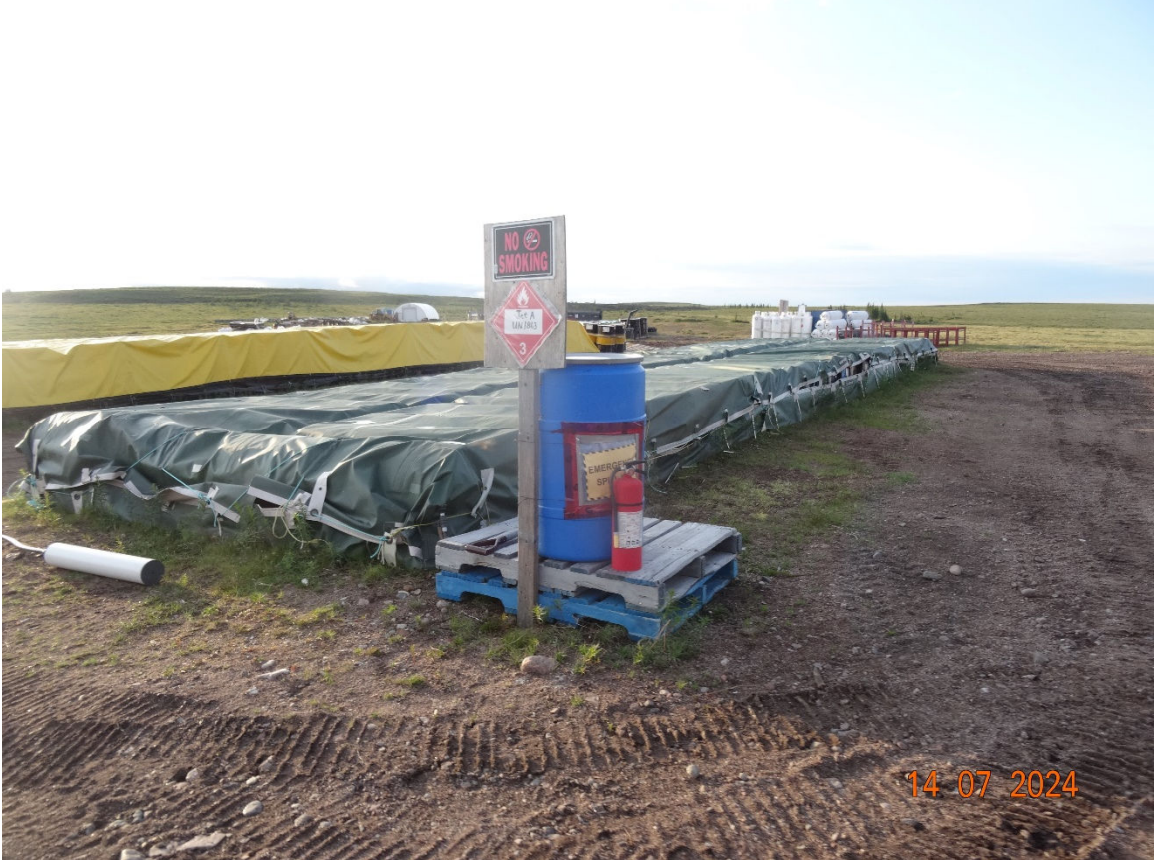
Date:	Authorization Number:	Camera/Model:	Inspector
July 14, 2024	N2019C0013	Sony DSC-HX50V	RMO Amsel
Photo No.	Lat/Long (DD.MM.SS.SS, NAD83)		
Photo 1	N62° 34' 23.1" W98° 27' 34.9"

Description:
Lined fuel drum storage

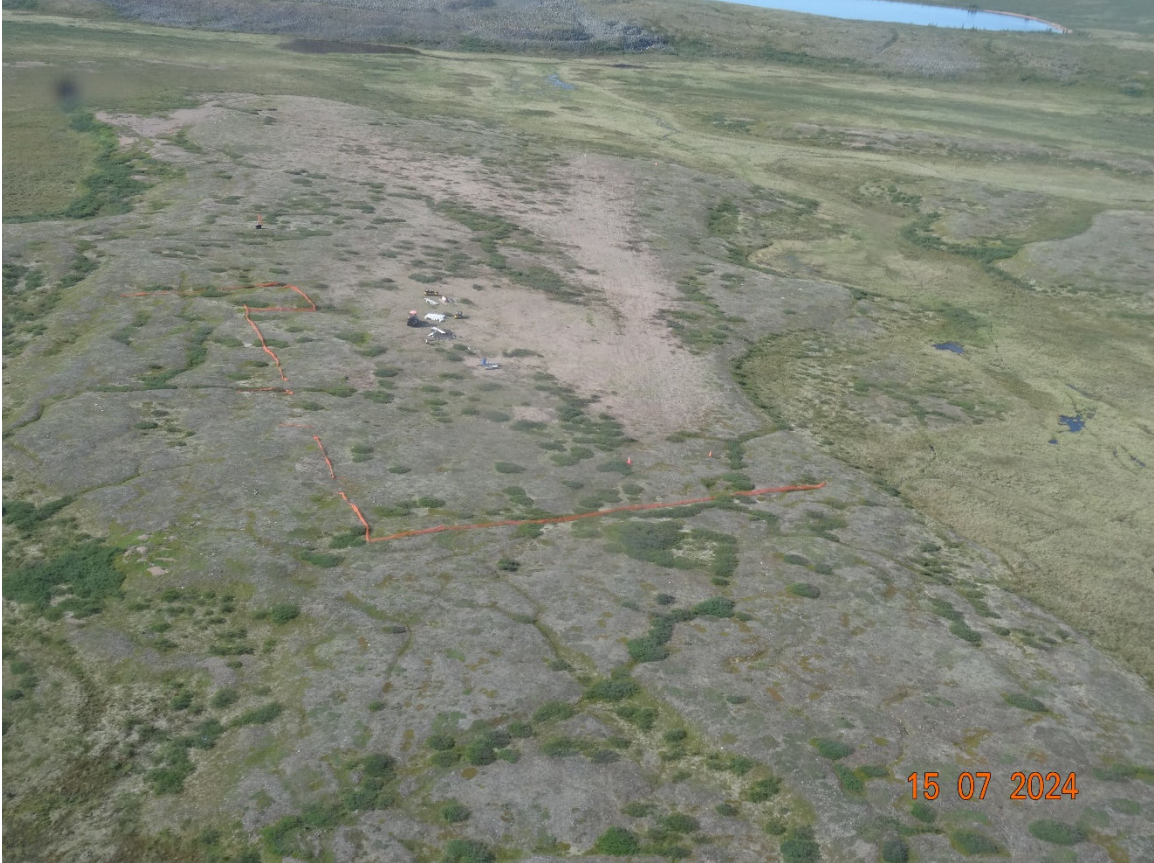
Photo No.	Lat/Long (DD.MM.SS.SS, NAD83)
Photo 2	N62° 34' 31.8" W98° 28' 59.6"

Description:
Landing strip West of Camp
