Re: Chidliak Field Program Summer 2015

This letter is being written as follow-up to the field inspection conducted on July 17, 2015 and the inspection report received on October 21, 2015. Peregrine appreciates AANDC conducting an inspection in 2015 and looks forward to an inspection again in 2016.

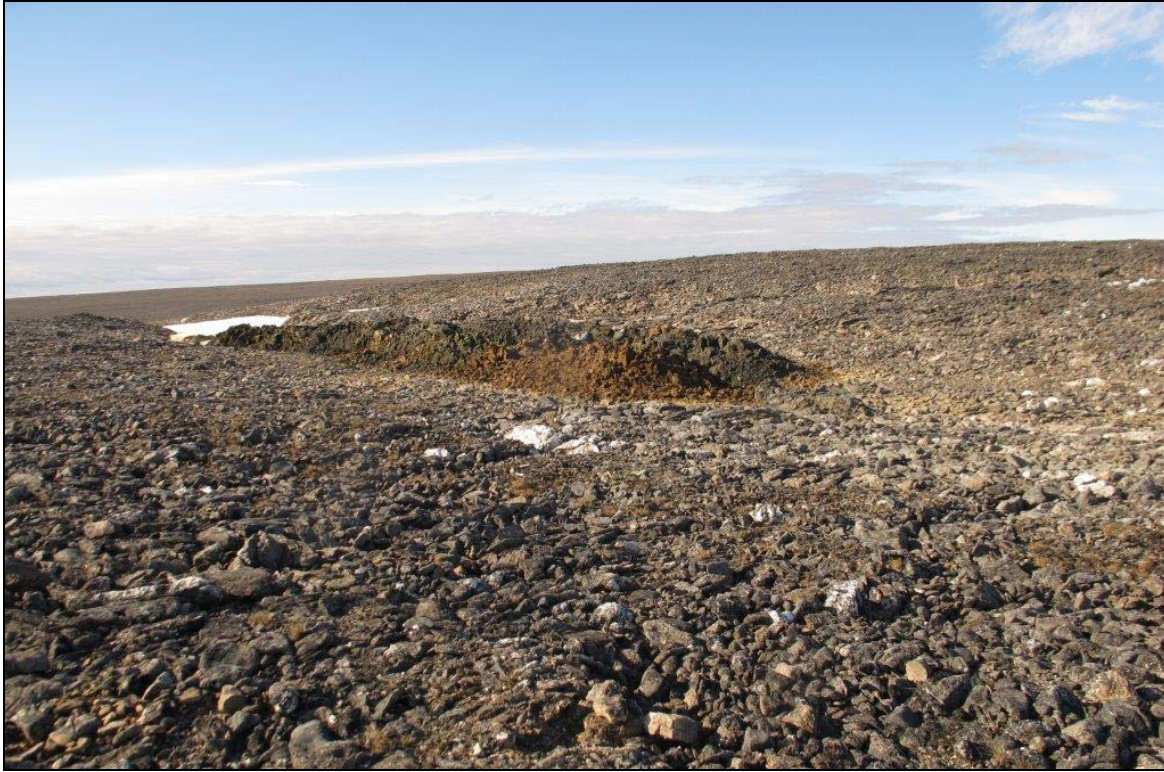
Figure 1: Drill Waste Disposal Area

A natural rock basin measuring 25 meters wide by 300 meters long and 2-3 meters deep (Figure 1) was selected as the best cuttings containment area close to kimberlite CH-7. The base of the rock basin is composed of shattered rock and additional volumetric capacity was noted within the rock fractures but not calculated.

The area was visited at both the beginning and end of the Summer 2015 field program. Any debris (bulk bags, wood) left behind from the Winter 2015 field program was consolidated and removed. No discharge was noted from this area during the Summer 2015 field program. The area will continue to be monitored and, to allay any concerns, in 2016 a water sampling station will be added if any water discharge is noted.

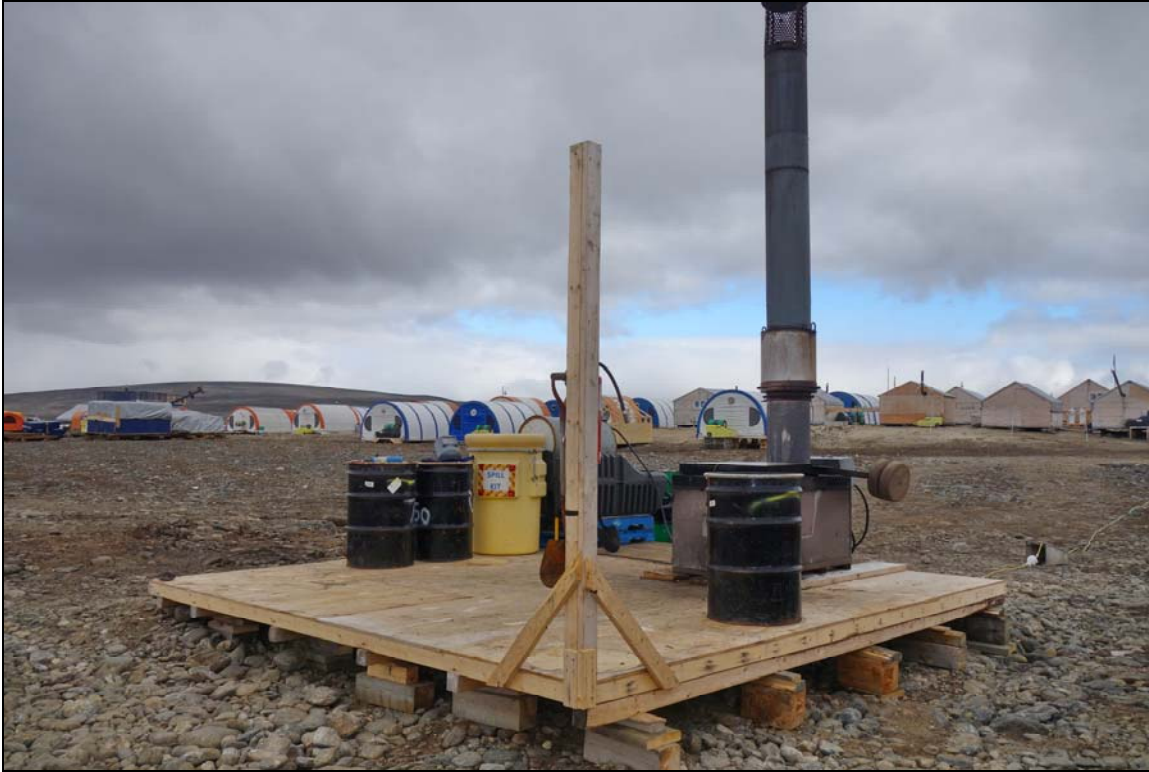
Figure 2: Incinerator Station.

The incinerator area was in need of maintenance being at the most westerly edge of the camp facility and receiving the full brunt of winter winds. When field staff returned to the camp in July they immediately addressed this matter, cleaned up woody debris and made improvements to the incinerator station. The station now includes a large incinerator platform upon which to store debris destined for incineration (Figure 2)
